MARINE SAFETY INVESTIGATION REPORT

Safety investigation into the serious occupational accident on board the
Maltese registered heavy lift /pipelay vessel

PIONEERING SPIRIT

MARINE SAFETY INVESTIGATION REPORT NO. 02/2021

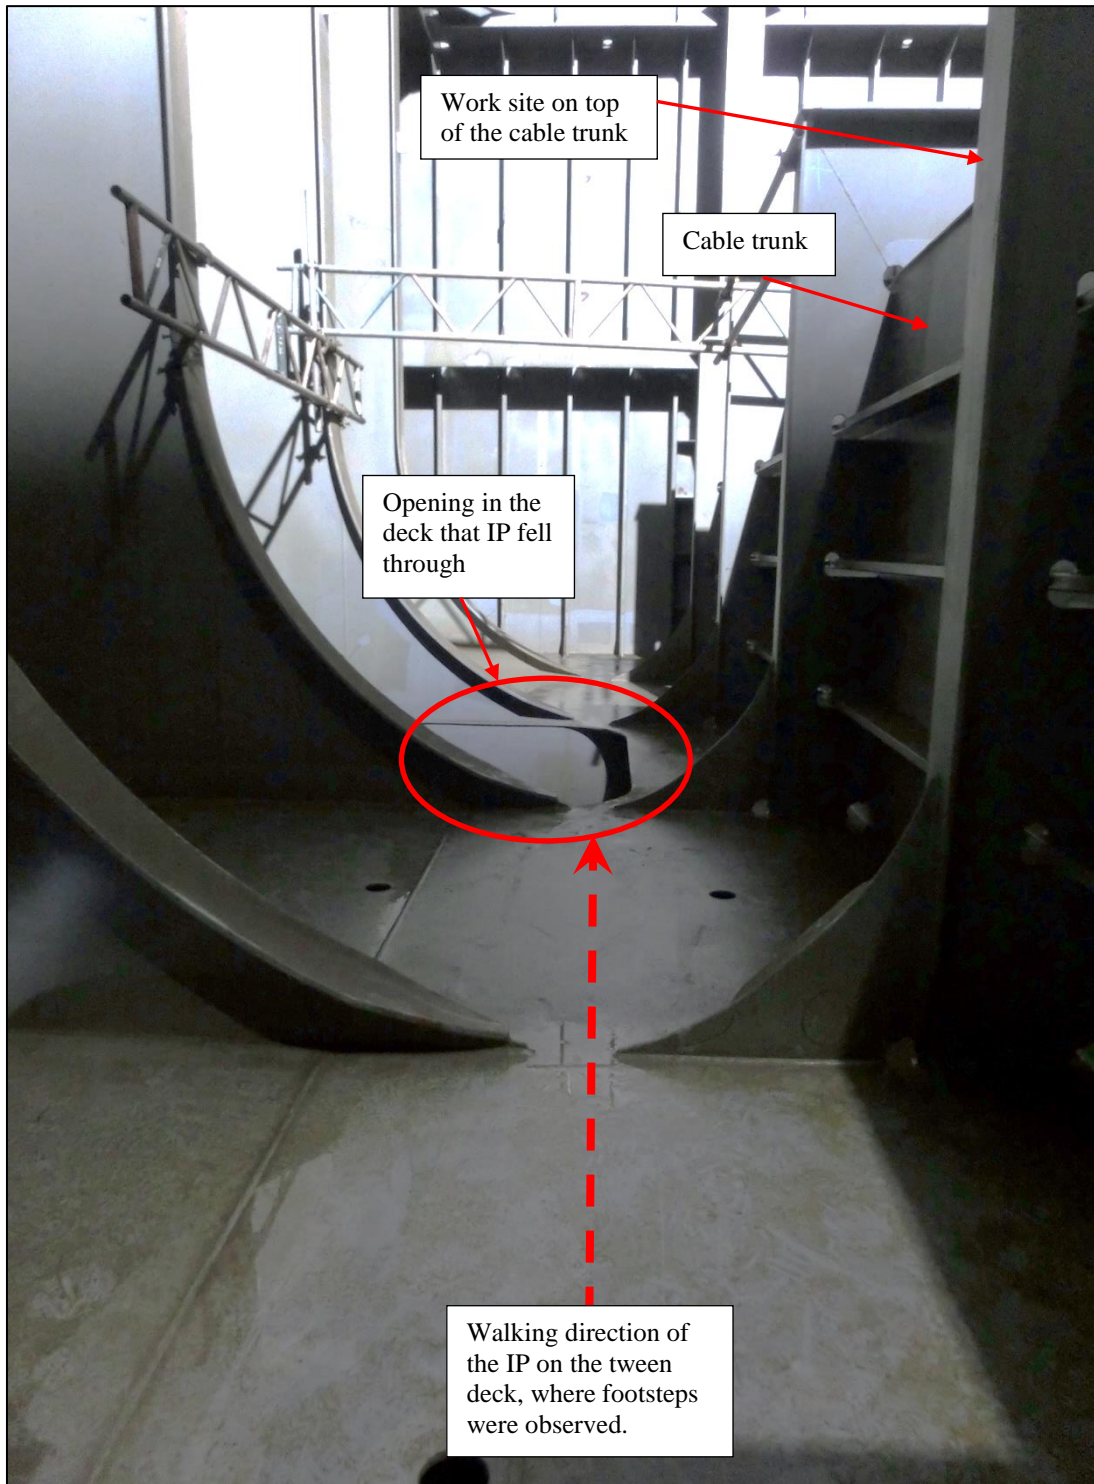
Figure 12: Access ladder passing cable trunk. Lighting conditions are similar to those at the time of the accident

The opening in the deck through which the IP fell, was located about halfway from the guard railed passageway to the aft bulk head of the tank (Figure 12). Neither permanent nor temporary barriers had been fitted specifically around the opening in the deck.

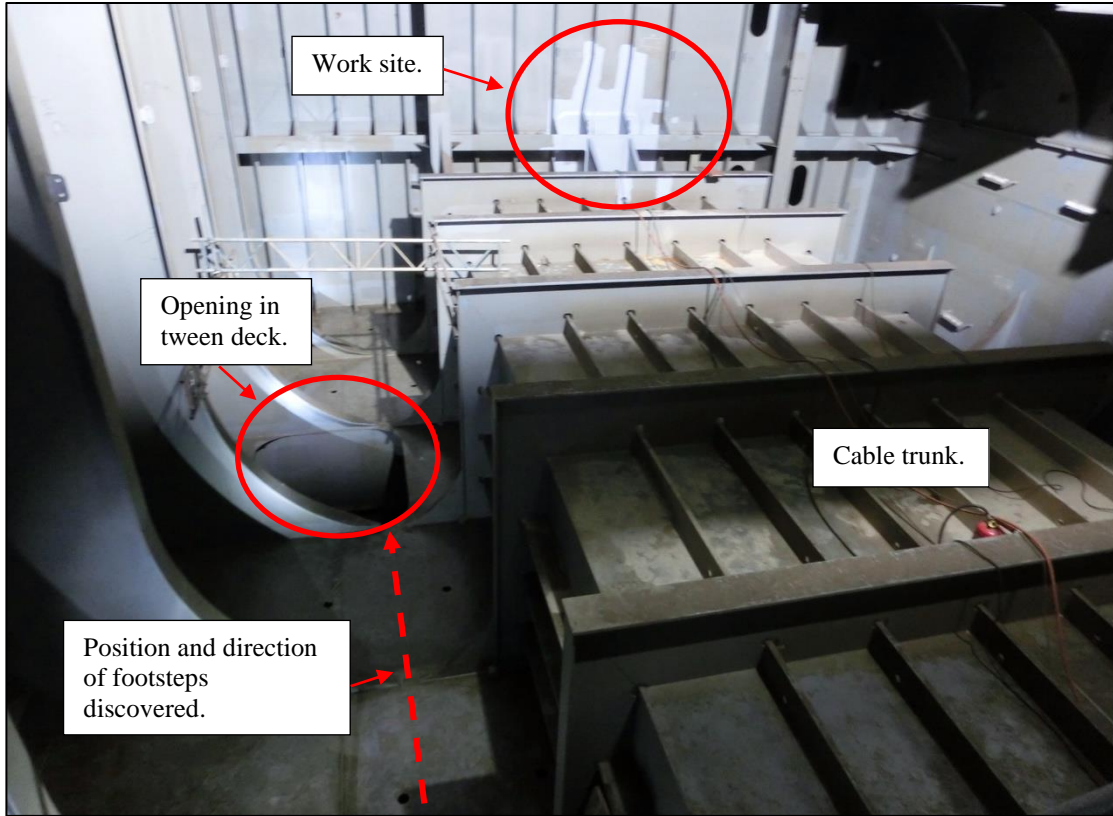
Figure 6: Most probable route taken by the IP

At around 1330, on his way down the ladder, the first welder helper shouted for the IP but received no response. He shouted to the welder that the IP was nowhere to be found on the tween deck below the trunk. When the first welder helper made a turn at the bottom of the access ladder, he observed fresh shoe prints on the otherwise untouched sludge coating on the tank tween deck going aft from the tank access pathway, which was bounded by hand railings. The shoe prints led along the side of the trunk in the direction of the work site (Figure 6).

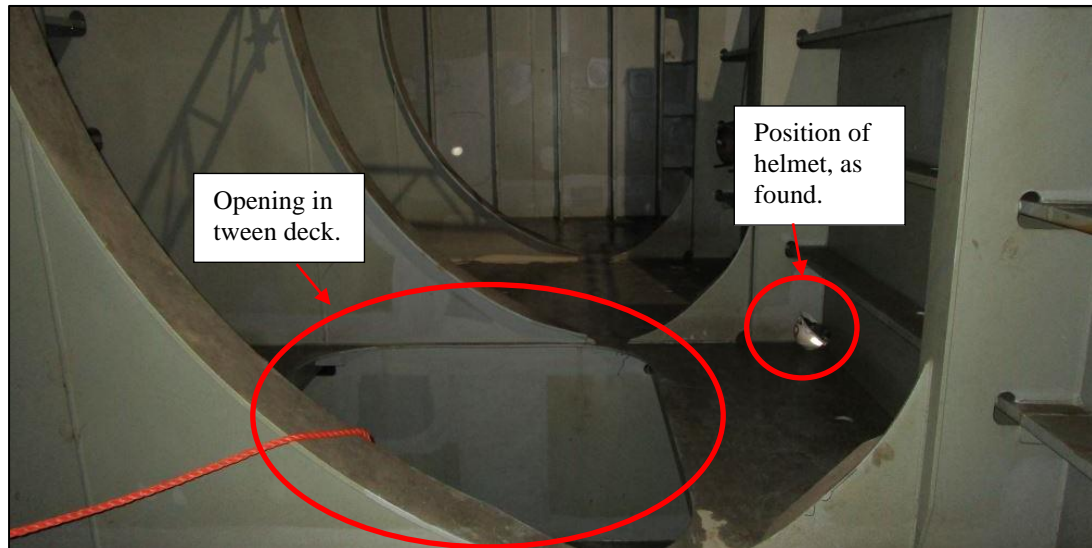
Figure 7: Accident site

There, the first welder helper discovered a hard hat lying on the deck with the head torch still lit just next to a large opening in the deck leading to the lower level of the WBT (Figure 7).

This safety investigation believes that absence of material barriers around the tween deck opening inside of WBT no. 1006, was contributory to this occurrence.

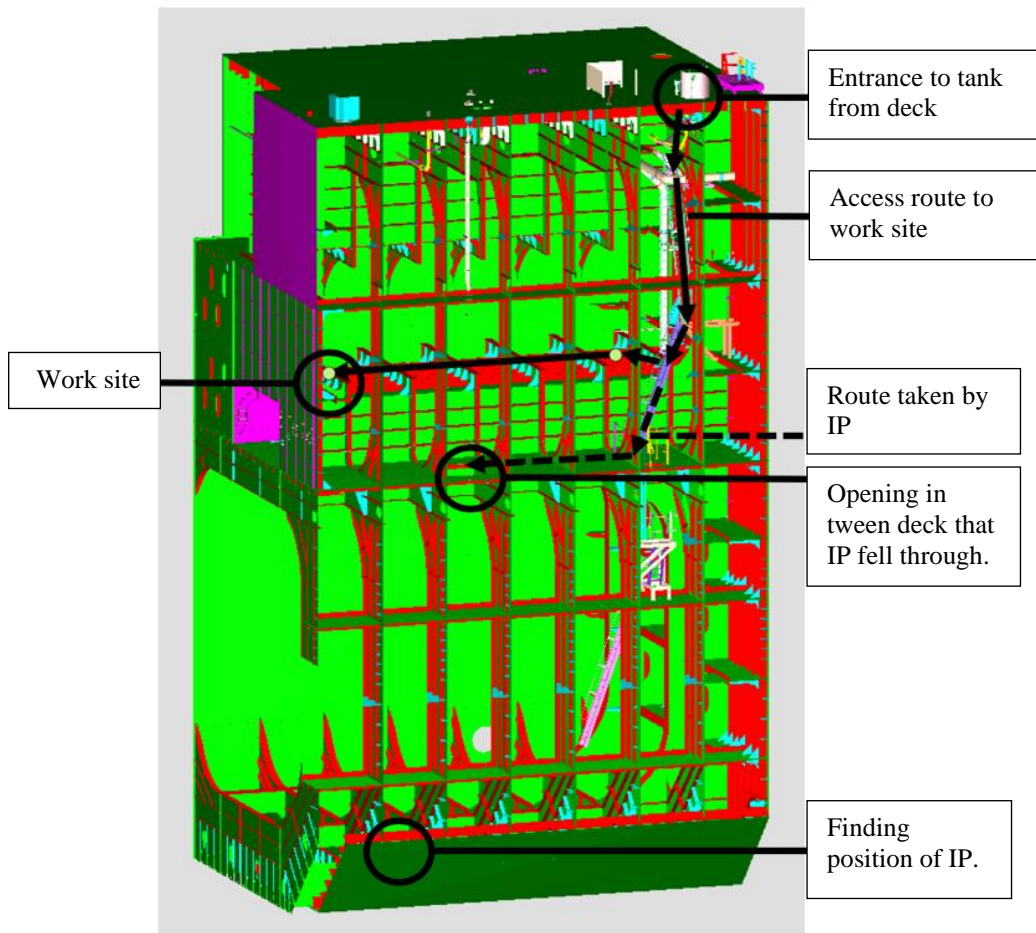
Figure 15: 3D model of water WBT no. 1006, as viewed from starboard side - walking routes marked

- the IP was looking up in the direction of the work site while walking ahead, failing to see the opening;
- the bag he was carrying may have obstructed the opening on the tween deck;
or
- the IP noticed the opening ahead of him but, while circumnavigating it, slipped and fell through the opening.

Through these hypothesis, the safety investigation also considered the possibility that the IP was uncomfortable with crossing the one metre gap in between the access ladder and the cable trunk.

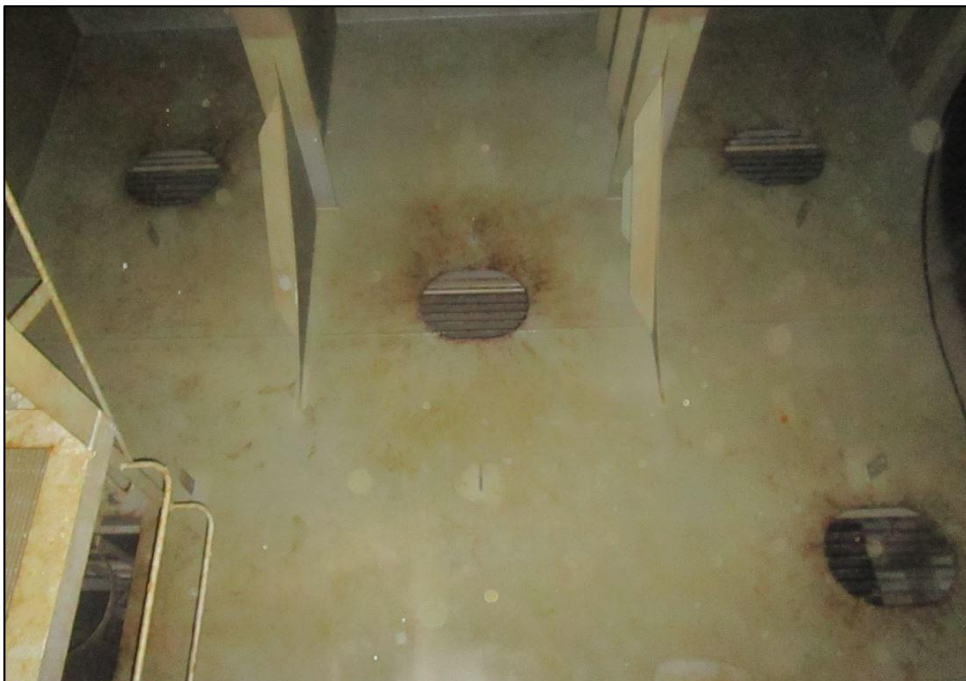
Figure 16: Protected openings on tween decks of other water ballast tanks

It was later revealed that some WBTs fitted on board *Pioneering Spirit* had bars across the tween deck openings to prevent someone from going through. These openings were noted to be of smaller diameters than the ones fitted in the WBT (Figure 16). It was not known why these bars had not been installed on all tween deck openings of all tanks present on board.
