SAFETY INVESTIGATION REPORT

REPORT NO.: 01/2021

January 2021

MV STARA PLANINA **Two manoverboards** **in position 66° 05.0' N 005° 26.3' E,** **02 January 2020**

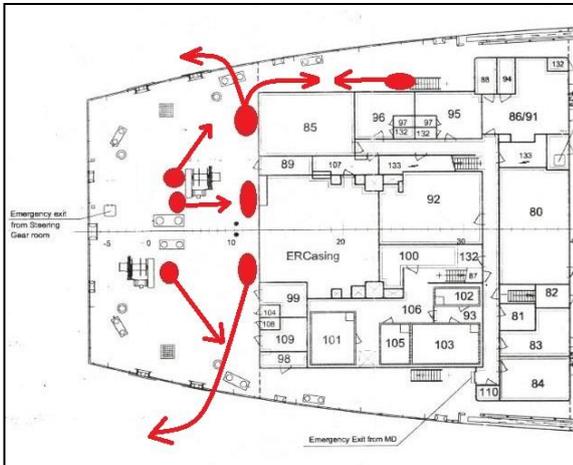
At around 1000, on 02 January 2020, the second engineer observed loose mooring ropes around the poop deck, with some dangling over the vessel's guard rails (Figure 2). He immediately notified the third officer, who was keeping a navigational watch on the bridge, via telephone.

Figure 2: Poop deck. Red dots indicate the stowed position of the mooring ropes. The arrows indicate the direction that the mooring ropes were scattered

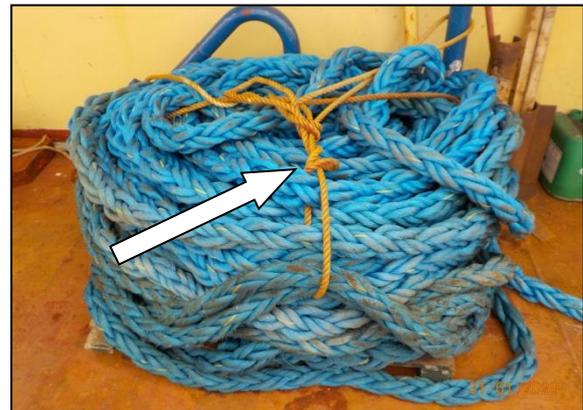
Figure 3: One of the mooring ropes on the poop deck, secured on a pallet and an adjacent fitting

The mooring ropes were secured on pallets, using two smaller ropes, and crossed and wound around a fixed structure. It was noted that the smaller ropes did not secure the mooring rope in its entirety, but only the topmost coils (Figure 3).

This procedure may have sufficed in fair weather conditions, when the movements of the vessel would have been limited. However, considering the rolling and pitching movements of the vessel in inclement weather, coupled with the wash of the waves over the poop deck from time to time, may have led to the bottom coils of the mooring ropes to slip out of the securing and scatter around the deck.

It appeared that the approach applied to secure the aft mooring ropes, did not suffice to prevent the mooring ropes from scattering around the poop deck and over the rails in the encountered adverse weather conditions.

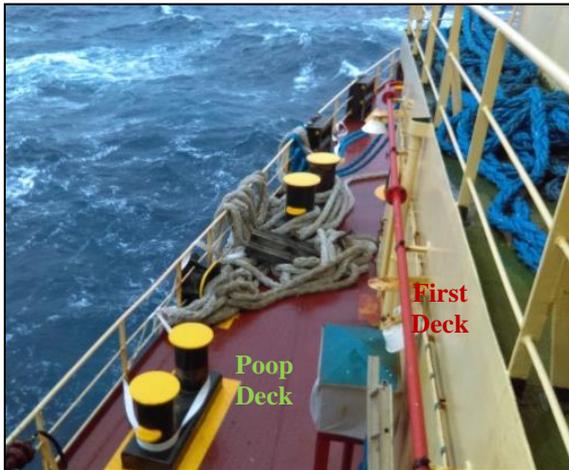
At around 1100, two ABs and the deck trainee arrived on the first deck to assist. The operation moved to the starboard side and, at one point, the deck trainee was seen on the poop deck assisting the chief officer. As the crew could not untangle two of the mooring ropes on the starboard side, the crew members secured them to the guard rails of the poop and first decks (Figure 4).

Figure 4: Situation on starboard side, two ropes secured to the railings of the poop deck, while the end of one of the ropes was hauled onto the first deck

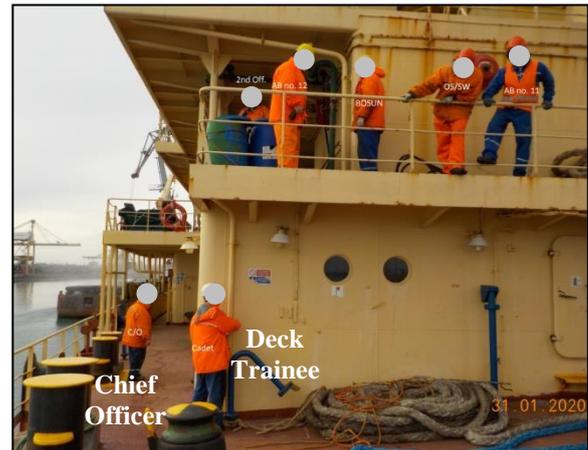
The crew reported that at this moment, a large wave suddenly washed over the poop deck from starboard to port sides. Unexpectedly, a second larger wave washed on board from the same direction and within seconds of the first one. Both the chief officer and the deck trainee were swept overboard. Figure 5 shows the position of the crew members at the time of the accident.

Figure 5: Simulation of the crew's location when the waves washed over the poop deck

Two consecutive, unexpected large waves (the second one reportedly larger than the first), washed over the poop deck where the chief officer and the deck trainee were located. Reportedly, both crew members were not secured to the vessel, given that the securing operation of the mooring ropes had been completed.

The safety investigation hypothesized that a sudden roll of the vessel was possibly induced by the waves. Furthermore, the force of the wave itself may have been too strong for the chief officer and the deck trainee to react, leading to their fall overboard.

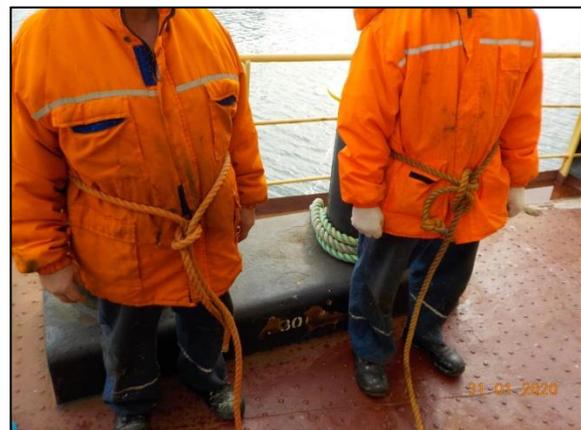
and the deck trainee had ropes tied around their waists (Figure 6). Most of the crew members could not confirm whether the other end of their rope was secured to the vessel during the recovery of the mooring ropes. One of the crew members stated that the rope was not secured to any part of the vessel, as the other end was noticed lying free on deck. Another crew member stated that the chief officer and the deck trainee were tied together with the same rope.

However, all crew members confirmed that when the two large waves washed over the poop deck, both the chief officer and the deck trainee were not secured to any part of the vessel⁶

Figure 6: Simulation of how the rope was tied around the chief officer's and deck trainee's waists

The crew used ropes around their waists. Although the plan to secure oneself had been put in practice, this did not provide the necessary protection to the two crew members. A fall of a crew member from a height, while being secured with a rope, would result in internal/external injuries in the abdominal region and back. A safety harness is designed to prevent such injuries¹³.
