**MARINE ACCIDENT
INVESTIGATION REPORT**

Vessel type and name: Cargo vessel JIA DE

Accident/Incident type: Foundering

Date and time: Around 21:39, October 12, 2019 (local time, UTC+9 hours)

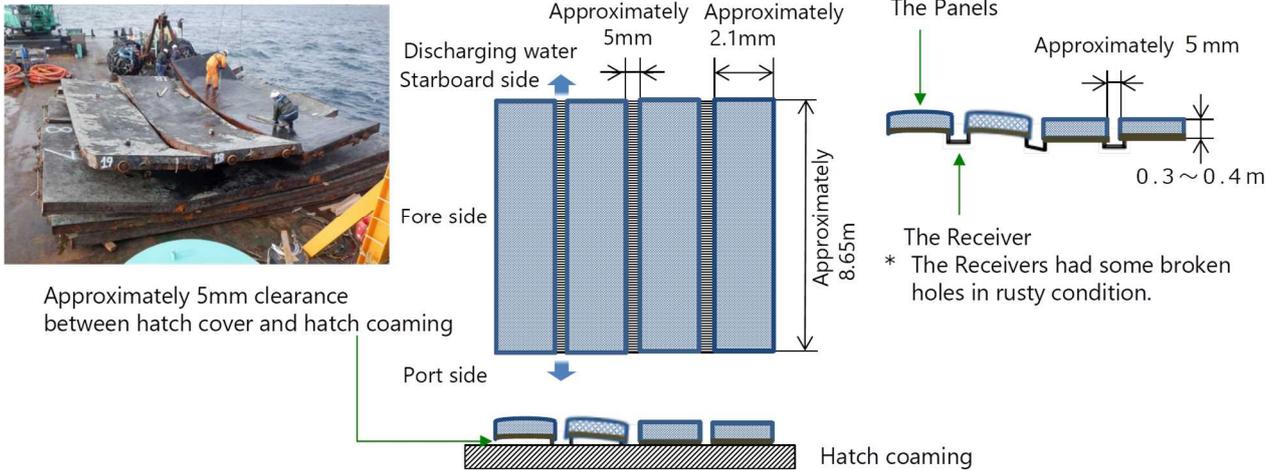
Figure 5 Construction and Condition of the Panels

The Panels after recovery

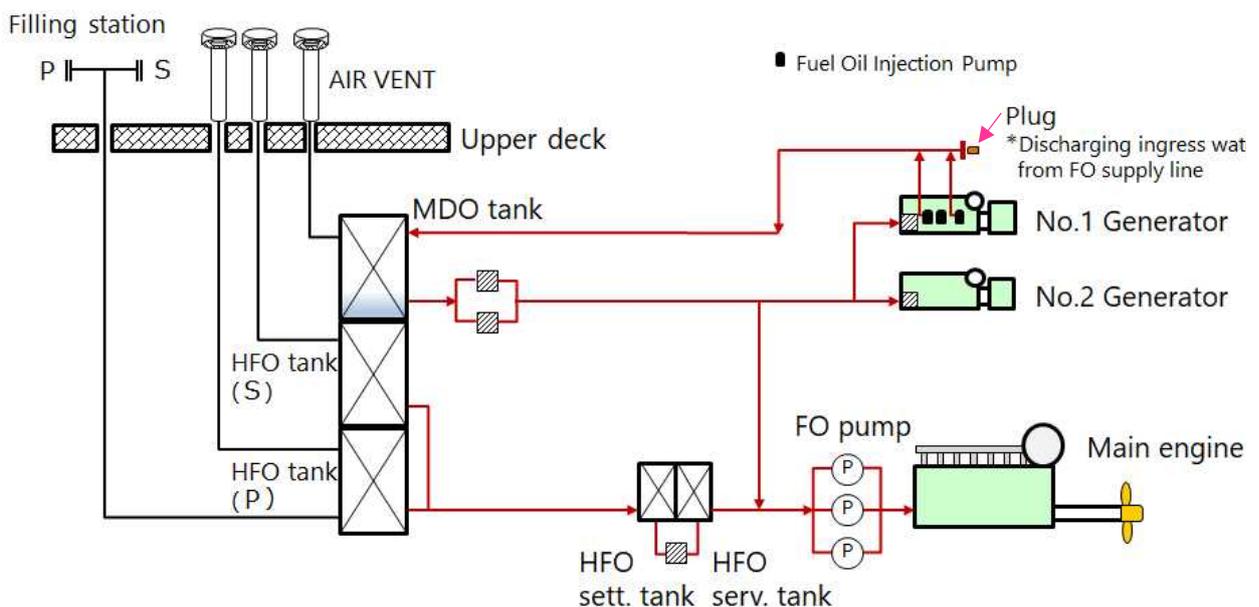
Figure 6-1 Schematic Diagram of the FO Supply Line

Chief Engineer and Engineer checked the fuel oil supply line (hereinafter referred to as "the FO line") of No.2 diesel generator engine, and then they discovered that some ingress water had infiltrated in the FO line, and subsequently conducted work to discharge ingress water from the FO line and put the No.2 generator into a condition of being available for running.

MDO was stored in the MDO tank, with the height of MDO tank being from the bottom deck to the second deck, and was supplied through a duplex strainer to the generators and the main engine, which was in stand-by condition while entering and leaving port, etc.

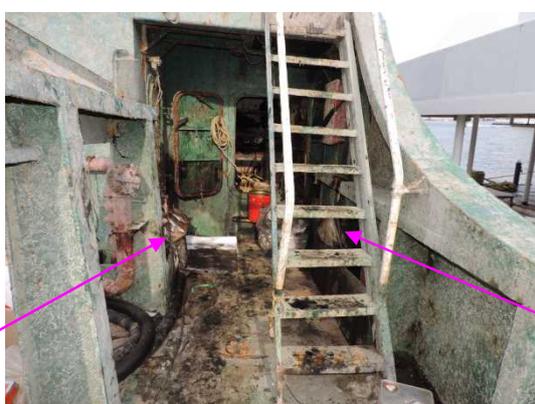
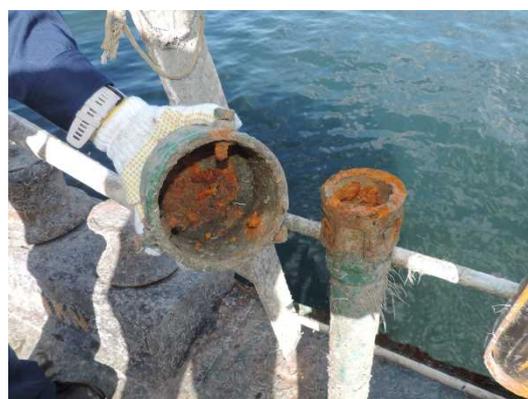
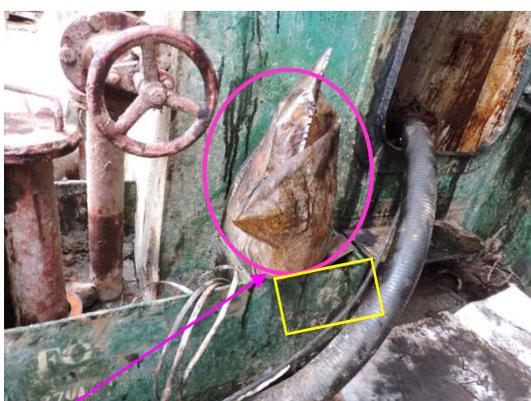
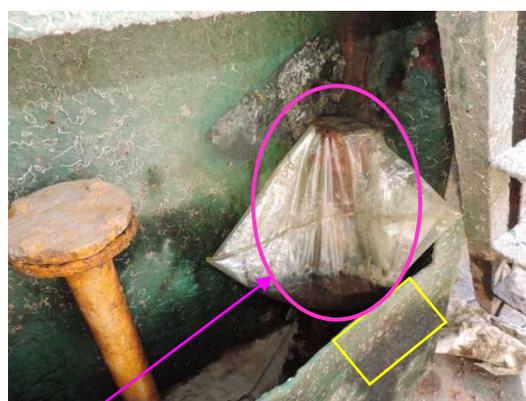
Arranged position, port-stern part on upper deck Construction of air vents for similar air vents

① Deck house side of port-stern part

② Bulwark side of port-stern part

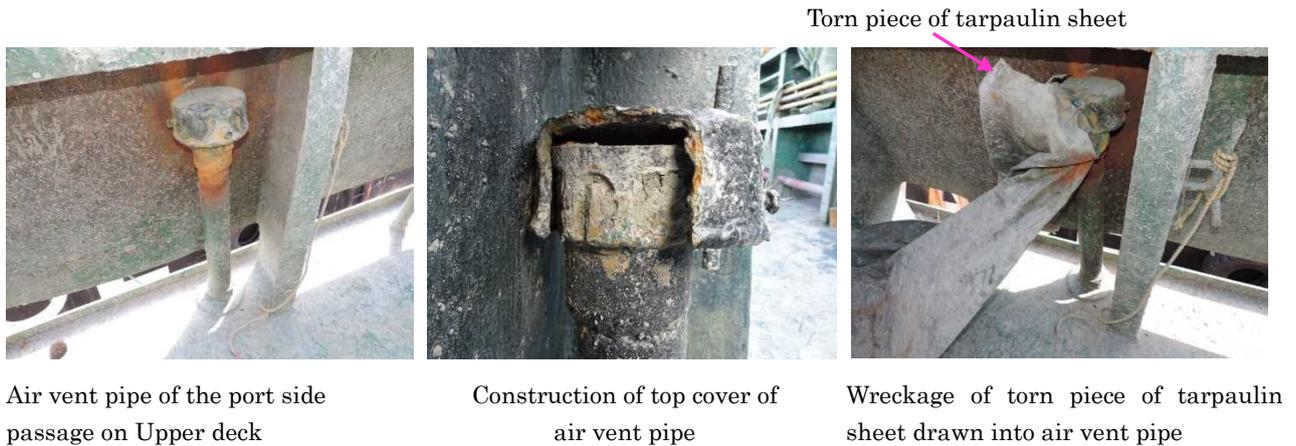
Figure 7 Condition of Air Vent Pipe of Ballast Water Tank

were drawn with ingress water into the ballast tanks when the accident occurred. (See Figure 7)

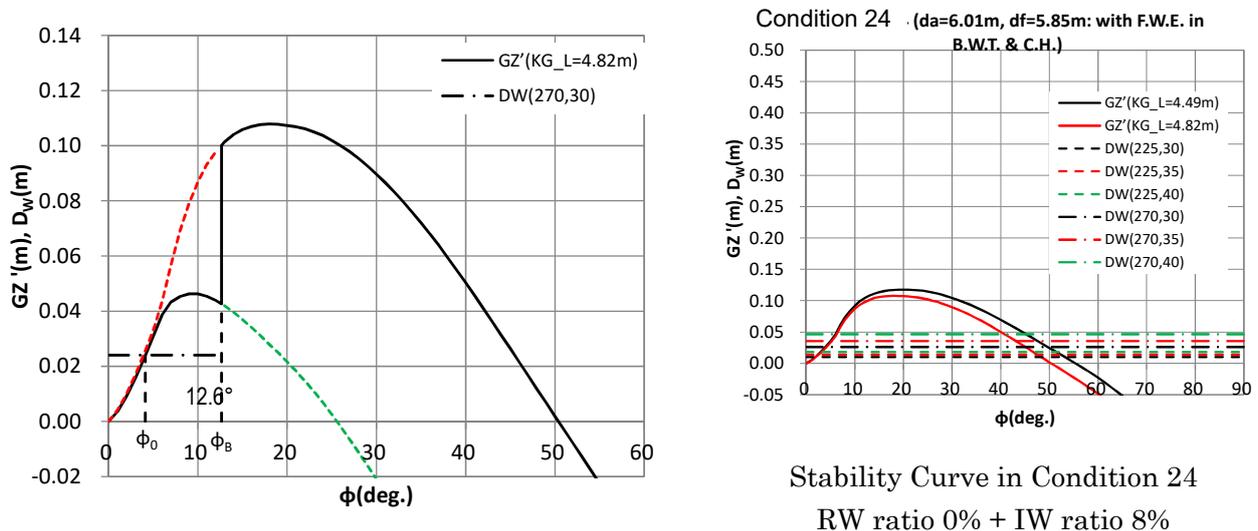
Figure 16 Stability Curve and Heeling Couple of Force Lever at the Accident Occurrence
 Stability curve Condition 14, Condition 24: $KG_L=4.82m$
 Heeling couple of force lever Heading: 270° , Wind force: 30 m/s; Condition 14

In Figure 16, the red dotted line is the stability curve of Condition 24 in the case of $0 \leq \phi \leq \phi_B$, and the green dotted line is the stability curve of Condition 14 (a Retained Water ratio of 75%) in the case of $\phi_B \leq \phi$.

However, in case that the lateral heeling angle exceeds the submerged angle 12.6° of the top of the bulwark, the stability transits to the condition of ingress water being in the cargo holds without the Retained Water (Condition 24), and furthermore it is assumed that the heeling couple of force due to winds also transits to the couple of force of Condition 24.

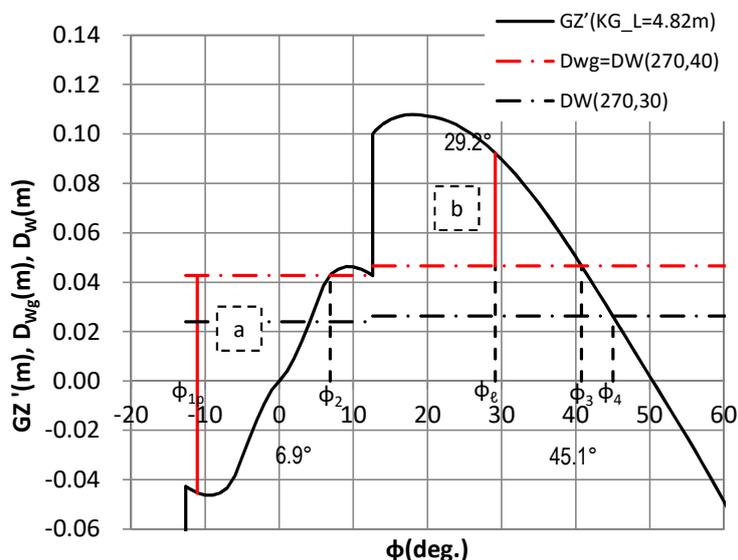
Figure 18 Calculation of Energy Balance

D_{wg} by means of gusts of wind is defined as the heeling couple of force DW (270, 40) due to wind of a wind speed of 40 m/s in a condition of the heading of the Vessel as 270° and the lateral heeling angle is 6.9° (Table 14) in the case of gusts of wind acting quasi-statically. Furthermore, conducting the analysis utilizing the analyzed value ($\phi_{1p} = -11.1^{\circ}$) in item (ii) as the maximum heeling angle to the port side, the maximum heeling angle is 29.2° . Moreover, the transit of the stability curve in case of a lateral heeling angle to the starboard side exceeding the submerged angle 12.6° (ϕ_B) of the top of the bulwark is similar to that mentioned above.
