# National Transportation Safety Board

## Marine Accident Brief

### Contact of Liquid Petroleum Gas Carrier *Levant* with Mooring Dolphin

<b>Accident type</b>	Contact	<b>No.</b> DCA20FM006
<b>Vessel name</b>	<i>Levant</i>	
<b>Location</b>	Petrogas Ferndale Wharf, about 5 miles west of Ferndale, Washington <sup>1</sup> 48°50.36' N, 122°43.26' W	
<b>Date</b>	December 15, 2019	
<b>Time</b>	0406 Pacific standard time (coordinated universal time – 8 hours)	
<b>Injuries</b>	None	
<b>Property damage</b>	\$8.25 million est.	
<b>Environmental damage</b>	None	
<b>Weather</b>	Visibility 7 miles, overcast, winds west-northwest at 15 knots, waves 2 feet, air temperature 45°F, water temperature 46°F, sunrise 0751	
<b>Waterway information</b>	Located in the Strait of Georgia, the Petrogas Ferndale Wharf's depth alongside at mean lower low water is about 36 feet, height of tide 2.9 feet, and mean range of tide 5.9 feet.

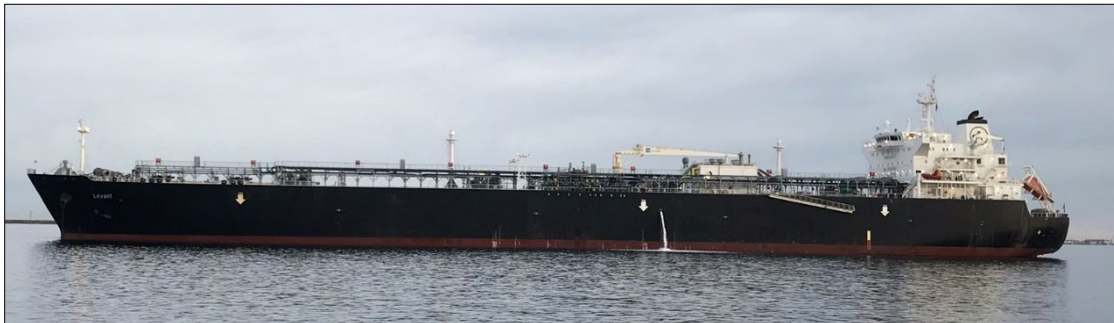
Postaccident photo of the *Levant* at anchor.

After the contact with the mooring dolphin, the *Levant* crew discovered that an empty forward ballast tank was taking on water. A subsequent damage assessment found four hull breaches below the waterline in the *Levant's* number one port ballast tank, and a crease approximately 40-60 inches long on the port bow. The estimated cost to repair the damage to the vessel was \$1.5 million. The south mooring dolphin and adjoining catwalk at the Petrogas Wharf were completely destroyed; the estimated replacement cost was \$6.75 million.

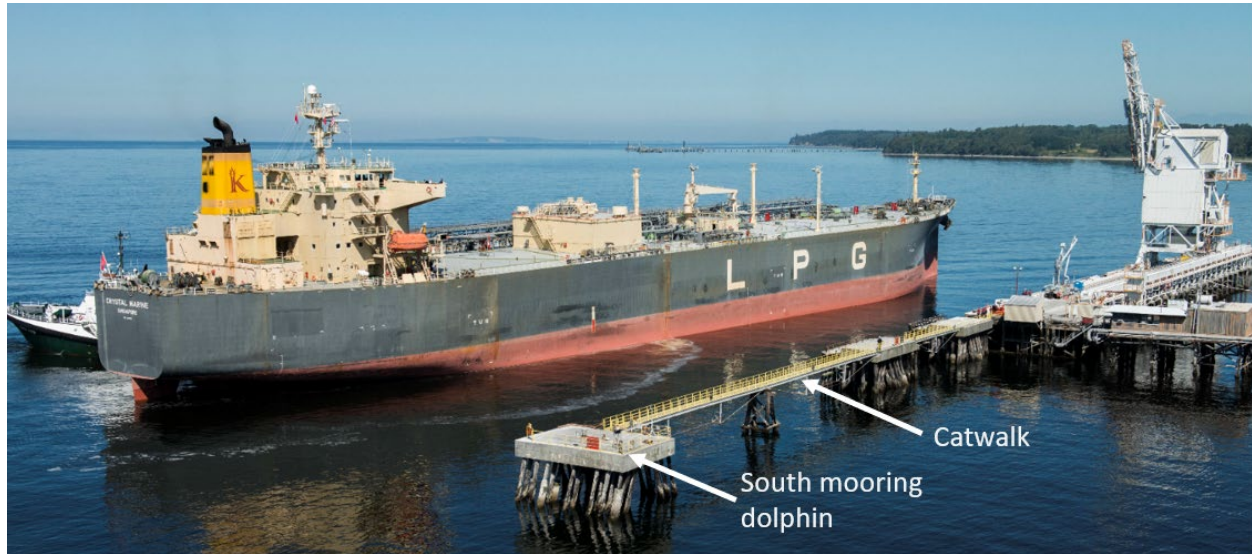
The Petrogas Wharf with a tanker of similar size to the *Levant* docking starboard side to the wharf. (Source: Petrogas, LLC)

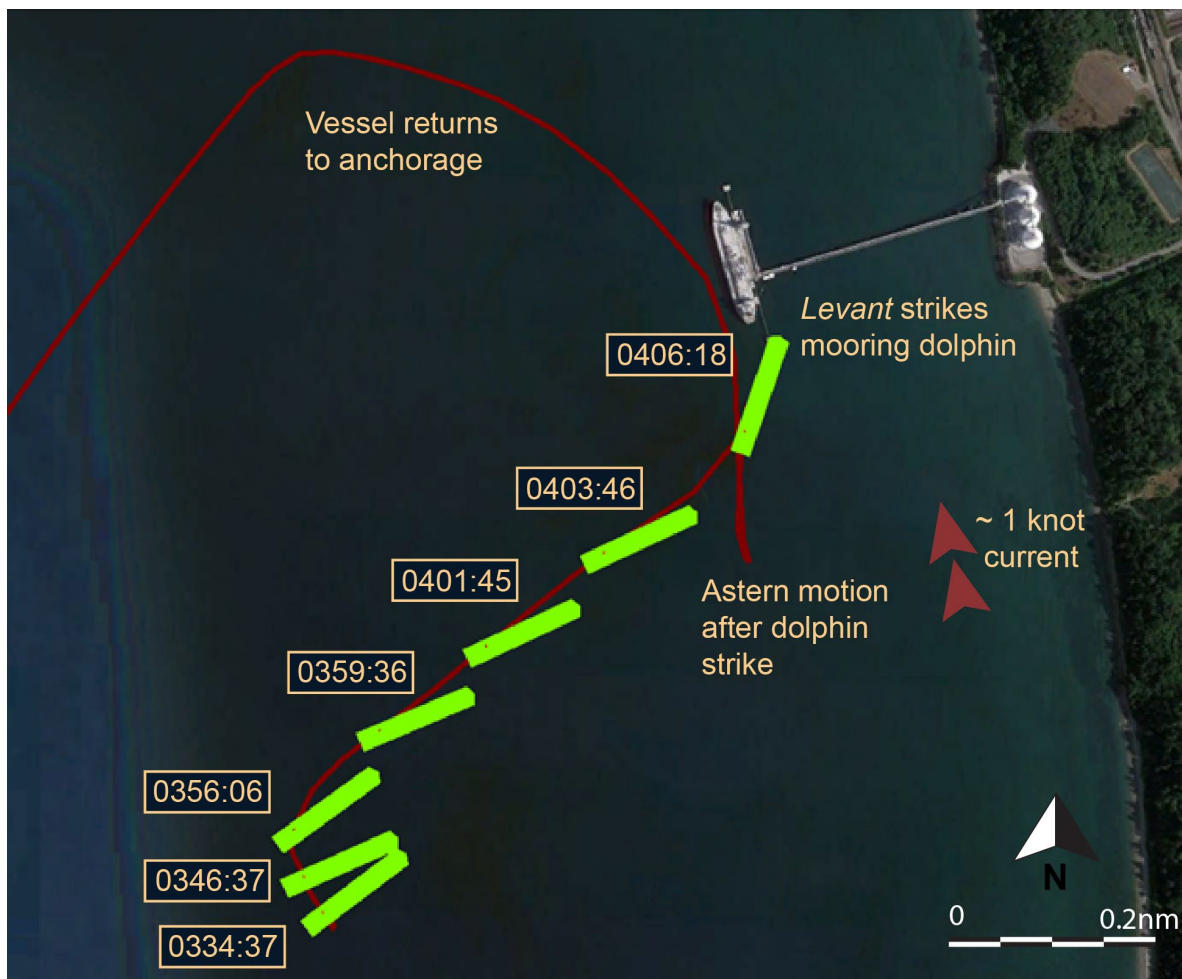
a position where they could see the wharf and south mooring dolphin. The fourth officer radioed the master that there was a 40-meter distance to the mooring dolphin, and the master relayed this distance to the pilot. After hearing this distance, the pilot ordered dead slow astern propulsion. The pilot asked for the distance to the wharf again, and he heard 10 meters as the reply over the radio. At 0406, the bosun announced over the radio the distance from the wharf was 5 meters before both he and the fourth officer moved further aft for personal safety. At that time, the heading of the *Levant* was 024 degrees with a speed of 4.3 knots, about 41 degrees off the dock alignment heading of 343 degrees.

The *Levant's* positions as it moved from the anchorage to the Petrogas Wharf, based on automatic identification system (AIS) data. Vessel scale approximate; vessel at pier was not present at the time of the accident. (Background source: Google Earth)

The *Levant* approached the Petrogas Wharf at too steep of an angle, at an excessive speed for the proximity to the wharf. After getting under way, the pilot ordered a heading of 065 degrees, toward the shoreline at an angle of about 80 degrees to the Petrogas Wharf (343 degrees) to account for the current. The pilot, who said he did not typically rely on the bridge team, only explained to the master his reason for the approach heading he chose. The vessel's speed increased to about 4.5 knots before the pilot ordered the rudder hard to port to bring the ship in line with the wharf. This order came too late, less than 3 minutes before the contact and when the *Levant* was less than two ship lengths from the wharf. By comparison, past approaches to the Petrogas Wharf were at a slower speed and a shallower angle (about 25 degrees). Additionally, Petrogas Wharf operators familiar with seeing vessels approach the wharf explained that the *Levant* had an unusual approach

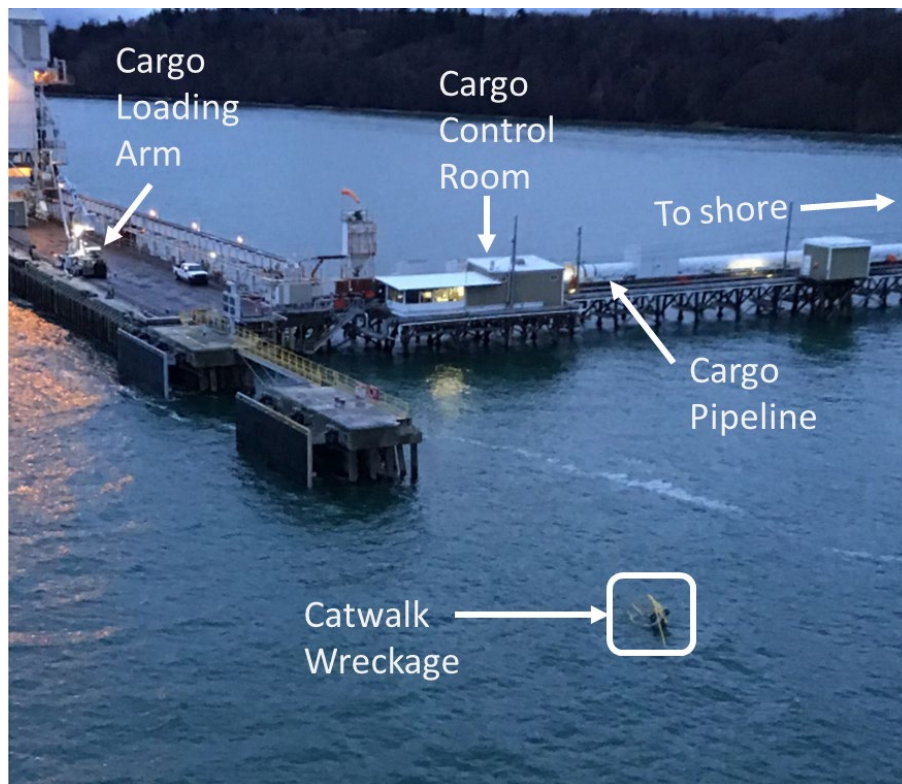
Postaccident photo of the Petrogas Wharf on the morning of December 15 with the catwalk and south mooring dolphin missing. (Source: US Coast Guard, annotated by NTSB)

Due to ongoing electrical work on the wharf, the south mooring dolphin and catwalk were not illuminated by floodlights and the direct-powered aid-to-navigation light on the south mooring dolphin was not operational. Petrogas stated the backup navigation light was operational during its most recent check about 5 days before the accident; however, witnesses could not recall whether they saw a flashing light, and poor-resolution video did not indicate any flashing light on the south mooring dolphin. The floodlights on the catwalk and aid-to-navigation light on the south mooring dolphin would have provided additional reference points, but the remainder of the wharf was well lit. The pilot stated he was judging his distance to the apron of the wharf by visual reference. Visual cues and depth perception can be affected by darkness because the eye does not have adequate reference points with which to measure. As such, use of visual reference, at night, as a sole means for judging the distance to an object (such as a wheel over point) would have been inaccurate.

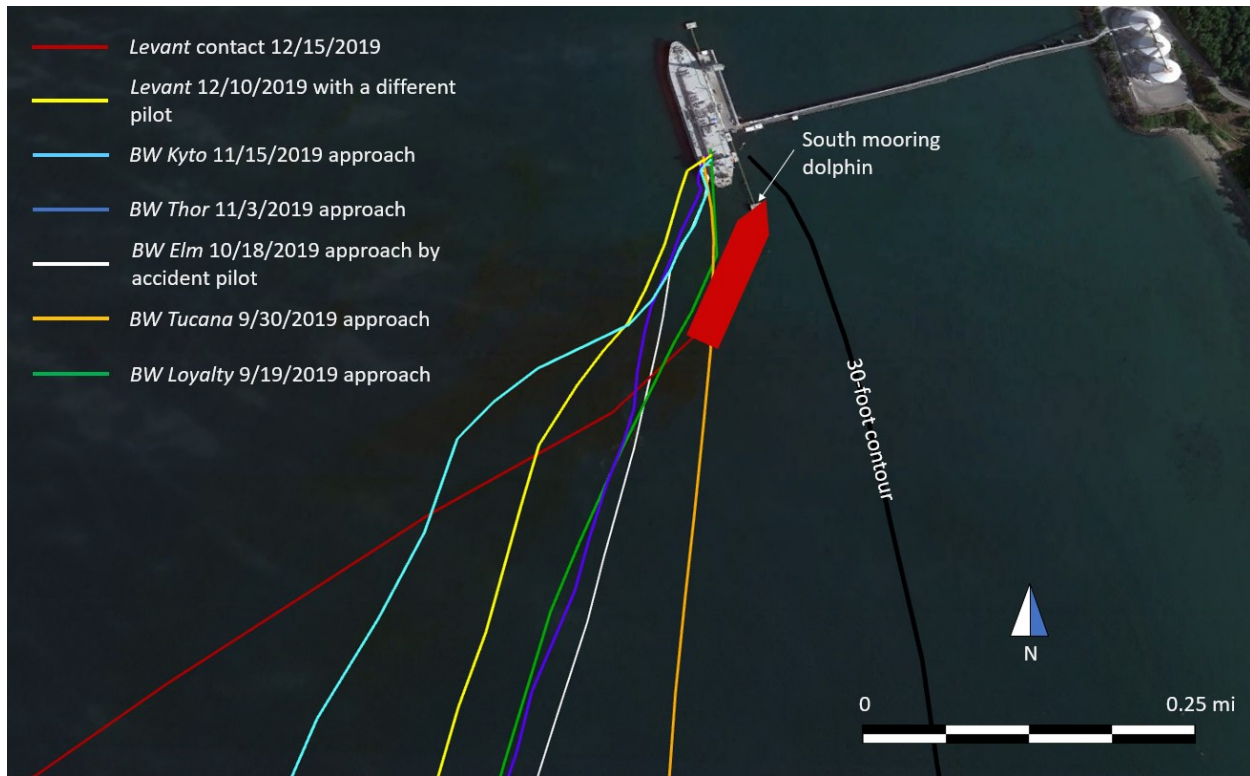
**Other Recent Dockings.** For the *Levant*’s approach to the Petrogas Wharf on December 10, with a different pilot, the approach angle was about 25 degrees to the wharf with a speed of 2-3 knots. Once the bow of the ship was abeam the south mooring dolphin, tugs pushed the ship toward the wharf. The fourth officer commented that on the last approach to the Petrogas Wharf, he was also located on the bow, and the approach went “very slowly.”

A sample of similar size liquefied petroleum gas carrier approaches to the Petrogas Wharf in the 90 days before the accident, including the accident pilot’s last docking of a similar size tanker at the Petrogas Wharf on October 18, 2019, was examined. All six approaches, including the *Levant*’s December 10 approach, were at a shallower angle than the accident docking. Additionally, all other approaches had less than 3 knots approach speed within 0.25 miles of the south mooring dolphin.

AIS tracks of all liquid petroleum gas carrier approaches to the Petrogas Wharf from September 19 to December 15, 2019. Included is the initial approach of the *Levant* to the wharf on December 10 (yellow line), and the accident pilot's last approach to the wharf on October 18 (white line). *Levant* scale approximate; vessel at pier was not present at the time of either approach. (Background source: Google Earth)
