Marine Transportation Safety Investigation Report M20P0092

DRAGGING ANCHOR AND SUBSEQUENT COLLISION

Bulk carriers *Golden Cecilie* and *Green K-Max 1*
Plumper Sound, Southern Gulf Islands, British Columbia
30 March 2020

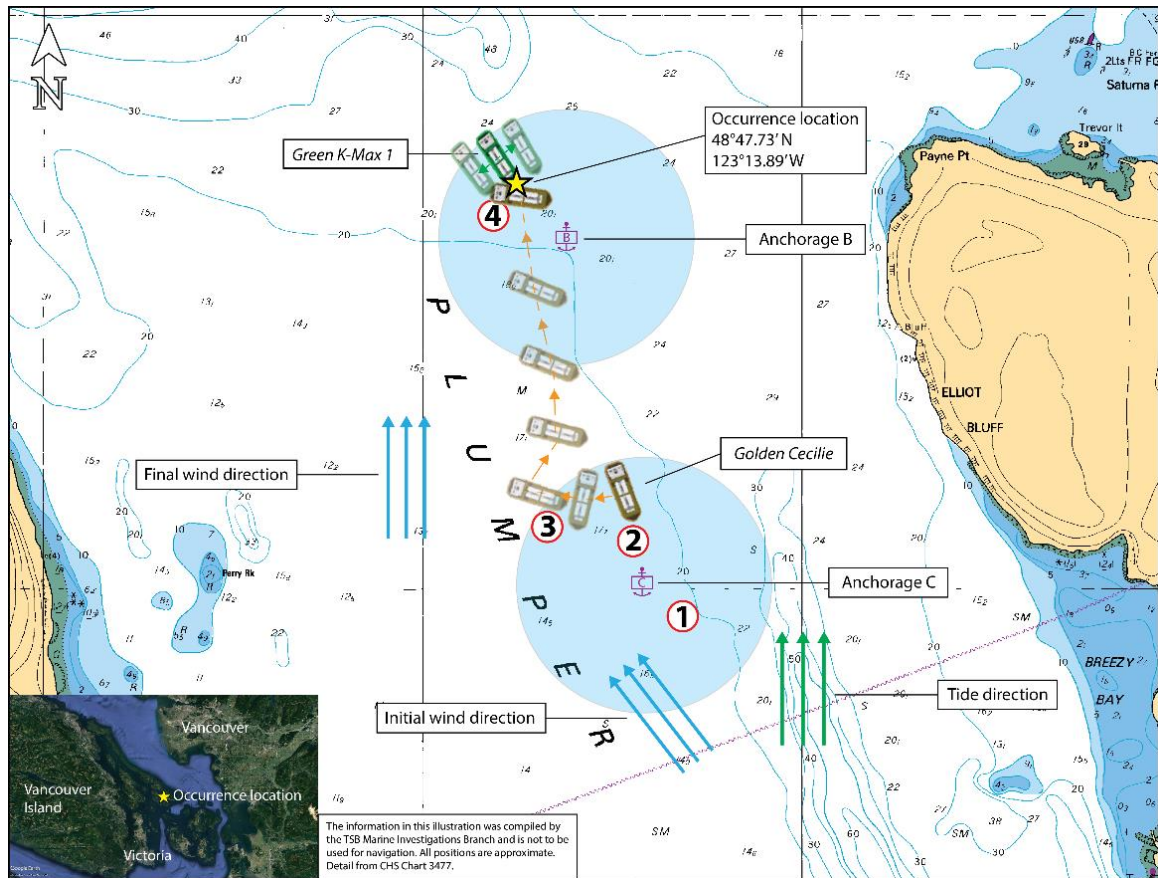
Figure 3. Area of the occurrence (Main image source: Canadian Hydrographic Service, with TSB annotations; inset image source: Google Earth, with TSB annotations)

When the *Golden Cecilie* arrived at Anchorage C, the *Green K-Max 1* was anchored at neighbouring Anchorage B³ and had been since 24 February (Figure 3). The distance between the *Golden Cecilie* and the *Green K-Max 1* was about 1280 m. Both of the vessels were in ballast condition and were awaiting berthing instructions as their cargoes were not ready for loading. The *Golden Cecilie* had a draft of 4.63 m forward and 6.77 m aft with a freeboard of 12 m.

- 1 Initial anchored position of the *Golden Cecilie* on 28 February
- 2 New anchored position of the *Golden Cecilie* on 19 March after changing anchors
- 3 Anchor dragging alarm activates on the *Golden Cecilie*
- 4 The *Golden Cecilie* collides with the *Green K-Max 1*
