SAFETY INVESTIGATION REPORT

REPORT NO.: 06/2021

MT SICHEM MANILA **Serious injury to a crew member** **during tank cleaning operations,** **at Tarragona anchorage, Spain** **17 February 2020**

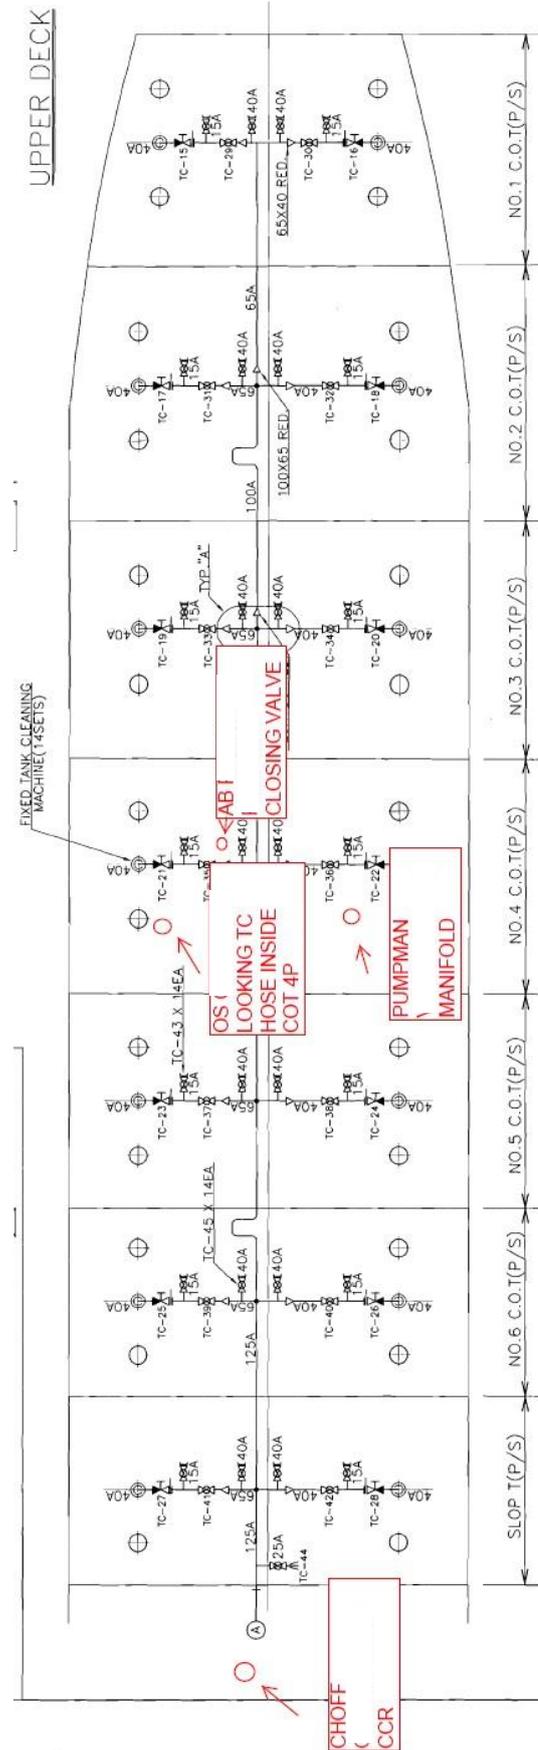
Figure 2: Extract of the Tank Cleaning System Plan, showing the location of the crew members

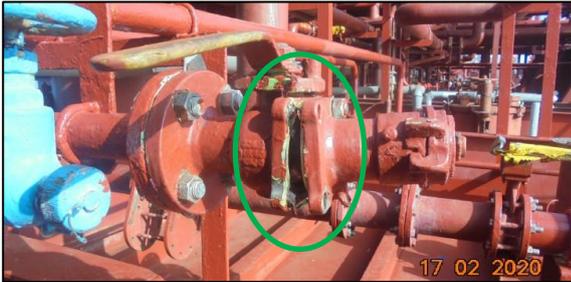
At about 1130, whilst AB 1 was shutting the valve, the valve block burst open (Figure 3). Consequently, the pressurized, hot wash water sprayed over AB 1's left arm (Figure 4). As he tried to turn away to protect his face, the hot water continued to spray onto the left side of his body (Figure 5).

Figure 3: Valve block which burst open

The damaged valve block was made of stainless steel. Of the four securing bolts of this block, three were mild steel, while the other was stainless steel. All the three mild steel bolts had ruptured. A closer look at the ruptured bolts indicated heavy corrosion of the bolts.

The three mild steel bolts which were used to secure the valve block had failed. The ruptured bolts were not made available to the safety investigation for further inspections / tests, as they had reportedly been disposed of, following the accident. However, a closer look at photographic information indicated heavy corrosion of the bolts, which would have compromised their strength (Figure 7).

1. All bolts on the *Sichem Manila*'s cargo tank cleaning line were checked and replaced, as necessary, with stainless steel bolts.
2. All vessels under the Company's management were instructed to check the fittings of their respective cargo tank cleaning lines.
3. All serving masters were instructed to record the pre-operation checks of the cargo tank cleaning system in the deck logbook.
4. The planned maintenance system of the Company's vessels was revised to include the inspection of the tank cleaning line and bolts during the Company's recommended annual pressure test of the tank cleaning line.

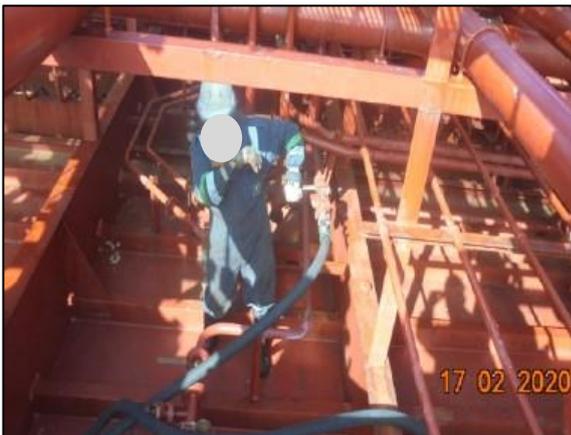
Figure 4: Simulation of hot water spraying onto AB 1, while shutting the valve

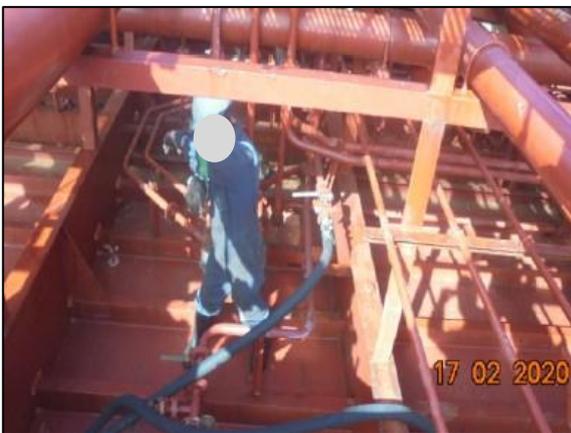
Figure 5: Simulation of AB 1 trying to protect his face from the hot water spray

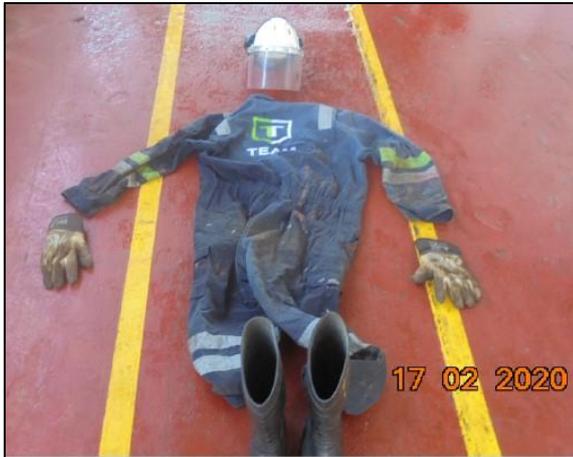
Figure 6: PPE worn by AB 1

AB 1 was reportedly wearing coveralls, a safety helmet with a face shield, safety gloves and rubber boots.

7. The PPE worn by the injured AB did not protect him against the hot water spray.

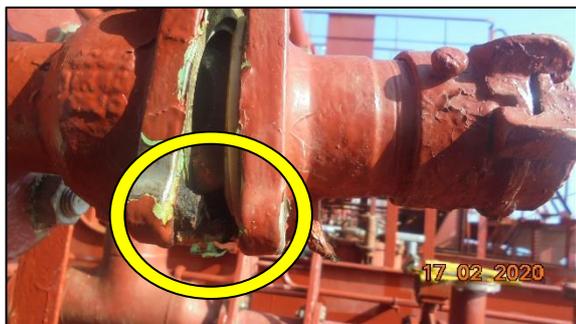
Figure 7: Close-up on the valve block, showing one of the ruptured bolts (circled in yellow)

The safety investigation, therefore, hypothesized that when the stainless steel-ball valve was turned to shut off the flow of the hot wash water, the pressurized stream of water was directed onto the part of the valve block where the strength of the bolts was already compromised by their corrosion. This pressurized stream of water was enough

It was not excluded that a pressure surge towards the valve, or, what is commonly known as a water hammer effect, may have developed when the valve was shut off. This may have caused the valve block to rupture at its weakest points *i.e.*, the corroded mild steel bolts.

In all probability, the ruptured bolts had been affected by galvanic corrosion, considering that they were mild steel bolts used to secure the stainless-steel valve block.

Further checks by the Company revealed another valve on the COT cleaning line, which was fitted with mild steel bolts. It is highly likely that these mild steel bolts were fitted before the change in the vessel's management and slipped past routine checks due to the paint coating.
