INVESTIGATION INTO AN
INCIDENT INVOLVING THE
GROUNDING OF THE VESSEL
'MV ALTA'

AT BALLYANDREEN BAY,
BALLYCOTTON, CO. CORK

16 FEBRUARY 2020

REPORT NO. MCIB/299
(No.1 OF 2021)

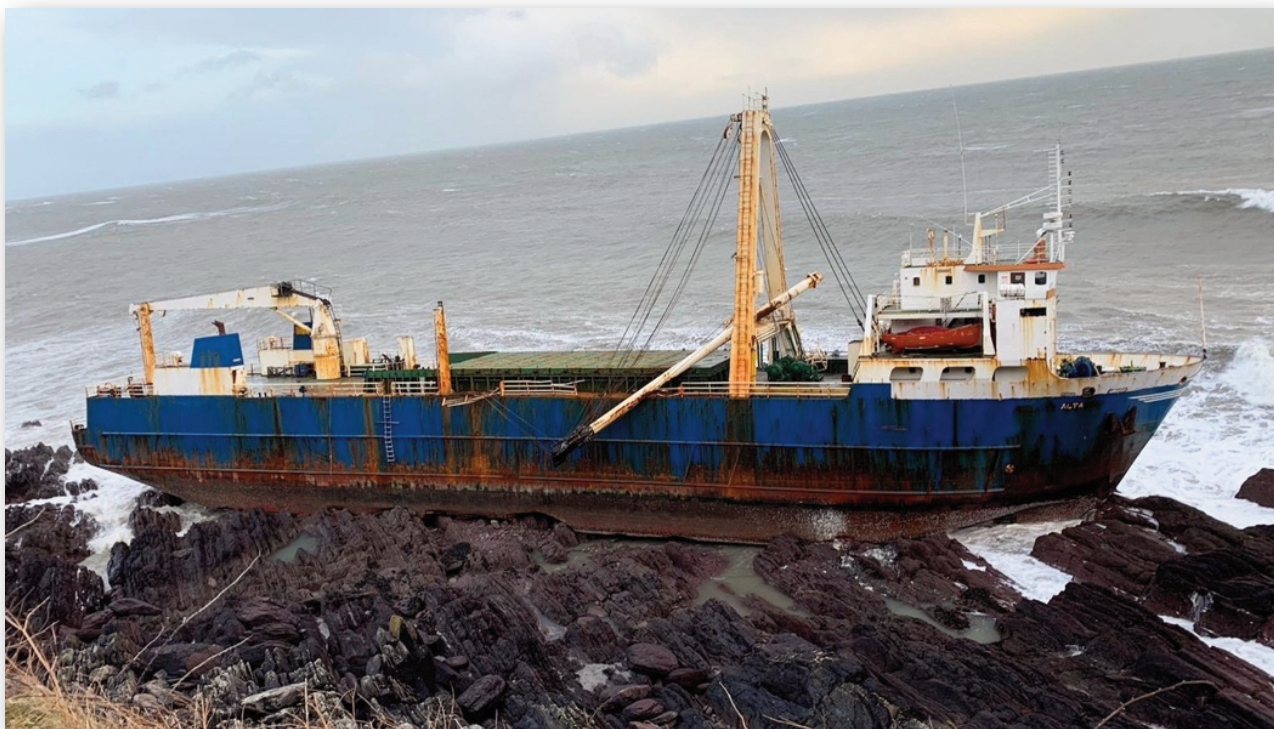
Photograph No.1 - 'MV Alta' aground in Ballyandreen Bay, Co. Cork.

- 3.3 The vessel continued drifting across the North Atlantic influenced by the Gulf Stream, until it entered European waters and came ashore on the coast of Ireland. On 16 February 2020, during Storm Dennis, members of the public (MoP) alerted the Irish Coast Guard (IRCG) Marine Rescue Co-ordination Centre, Valentia (MRCC Valentia) when the ship was sighted ashore on the rocks at Ballyandreen Bay, position 51°48.98'N 008°02.86'W.

- 3.5 RCC Bermuda reported that at the time of abandonment the vessel had approximately 86 cubic meters of marine gas oil onboard. Contractors on behalf of Cork County Council (Cork CC) boarded the vessel to ascertain the pollution risks. The contractors found the main fuel tanks empty and open to the sea. It is highly likely that any fuel was lost and was dispersed by the storm when the vessel grounded. The vessel had a number of barrels of oil and various gas cylinders on deck. The oil was transferred into new empty

barrels. The main engine and auxiliary engine sumps and the hydraulic storage tanks were also emptied into barrels for removal. Hoses connected to the main hydraulic system were cut and the oil drained into barrels. The engine room bilges were pumped into empty barrels and an absorbent boom was placed in the bilge space to catch any residual oils. All the collected oil barrels were airlifted off the vessel on 26 February 2020. Cork CC continues to assess the wreck for emerging environmental risks.

Wrecks, when lying in a fairway and in water of not sufficient depth to allow vessels to pass without striking, may pose a danger to safe navigation to other vessels. In the vessels present position, the *'MV Alta'* is a wreck and poses no danger to other ships. However, in its present position, the vessel has a potential risk over time of environmental impact due to decomposition of its materials of construction (metals and plastics), leakages of manufactured fluids (oils and lubricants) and subsequent pollution of the environment.

In its present position stranded ashore near Ballycotton, the wreck has a visual impact to the casual observer due to its location and appearance. The wreck lies on a known tourist route (The Wild Atlantic Way) and while the wreck remains an identifiable ship and an object of curiosity, as time passes the wreck, if not removed, will inevitably deteriorate to an unsightly collection of rusting plates and plastic wreckage. The *'MV Alta'* poses a potential for environmental pollution, both materially and visually.

- 5.2 ‘*MV Alta*’ grounded on the coast of Ireland. The likelihood of pollution as the wreck breaks up is high and will remain so until the wreck is removed. The costs of removal will likely be borne by the State. The monitoring and tracking of ships and vessels offshore is achieved by means of AIS, and/or LRIT electronic systems activated onboard the individual ships. These electronic systems require electrical supplies onboard the tracked ship. These electronic systems are ineffective in situations involving derelict ships such as the ‘*MV Alta*’ as they have no electrical power source onboard.

- 6.1 The Minister for Transport should, together with the Minister for Defence and the Minister for Agriculture, Food and the Marine, form a working group comprising members from the Irish Coast Guard, the Naval Service, Irish Lights, the Sea Fisheries Protection Authority and other interested parties. The working group should explore the risks and potential costs to the State presented by derelict ships entering Irish territorial waters and coming ashore in Ireland and make proposals for means to identify, monitor, track and interdict derelict ships before they endanger other ships and seafarers in the vicinity. The working group should be also aware of the EU dimension and be prepared to make recommendations to other European agencies including EMSA on their deliberations.

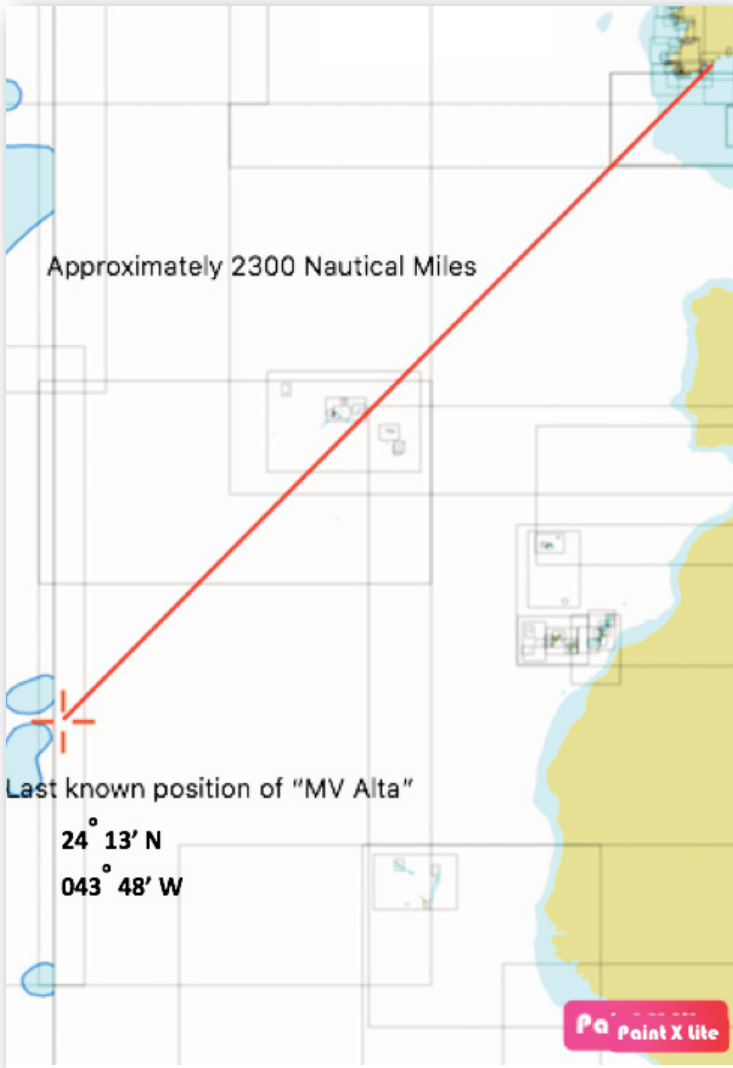
Appendix 7.3 Chart of Distance Travelled

- 3.7 From the ships recorded position of abandonment, the ‘MV Alta’ drifted for 496 days over a distance of 2,300 nautical miles (NM) to its current position in Ballyandreen Bay. The vessels exact position and distance travelled during this time is unknown and unrecorded and can only be estimated.

Although the track of the vessel was circuitous, an estimate of the daily average distance travelled was 4.63 NM per day towards the Irish coast. Ireland’s territorial waters extend to 200 NM from its territorial sea baselines. In theory the vessel may have spent approximately 43 days in Irish territorial waters without being reported.

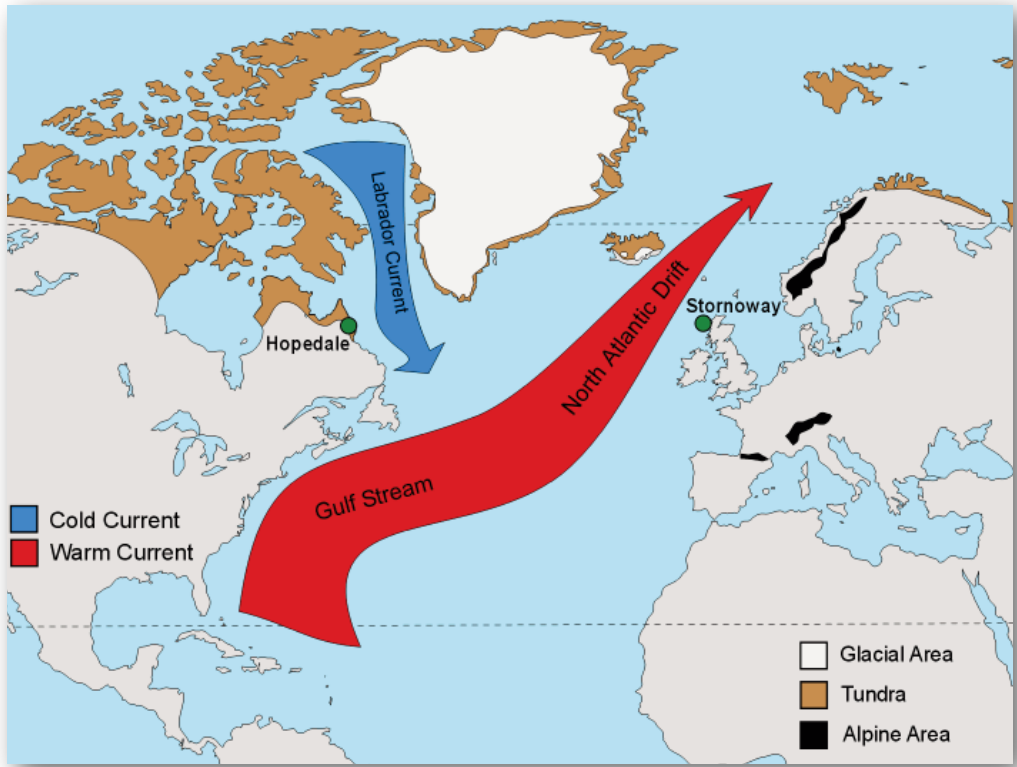
Figure 1 - Gulf Stream.

4.1 The vessel was abandoned and adrift in the Gulf Stream (see Appendix 7.5 Currents and Winds in the North Atlantic Ocean - Figure 1 - Gulf Stream). Being abandoned and adrift, the vessel was a derelict by virtue of definition. Derelict vessels, on the high seas, are a danger to navigation to other vessels, particularly during times of restricted visibility. The Gulf Stream influenced the derelict's meanderings across the seas, initially northwards along the eastern seaboard of the United States of America and then westwards as its meandering direction became influenced by the mid latitude westerly winds.

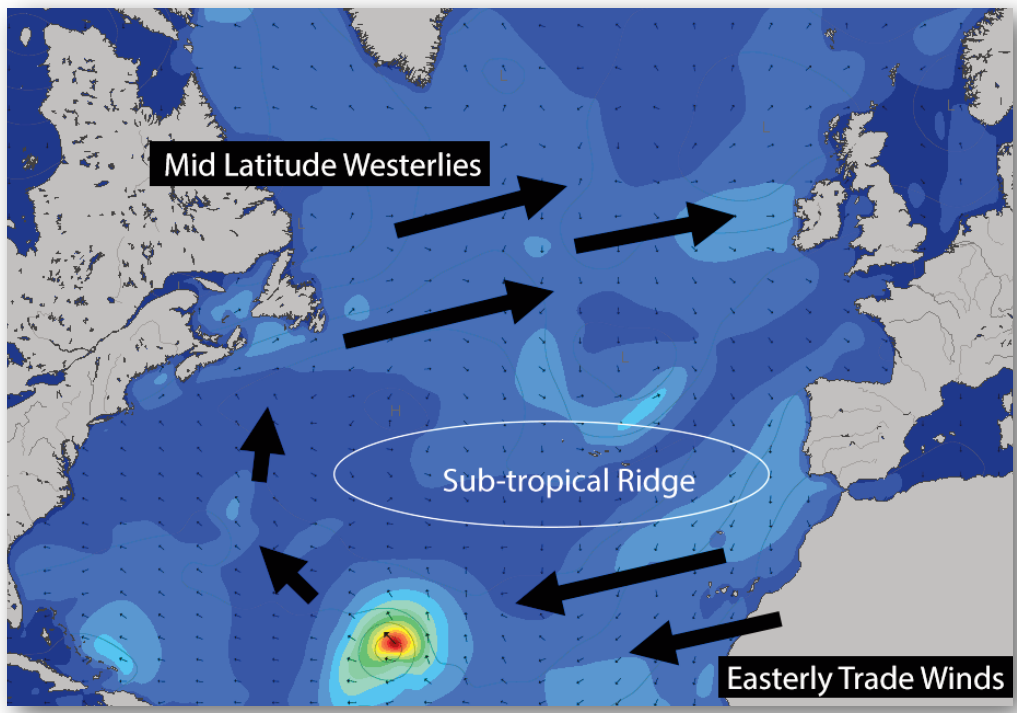
Figure 2 - Atlantic Trade Winds.

The combination of dynamic influences of the Gulf Stream currents and the mid latitude westerly winds pushed the derelict towards Europe and the seas off Ireland.
