# National Transportation Safety Board

## Marine Accident Brief

### Contact of *Savage Voyager* Tow with Jamie Whitten Lock & Dam

<b>Accident type</b>	Contact	<b>No.</b> DCA19FM049
<b>Vessel name</b>	<i>Savage Voyager</i> and tank barge <i>PBL 3422</i>	
<b>Location</b>	Jamie Whitten Lock & Dam, Tennessee-Tombigbee Waterway, mile 411.9, near Dennis, Mississippi 34°31.35' N, 088°19.41' W	
<b>Date</b>	September 8, 2019	
<b>Time</b>	0355 central daylight time (coordinated universal time – 5 hours)	
<b>Injuries</b>	None	
<b>Property damage</b>	\$4.4 million est.	
<b>Environmental damage</b>	117,030 gallons (2,786 barrels) of crude oil released into lock chamber; estimated 942 gallons (22 barrels) unrecovered	
<b>Weather</b>	Visibility 1.25 miles in mist, clear skies, calm air, air temperature 63°F, average water temperature 71°F	
<b>Waterway information</b>	The Jamie Whitten Lock & Dam is the uppermost lock of the Tennessee-Tombigbee Waterway and forms Bay Springs Lake.

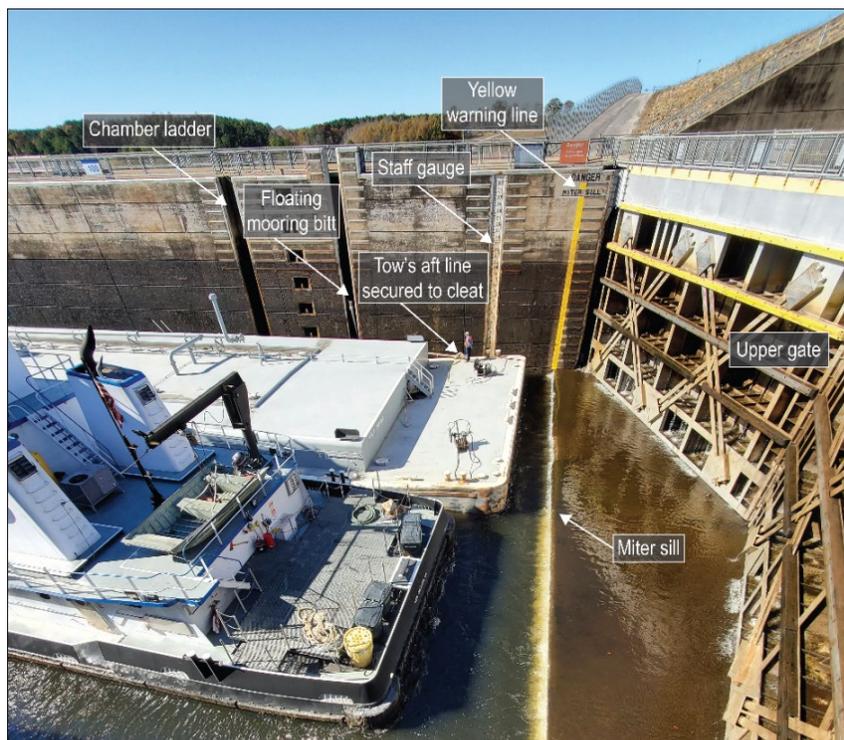
**A tow with a similar arrangement to the *Savage Voyager* locking down in the lock chamber after the accident, with newly re-painted warning line. (Source: Corps of Engineers)**

The lock operator's lock control station had a video monitor that showed (at an angle) the yellow warning line. The warning line was obscured below the staff gauge at 25 feet by a handrail. The Corps of Engineers reported that shortly after a tow began to descend, the lock operator could not see a barge's bow on the monitor after it dropped below 25 feet on the staff gauge, and therefore could not view its position relative to the warning line.

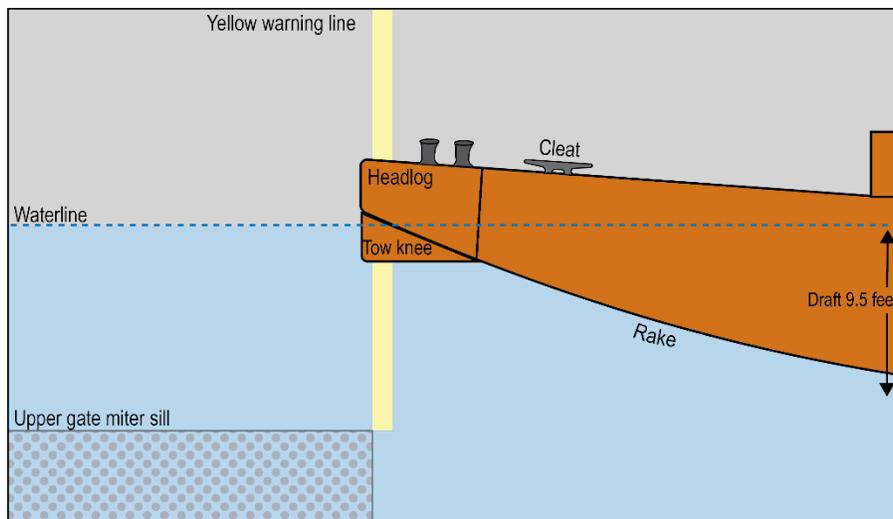
The deckhand stated that “maybe a couple seconds after . . . water had begun to come out of the chamber,” he noticed that the *PBL 3422* had “touched” and was hung on the concrete miter sill. He radioed the pilot in the wheelhouse to inform him that the tow was stuck and to “push ahead on it,” then radioed the tankerman to “give [him] some slack in that head line” so that the tow could move forward. In the wheelhouse, the pilot throttled both engines full ahead in an attempt to free the barge and heard “a loud noise.” About 0355, the pilot sounded the general alarm and radioed the lock operator to alert him of the situation and request that he stop the locking process.

Depiction of the *PBL 3422* in lock chamber during lock operations (not to scale).

After hearing the pilot over the radio, the lock operator looked out the window of his station, saw that the rake of the barge was about 3 feet out of the water, and immediately began closing the valves to stop the water from lowering in the lock chamber. He radioed the pilot to inform him that it would take a few minutes for the valves to close and he could not stop the water from lowering until the valve stop sequence completed. As the water continued to lower in the lock chamber, the rake of the barge was held in place while the rest of the barge descended, and the rake bent 45 degrees. The tankerman radioed the deckhand and told him to “get to safety,” so the deckhand ran forward toward the *Savage Voyager*. As the deckhand stepped onto the *Savage Voyager*, the *PBL 3422*'s rake end slipped from the concrete miter sill and dropped into the water. After the valves were closed, the water level was about 13 feet below the concrete miter sill.

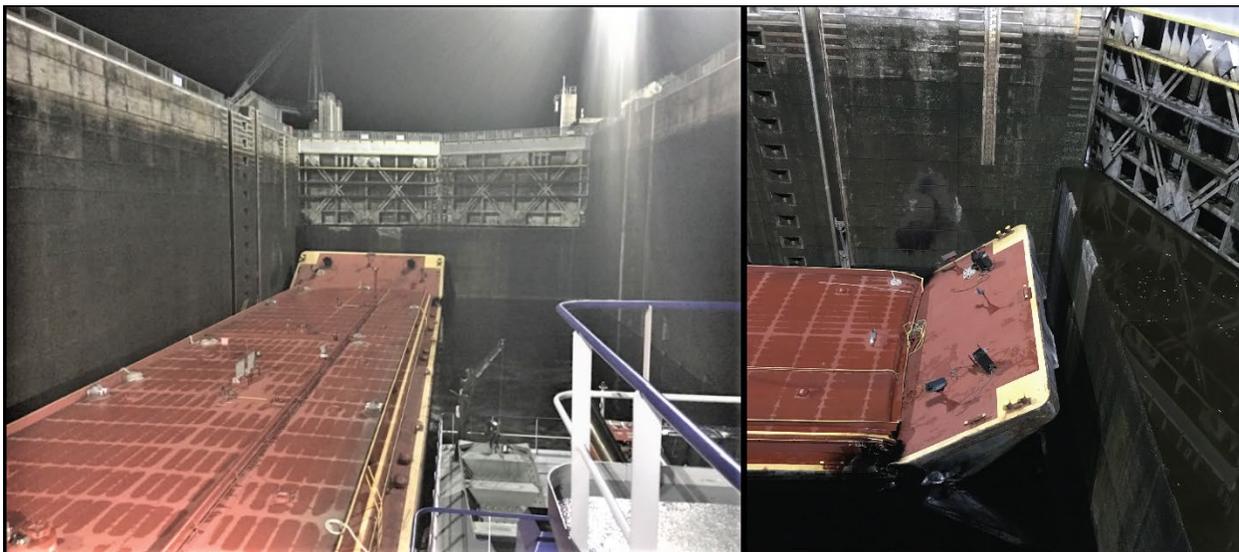
Postaccident photos of barge *PBL 3422* with the rake bent 45 degrees. (Source: *Savage Inland Marine* [left]; *Corps of Engineers* [right])

Once the *PBL 3422*'s rake became hung on the concrete miter sill, the deckhand notified the pilot, who sounded the towboat's general alarm about 0355 and radioed the lock operator to request he halt the locking process. The pilot also attempted to mitigate further damage to the barge and pull it off the sill by throttling both engines full ahead. However, since it took over 2 minutes for the emptying valves to fully close, the water continued to rapidly descend in the lock chamber, and the barge became hung on the sill, bending the rake and breaching the forward cargo tank before dropping into the water.

The National Transportation Safety Board determines that the probable cause of the contact of the *Savage Voyager*'s tow with the Jamie Whitten Lock & Dam was the tow moving out of position in the lock chamber while locking down when the crew did not effectively monitor and maintain the vessel's position during its descent, resulting in the aft barge becoming hung on the upper gate miter sill.

**Damage.** On October 28, 2019, the barge *PBL 3422* arrived at a shipyard and repair facility in Harvey, Louisiana, where its damaged bow was removed and extensive sections on the port- and starboard-side shell plating (forward of the collision bulkhead) were replaced. The weather deck plating aft of the collision bulkhead, sections of the bottom shell plating, the deck plating forward of the collision bulkhead, and the cargo tank top plating were also replaced. The repairs cost a total of \$402,294.
