# RISK ALERT

## Containerised Cargo – Stowage and Securing

Written by  
**Nahush Paranjpye**  
Loss Prevention team

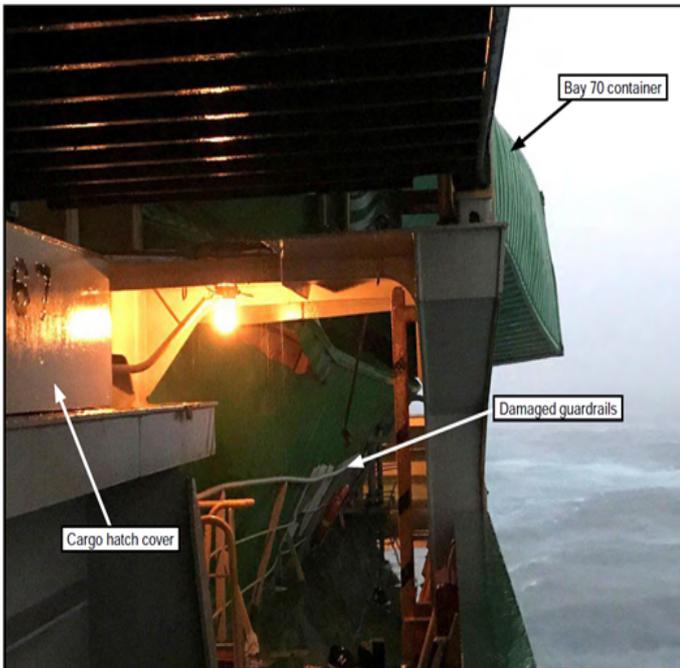
View from main deck: Ref: [MAIB REPORT NO 14/2020](#)

Once the weather had abated, the crew discovered that the container stacks on the aft most bay had collapsed and toppled to port. Of the 151 containers in the stow, 42 were lost overboard and 34 were damaged. Superficial damage was caused to the ship.

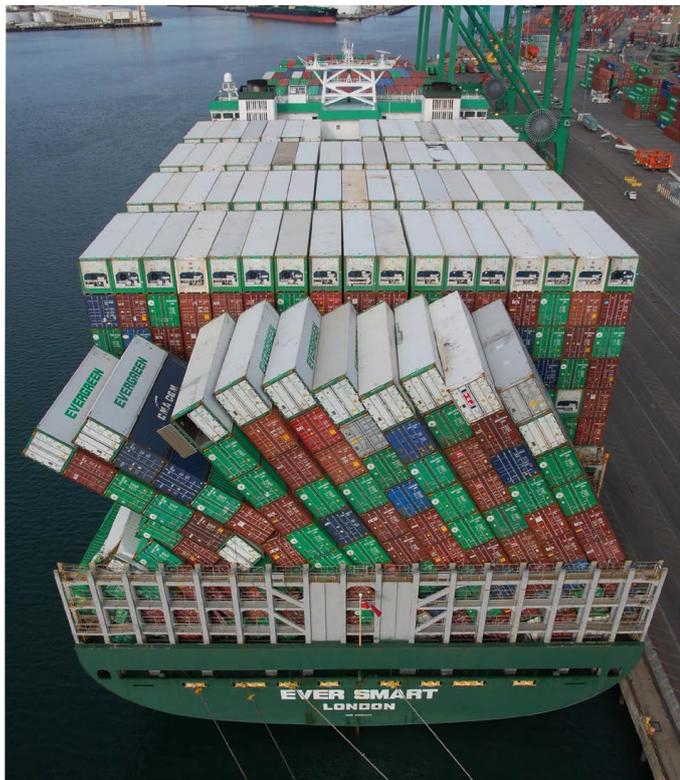
Stern: Ref: [MAIB REPORT NO 14/2020](#)

- Stack collapse **probably initiated** by a lashing system or structural container failure in bay 70's starboard outer stack
  - o Many lashing rod turnbuckle **lock nuts not applied**

- **Stowage plan - not complying with CSM**
  - o Container **weight distribution** not in accordance with stack weight tables;
  - o Outer stacks – **hi-cube containers loaded eight-high >> higher centre of gravity** for stack >> **increased acceleration forces** on containers and lashings, **increased windage area** of the outer stacks;

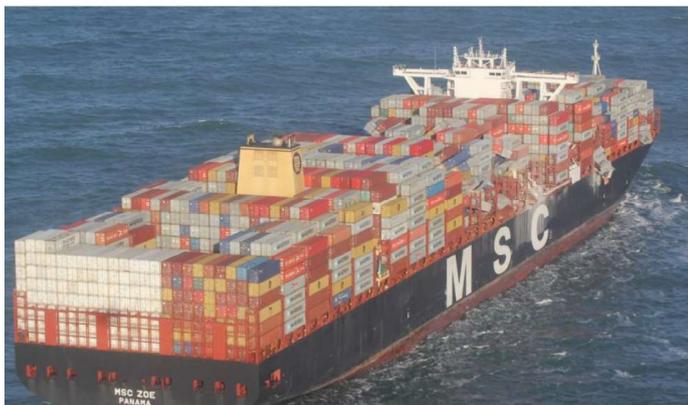
Starboard side: Ref: [Joint investigation report - MSC ZOE 01 - 02 January 2019](#)

Attempts to assess the damage was difficult due to the darkness and fallen containers on deck obstructing access. Containers in bay 58 were noted to have collapsed and were hanging overboard and a similar situation was noted in bays 10 and 26.

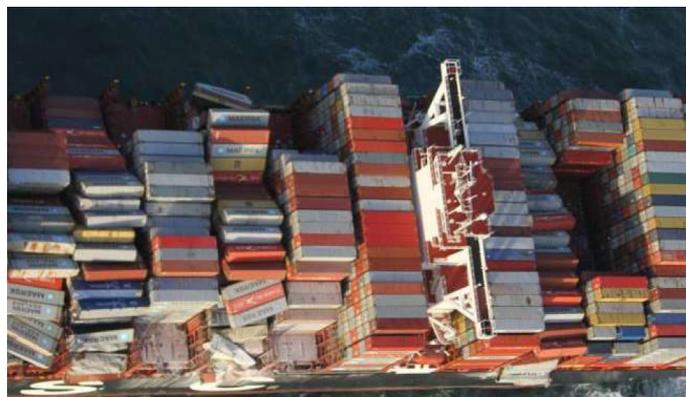
View from top: Ref: [Joint investigation report - MSC ZOE 01 - 02 January 2019](#)

Crew retightened loose lashings. Various loose parts of the lashings were noted, including tensioners from the lashing rods, hooks and locking pins, some twistlocks were noted broken in two.

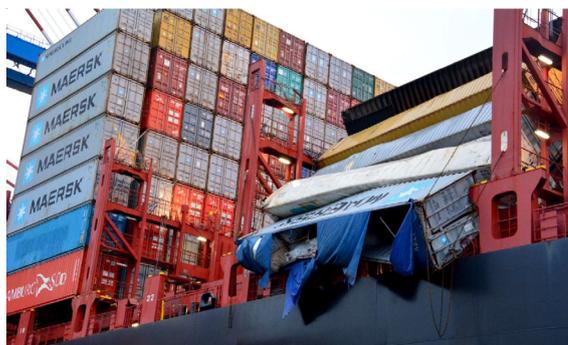
Container with polystyrene balls hanging outside Bay 26: Ref: [Joint investigation report - MSC ZOE 01 - 02 January 2019](#)

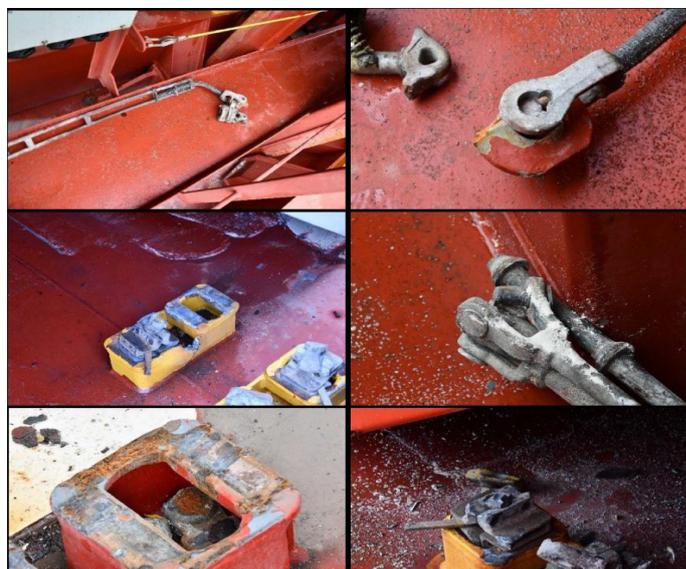
Broken lashings (Source: German water police) : Ref: [Joint investigation report - MSC ZOE 01 - 02 January 2019](#)

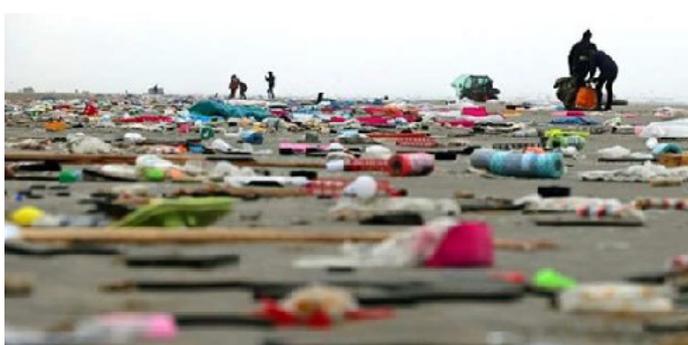
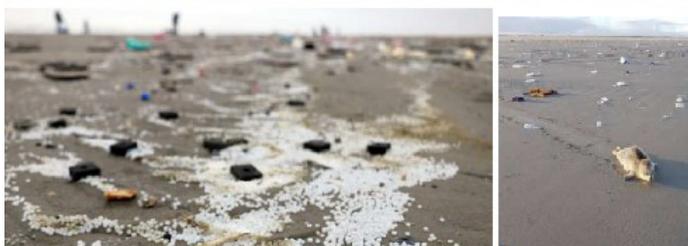
- Impact on the Dutch and German coasts, marine life and environment attracted considerable public concern in the Netherlands and in Germany.
- Debris sank or washed ashore as the fall from height and the waves destroyed most of the containers.
- Seabed survey identified more than six thousand objects.
- 2 of the lost hazmat containers contained IMDG cargo of Class 5 (Oxidising Agents and Organic peroxides) and Class 9 (lithium-ion batteries).
- Loss of raw materials destined for the plastics industry (Millions of small particles of plastic dispersed by wind and difficult to remove from the environment).

Cargo Debris on Wadden Island: Ref: [Joint investigation report - MSC ZOE 01 - 02 January 2019](#)

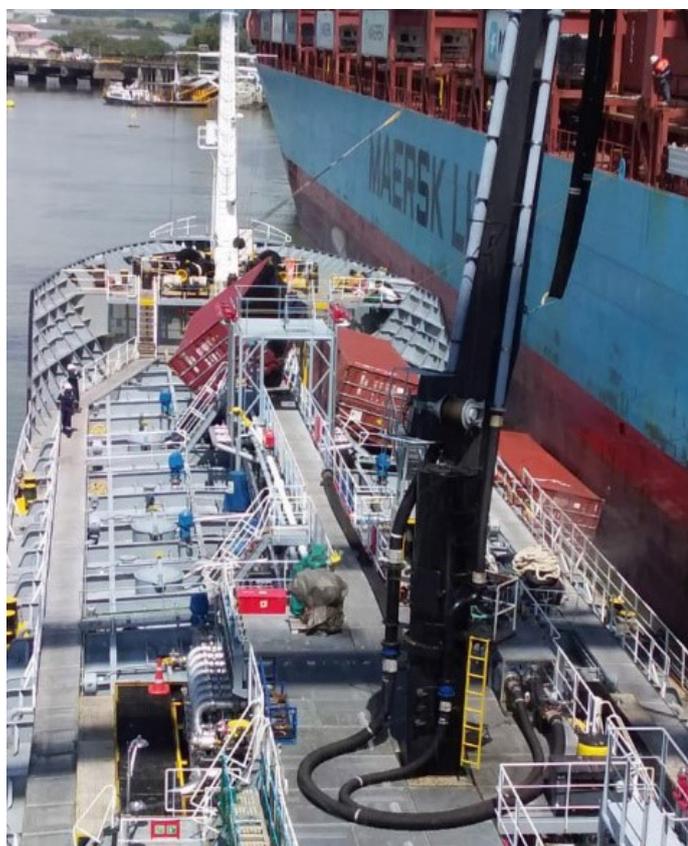
2 containers on deck / 1 container between the vessels Ref: [FLEETMON - Containers crashed on bunker tanker from MAERSK container ship](#)

Two containers landed on the bunker tanker KOLLUM, moored alongside the container ship (Charlotte Maersk) and one container fell into water between the vessels.

berth during cargo operations is possible since during this period (loading discharging of containers) the twist-locks/base locks of the bays being worked would ordinarily be in an unlocked position and the cargo lashings removed.

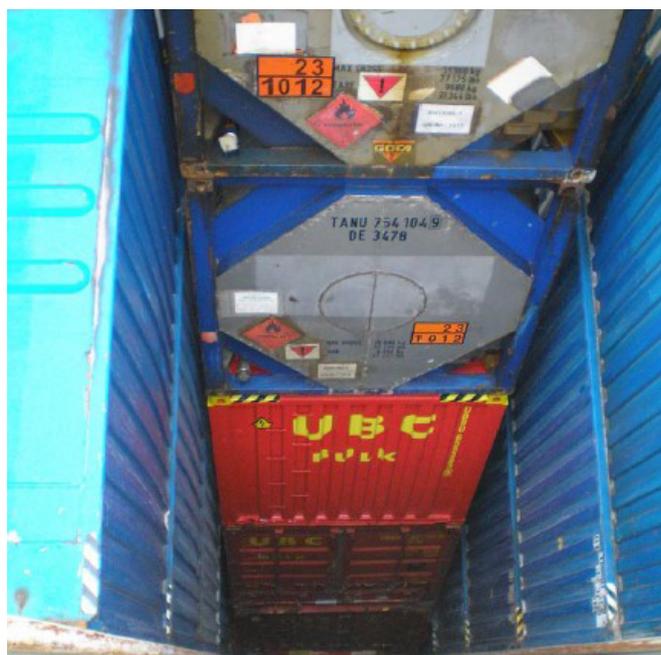
The collapse of cargo containers occurred as a result of downward compression and racking forces acting on the lower containers of the stack, which were not strong enough to support the stack as their maximum allowable stack weight had been exceeded.

Looking down on the aft end of the collapsed stack of containers, Ref: [MAIB Report No 21/2007](#)

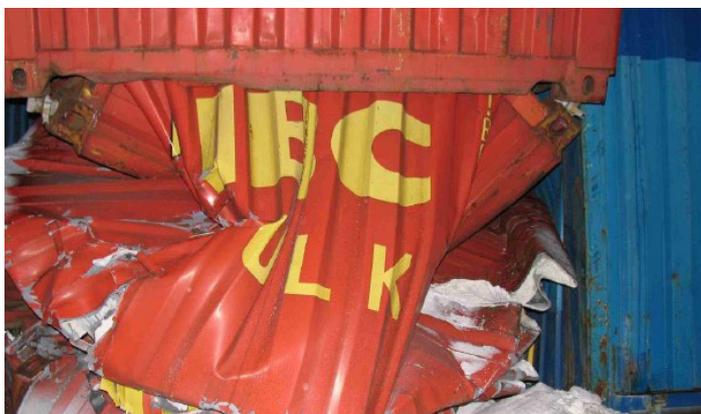
The total weight of the seven containers in the stack was 225 tonnes. The cargo securing manual indicated that the maximum permissible stack weight for 30 foot containers loaded in this location was 150 tonnes. Furthermore, the lower four containers in the stack each had a maximum allowable stacking weight of approximately 100 tonnes.

Crushed container at the bottom of the stack, Ref: [MAIB Report No 21/2007](#)

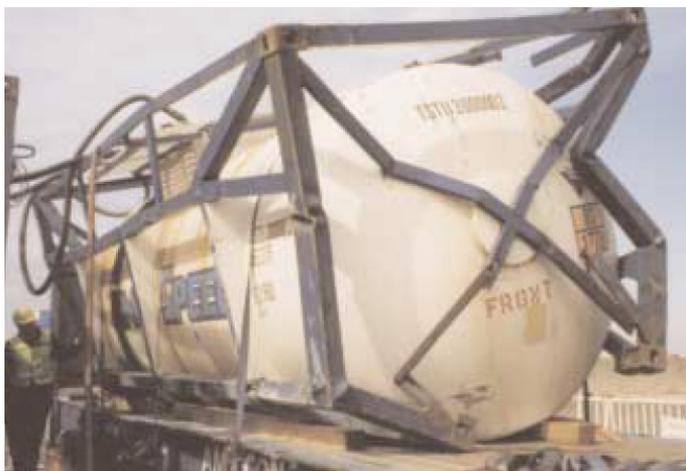
The investigation found that the masses of each of the three stacks of containers in Bay 1 of Dutch Navigator exceeded the limits set out in the vessel's cargo securing manual. This resulted in the lower containers being subjected to racking loads, greater than their design value, while the vessel was on passage. A damaged tank container was one of these at the bottom of a stack and was severely damaged. Further, both tank containers were over-stowed, which is not in compliance with the International Dangerous Goods Code and UK Regulations.

Damaged front end frame - Ref: [MAIB Report No 37/2002](#)

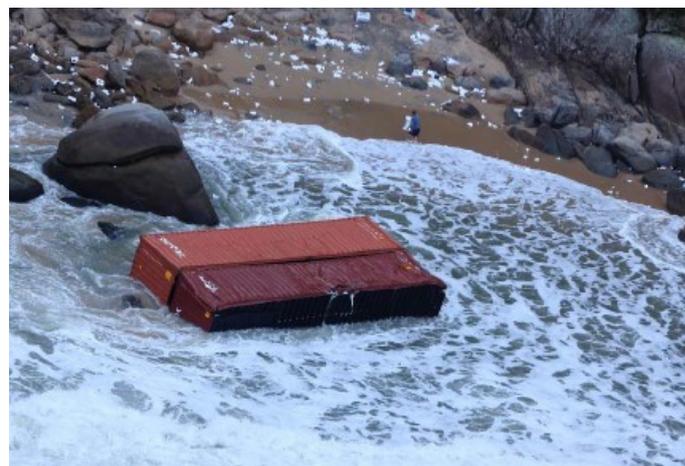
Containers washed up on remote beach

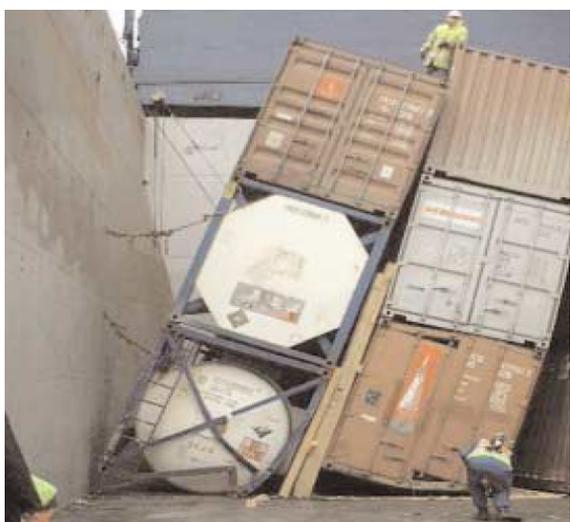
Stow in Bay 1 looking forward - Ref: [MAIB Report No 37/2002](#)

The report recommended that ships should have some means of monitoring motion and acceleration; this would enable the crew to identify when high stresses were developing and alter the ship's speed and heading to reduce any excessive forces.
