CASEBOOK

Contents

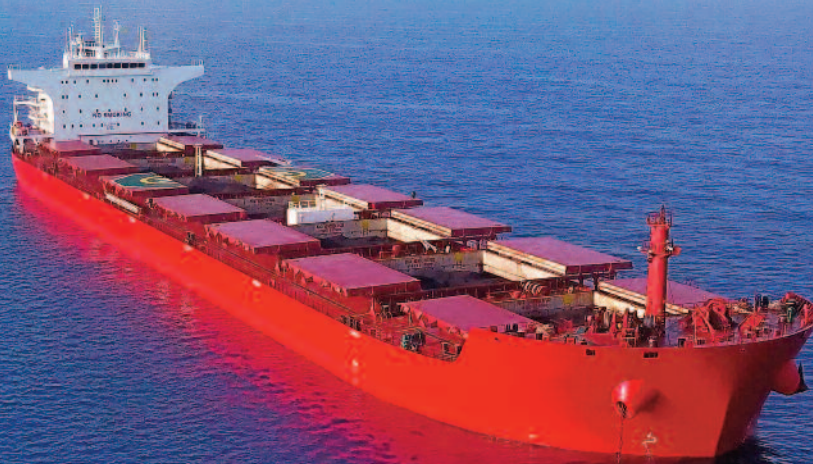
1.1

Leaking cargo hatch covers caused cargo damage

Whilst opening the cargo hatch covers it was found that cargo in a number of holds had been damaged by water. Most of the water-damaged cargo was below the middle cross joint of the hatch covers and below the aft hatch coaming's corners.

The survey indicated that seawater had leaked through the middle cross joint drain channel and through the corner of the hatch coamings.

- Before loading, completion of loading and after discharge, the crew should inspect the hatch covers to ensure they are in a weathertight condition. It is essential that cargo hatch covers are inspected and tested at regular intervals to ensure that the weathertight integrity is maintained, and that the vessel is in a cargo worthy and seaworthy condition.

- Ensure that gaskets and coamings are in good condition.
- It is important that records are kept about what maintenance and service has been completed in the PMS.

- Carry out a weathertightness test at least annually and always after repairing or replacing components in the cargo hatch system. When carrying water-sensitive cargo such as grain, soyabeans, paper, etc. it is recommended that weathertightness is tested before each loaded voyage. The most effective method is to use an ultrasonic device, which can pinpoint the area which is leaking, and if the compression of the gasket is sufficient. The advantages of using this type of equipment are evident, since ultrasonic tests can be carried out during any stage of the loading without risking cargo damage. The test can also be completed in sub-zero temperatures.

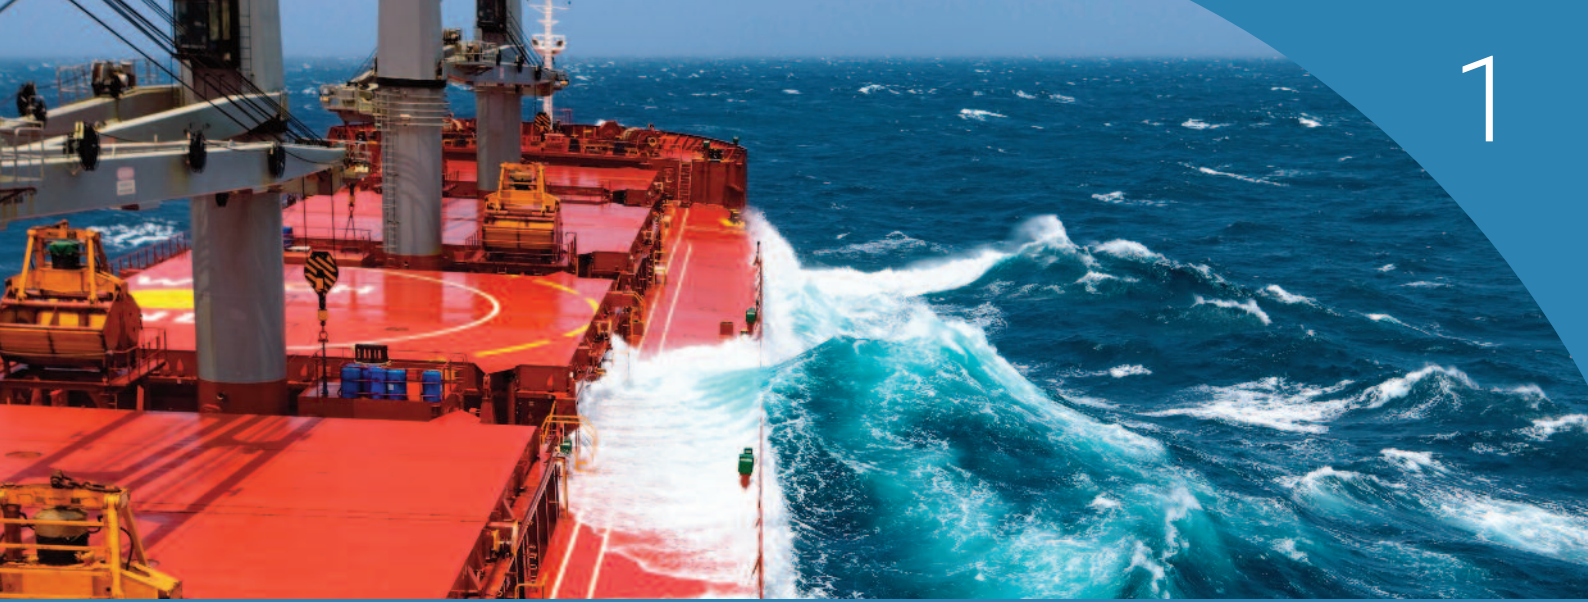
1.2

Crack in the cargo hatch cover caused wet damage

into the other holds. The Chief Officer also inspected the hatch coaming and the hatch cover for hold 1, and found a crack on the hatch coaming. The drain pipes for the non-return drain valves were also full of debris and cargo.

- It should be a PMS job to check that the drainpipes and drain valves are not clogged and that the float (ball inside) moves freely.
- Hatch covers, and coaming steel structures are heavily loaded elements. Their condition has a direct effect on the load carrying capacity and the safety of the vessel. The steel construction should always be inspected after an unusual loading case, and there should also be regular checks as per the PMS.

- When repairs are carried out, only steel approved by the classification society should be used. High tensile steel is commonly used for cargo hatches and coamings.

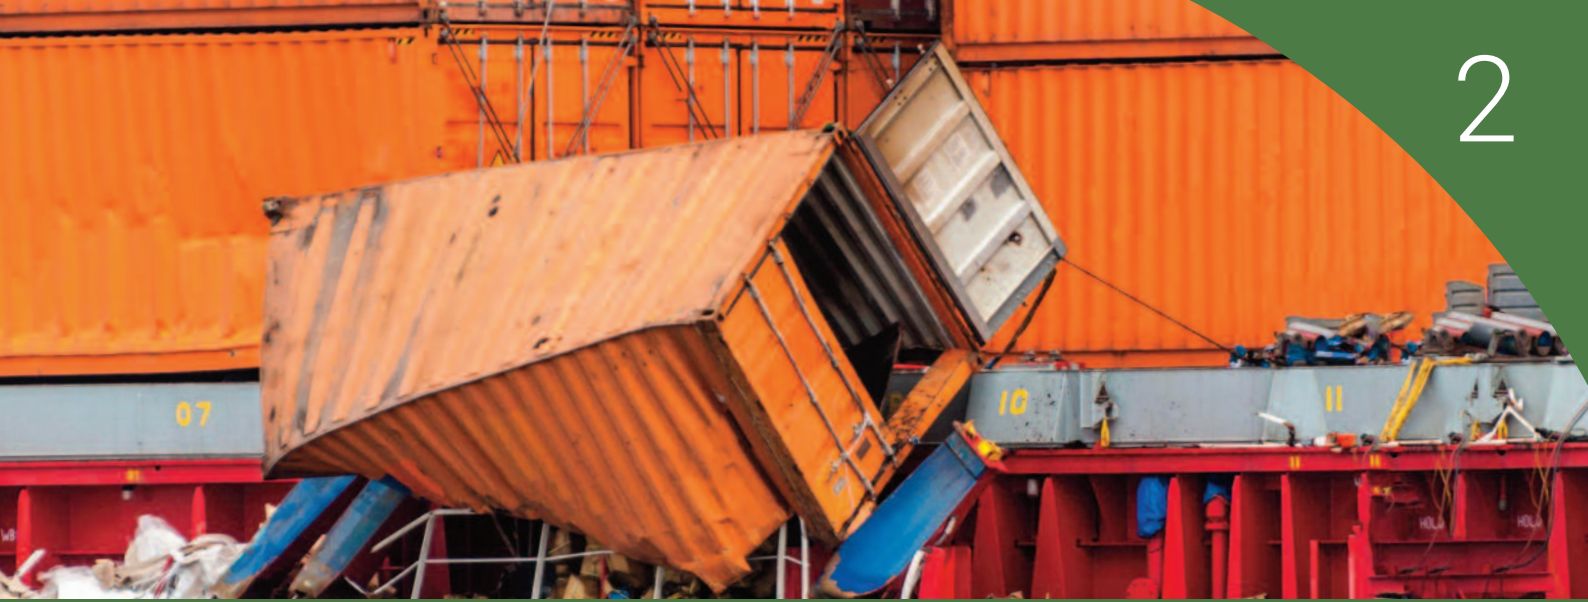
2.1

Containers were lost in heavy weather because of stiff vessel

- The base twistlocks had not been locked as they were found undamaged and still located in the shoe fittings. The combination of unlocked twistlocks and a very stiff vessel sailing through heavy weather led to the collapse of the container stacks.

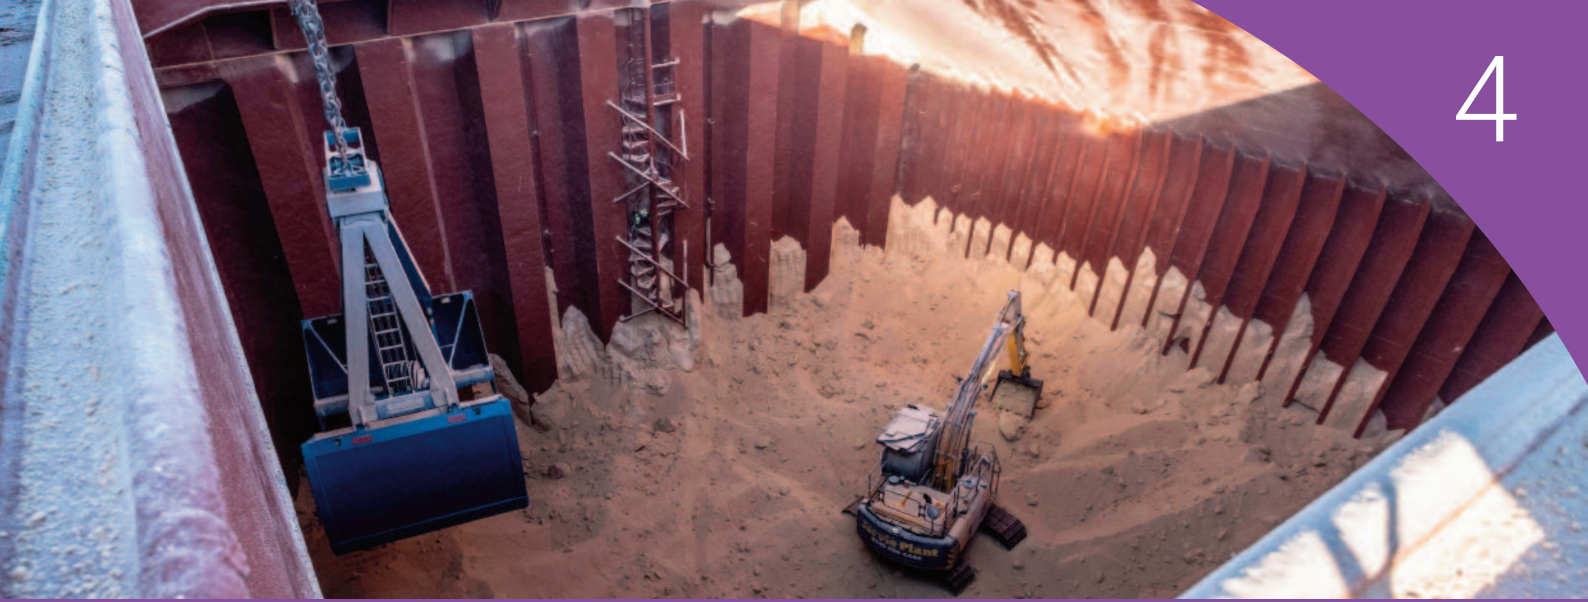
4.1 Fatal fall from ladder

It was later found that a steel bar was missing from one of the lower railings at the beginning of the spiral ladder. The railing was most likely damaged during the loading by one of the crane grabs, or an excavator as it was covered by the cargo when it arrived at the discharge port.

- After both loading and discharging, the Chief Officer should inspect the ladders to ensure they have not been damaged during the cargo operation.
- This accident highlights the minimal effort it takes to do a job safely, and the consequences of not making that effort.
