MA2021-3

**MARINE ACCIDENT
INVESTIGATION REPORT**

MARINE ACCIDENT INVESTIGATION REPORT

Accident type: Collision
Date and time: Around 19:25, June 10, 2019
Location: Keihin Port, Tokyo Section 3
Around 347° true bearing, 950 m from the Tokyo West Breakwater
Lighthouse
(Approximately 35°35.6' N, 139°46.9' E)

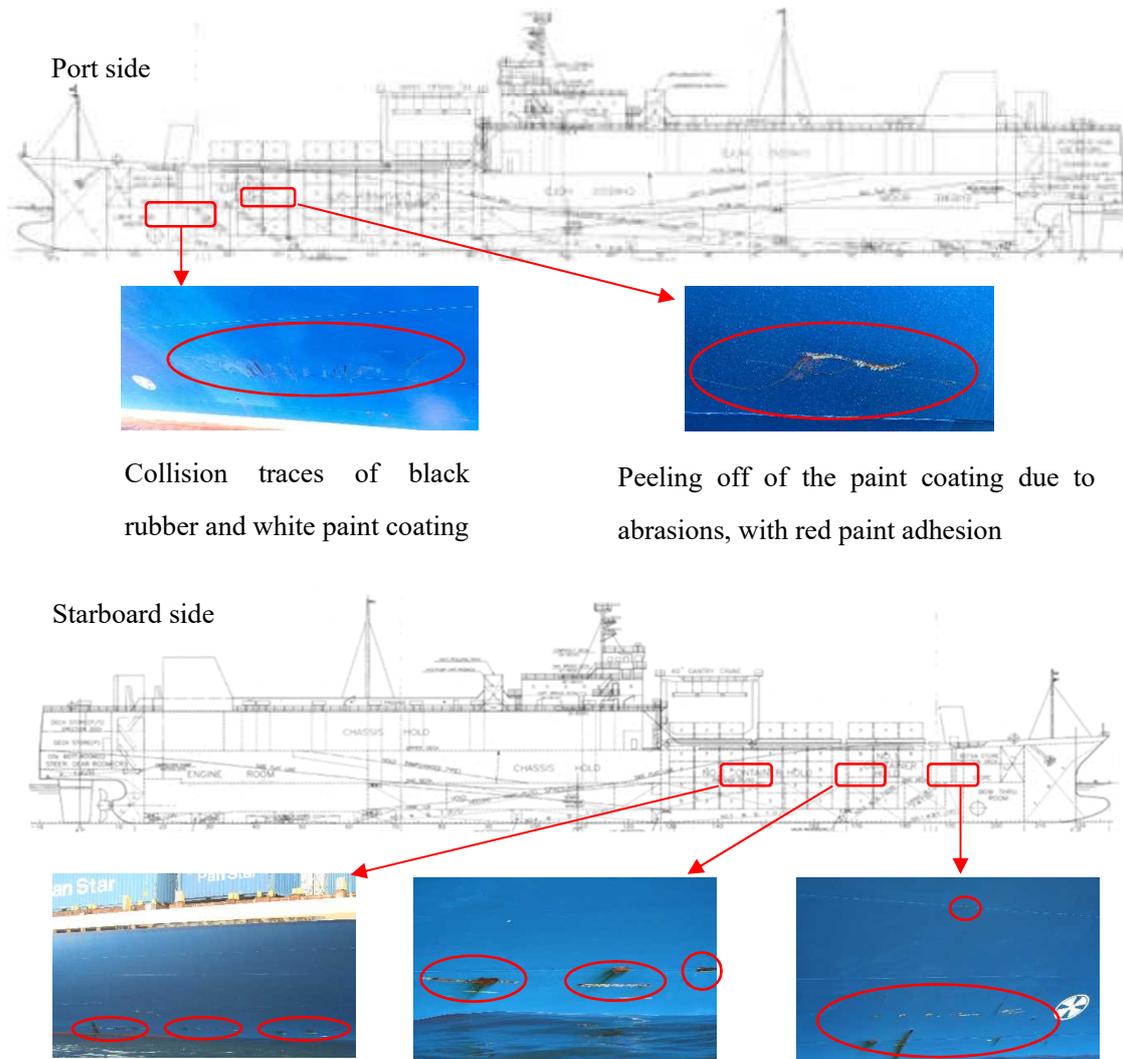
Figure 2 State of damage to Vessel A

- (1) Approximately 2 meters of abrasion and 12 meters of black rubber and white paint adhesion on the port bow's shell plating.
 - (2) Approximately 50 meter-long intermittent abrasion on the starboard bow's shell plating.
- (See Figure 2)

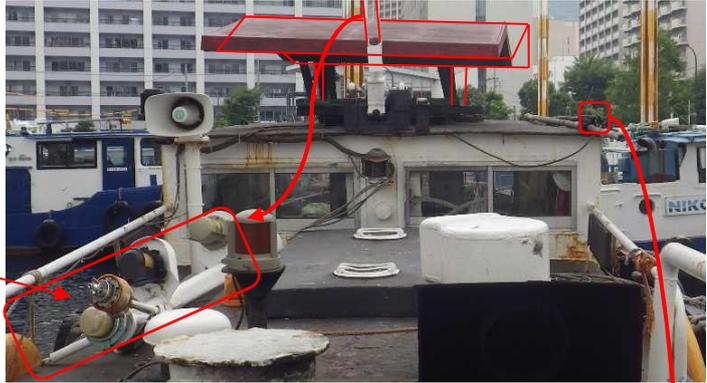
(1) Fractures of the mast, fallen from its original place

State of damage to the mast, starboard light, wheelhouse, etc. (Taken from the stern side)

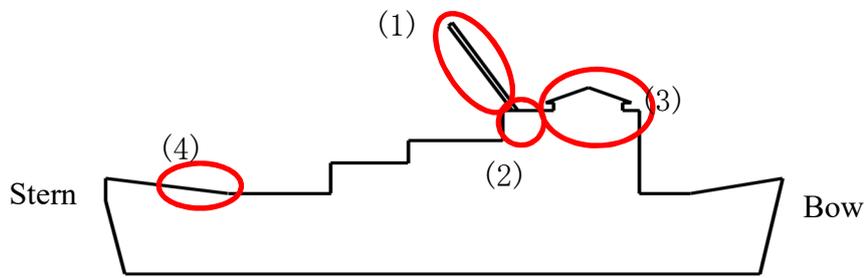
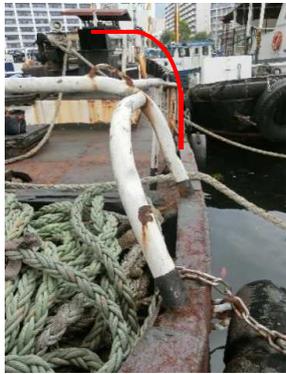
(4) The handrail on the starboard stern was bent to the port side

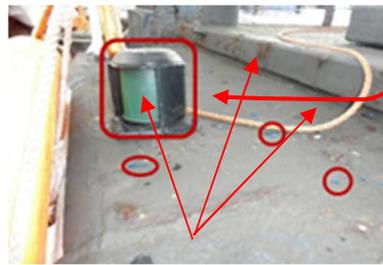
(2) Breakages of the starboard light

Fragments of the blue paint coating was found scattered

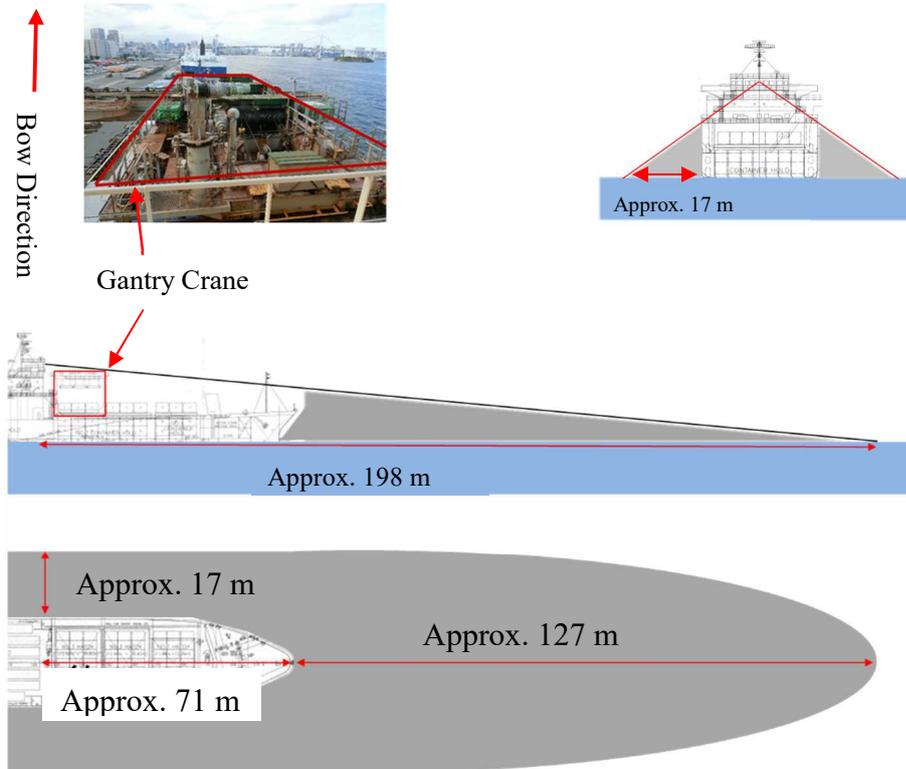
Figure 8 View from the Wheelhouse of Vessel A

Moreover, with observations made from the center of the wheelhouse to the vessel's side

directions, the sea-level visibility of approximately 17 meters to the sides of the vessel also fell into the blind area. (See Figure 8)

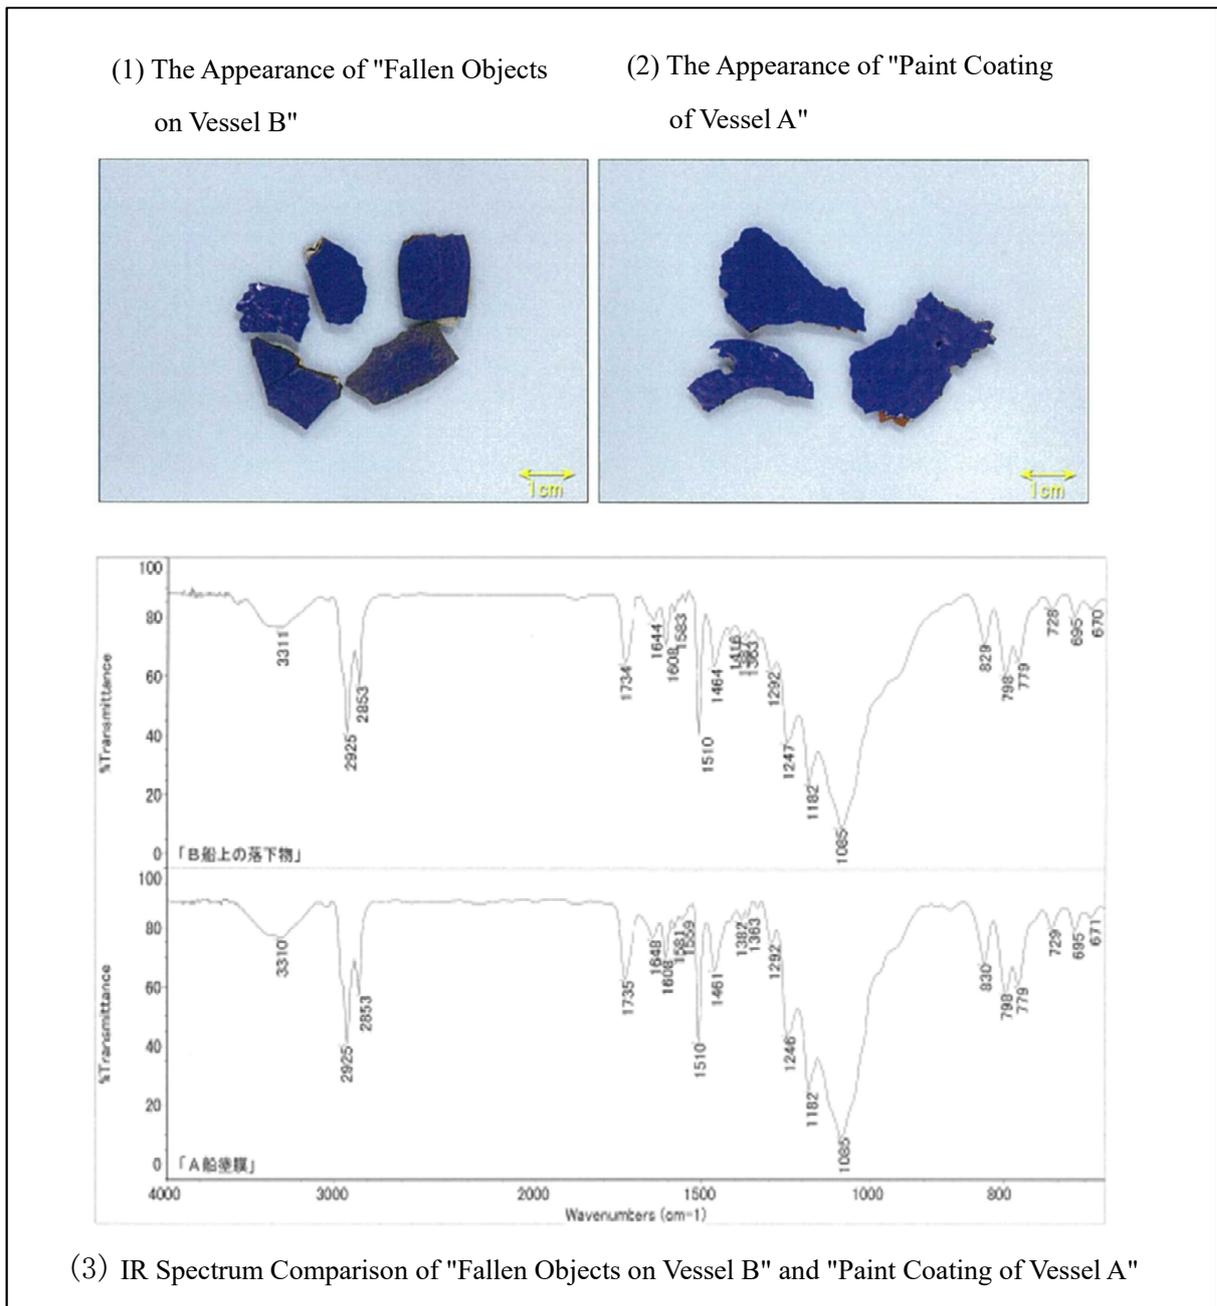
Figure 17 Result of an identification test using infrared spectroscopy (Excerpt)

As shown in Figure 17, the wavenumber region and the infrared absorption seen in the IR spectra of the "Fallen Objects on Vessel B" match well with the "Paint Coating of Vessel A". From this, it was concluded that "Fallen Objects on Vessel B" and "Paint Coating of Vessel A" are of the same component.

Therefore, it was probable that the "Fallen Objects on Vessel B" was derived from the "Paint Coating of Vessel A".

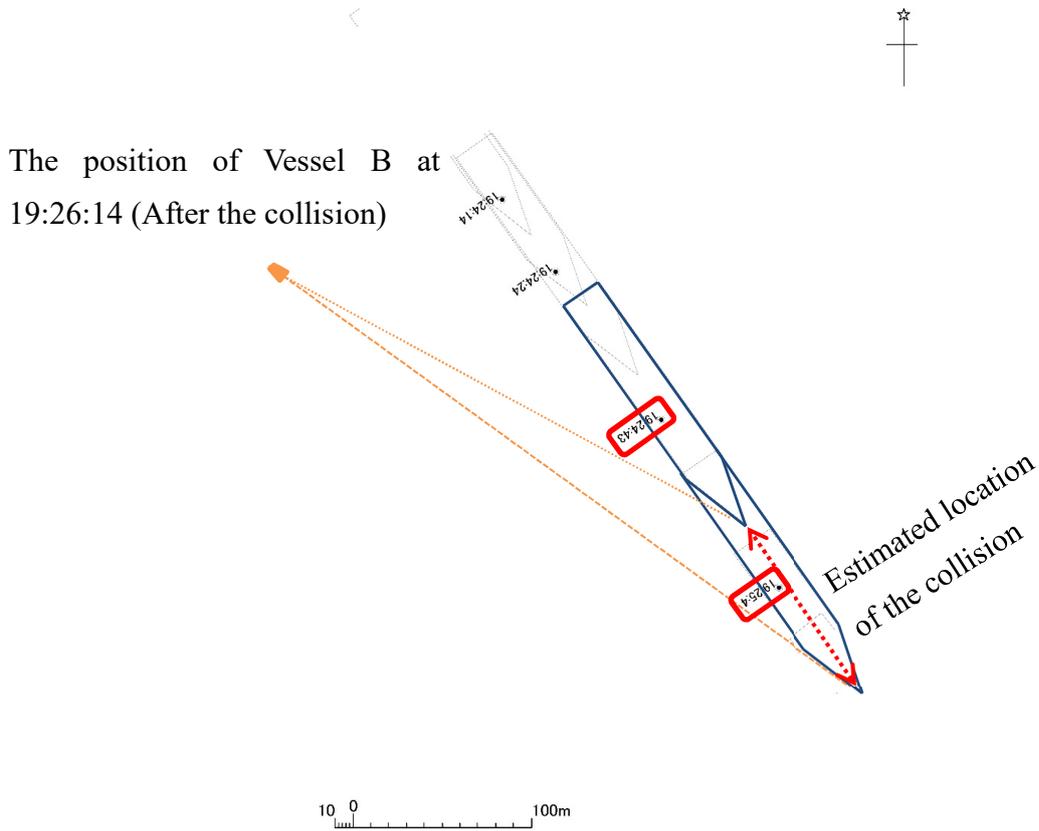
Figure 18 Estimated Location of the Collision

- ⑤ According to the GPS position information and the radar video recording which took into account the distance of approximately 75 m from Vessel A's radar antenna position to her bow, the time when Vessel B went over Vessel A's bulbous bow from the port side was between

19:24:43 and 19:25:04 (See Figure 18)

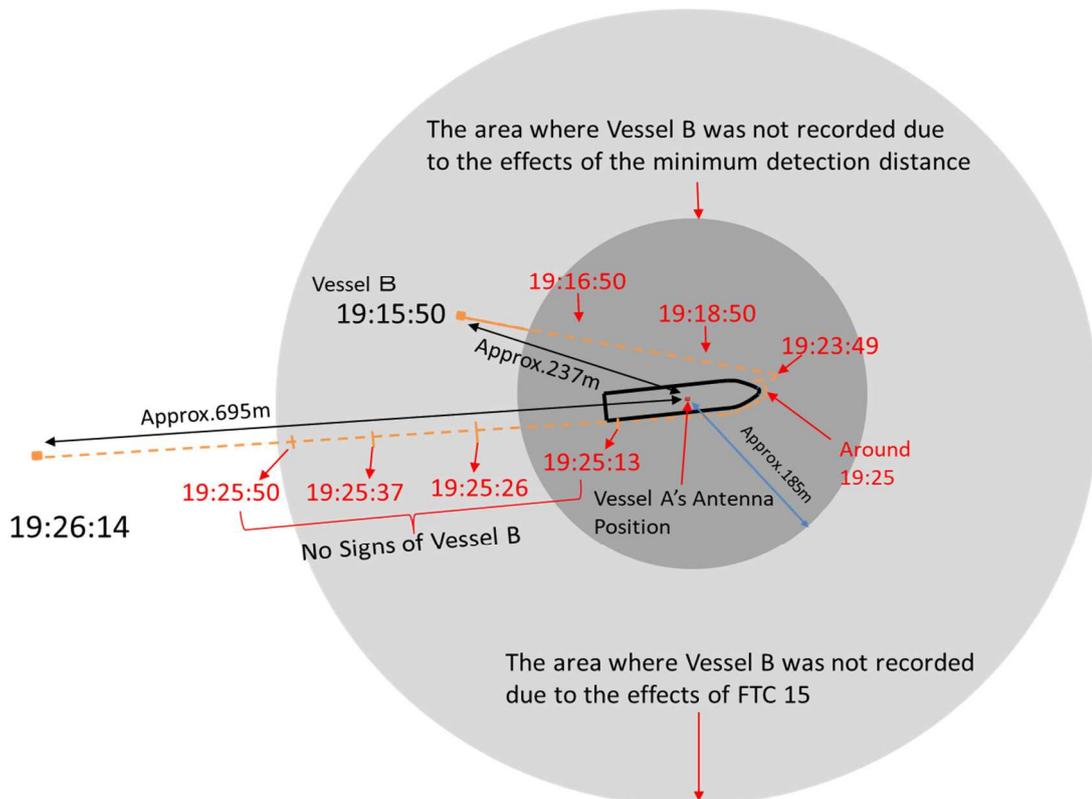
Figure19 Information on Vessel B based on the Recorded Images from the VDR of Vessel A

- (1) Between 19:10:14 and 19:14:50, Vessel B's signs were hidden by reflections of rain clouds.
- (2) At about 19:11:14, the FTC adjustment was set to 10 in order to reduce the effects of the rainfall.
- (3) Vessel A's minimum detection distance was about 0.1 M (approx. 185 meters), and the signs of Vessel B did not appear in the radar image after 19:15:50.
- (4) After 19:20:26, due to the effect of increasing the FTC adjustment from 10 to 14 and then further to 15 to reduce the effects of rainfall, the signs of Vessel B only reappeared after 19:26:14, at a distance of more than 695 meters from radar no.1's antenna. (See Figure 19)

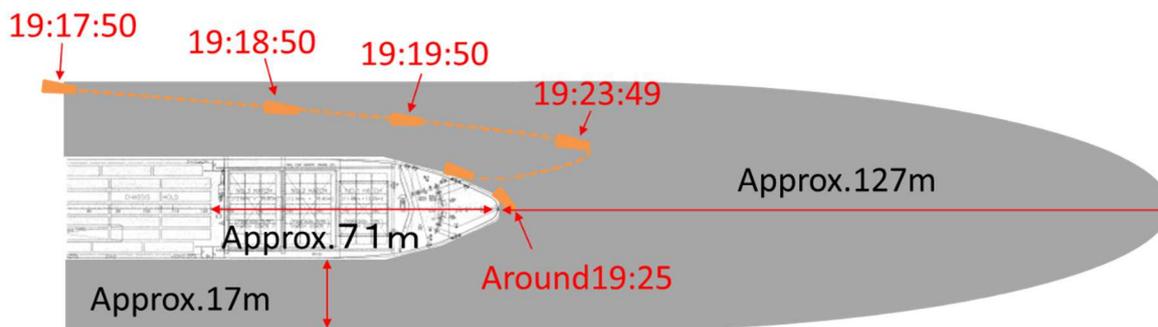
Figure 20 Blind Spot inside the Wheelhouse of Vessel A
and the Navigational Track of Vessel B

From 2.5.5, 2.7.3, and 3.2.6, it is probable that until around 19:17, Vessel B was navigating more than 17 meters away from Vessel A's port side, which did not fall under the blind spot from the center of Vessel A's wheelhouse. However, from around 19:18, Vessel B navigated closer to within 17 meters of the port side of Vessel A and entered the blind spot from inside Vessel A's wheelhouse. (See Figure 20)
