MA2021-3

**MARINE ACCIDENT
INVESTIGATION REPORT**

Vessel type and name: Container ship APL PUSAN
IMO number: 9234123
Gross tonnage: 25,305 tons

Vessel type and name: Cargo ship SHOUTOKUMARU
Vessel Number: 136463
Gross tonnage: 391 tons

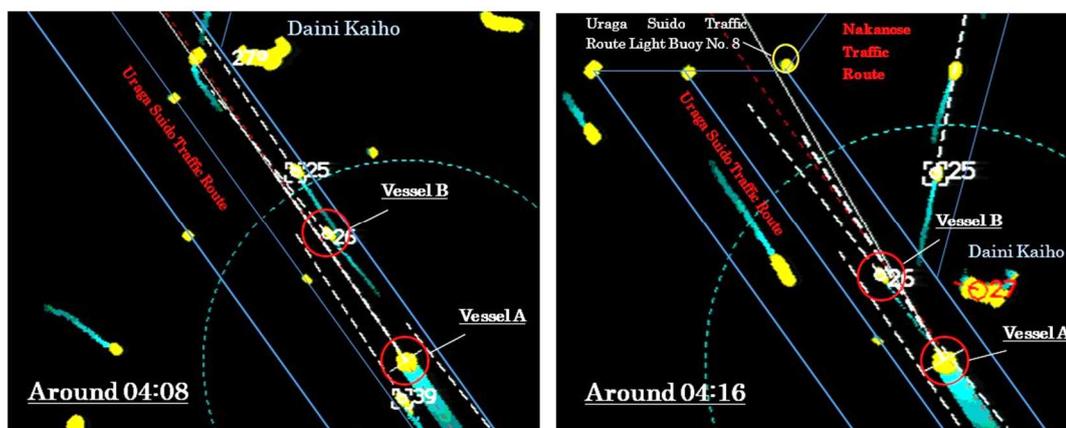
Figure 2 Radar image recorded in the S-VDR of Vessel A

At around 04:16, Pilot A noticed that Vessel B was proceeding northwest toward Nakanose Traffic Route without turning to starboard even though Vessel B had passed the southwest side of Daini Kaiho, and changed the course from approximately 325 ° to approximately 332 ° toward the starboard side of Vessel B.

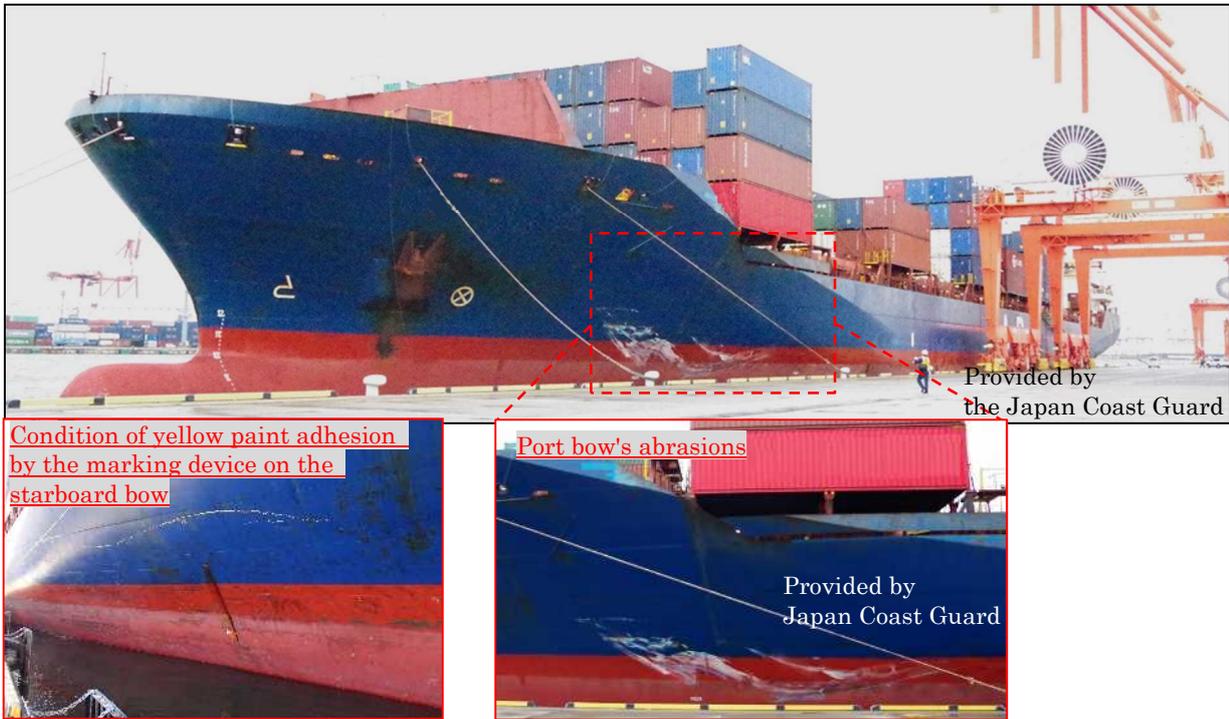
Photo 1 State of damage to Vessel A

According to the statement of Master A and the reply to the questionnaire by the Japan Coast Guard, Vessel A sustained a dent and abrasions on her port bow's shell plating, as well as abrasions on her starboard bow's shell plating. (See Photo 1)

- (1) Vessel A sustained a dent and abrasions on her port bow's shell plating, as well as abrasions on her starboard bow's shell plating.
- (2) Vessel B sustained a pressure collapse on her bow bulwark and fractures on her

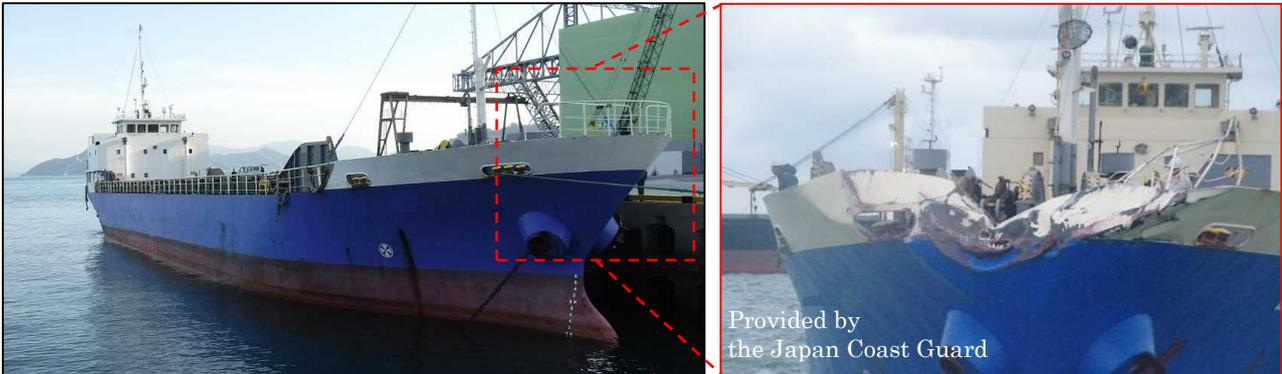
Photo 2 State of damage to Vessel B

According to the statement of Officer B₁ and the reply to the questionnaire by the Japan Coast Guard, Vessel B sustained a pressure collapse on her bow bulwark and fractures on her foremast. (See Photo 2)

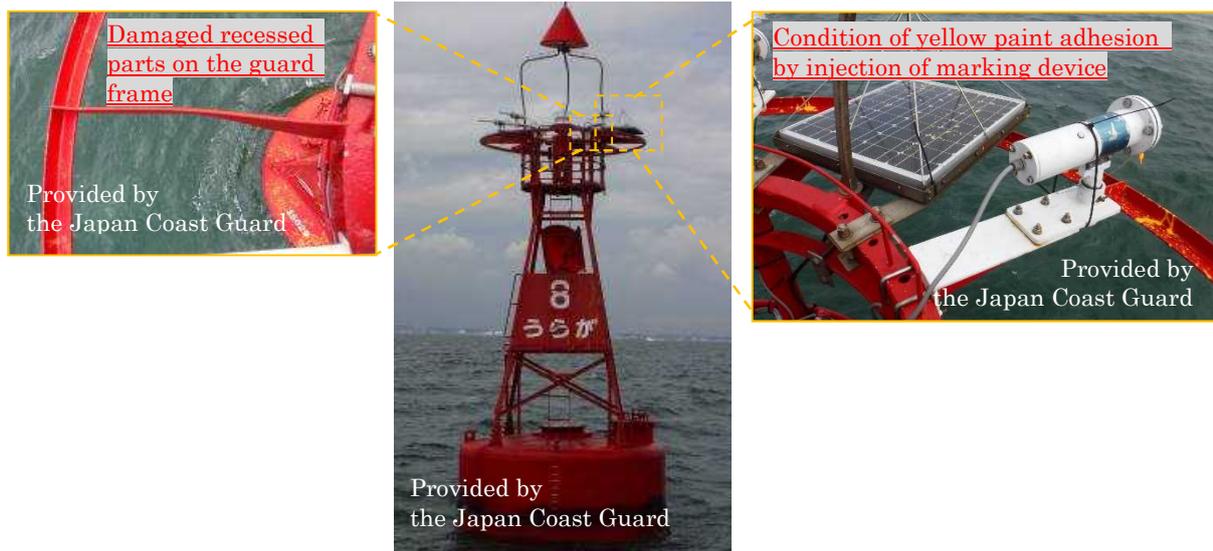
Photo 3 State of damage to the Buoy

According to the reply to the questionnaire by the Japan Coast Guard, the Buoy sustained damaged recessed parts on the guard frame and other parts, as well as fractures and other damages on the marking apparatus sensor. (See Photo 3)

- (3) The Buoy sustained damaged recessed parts on the guard frame and other parts, as well as fractures and other damages on the marking apparatus sensor.

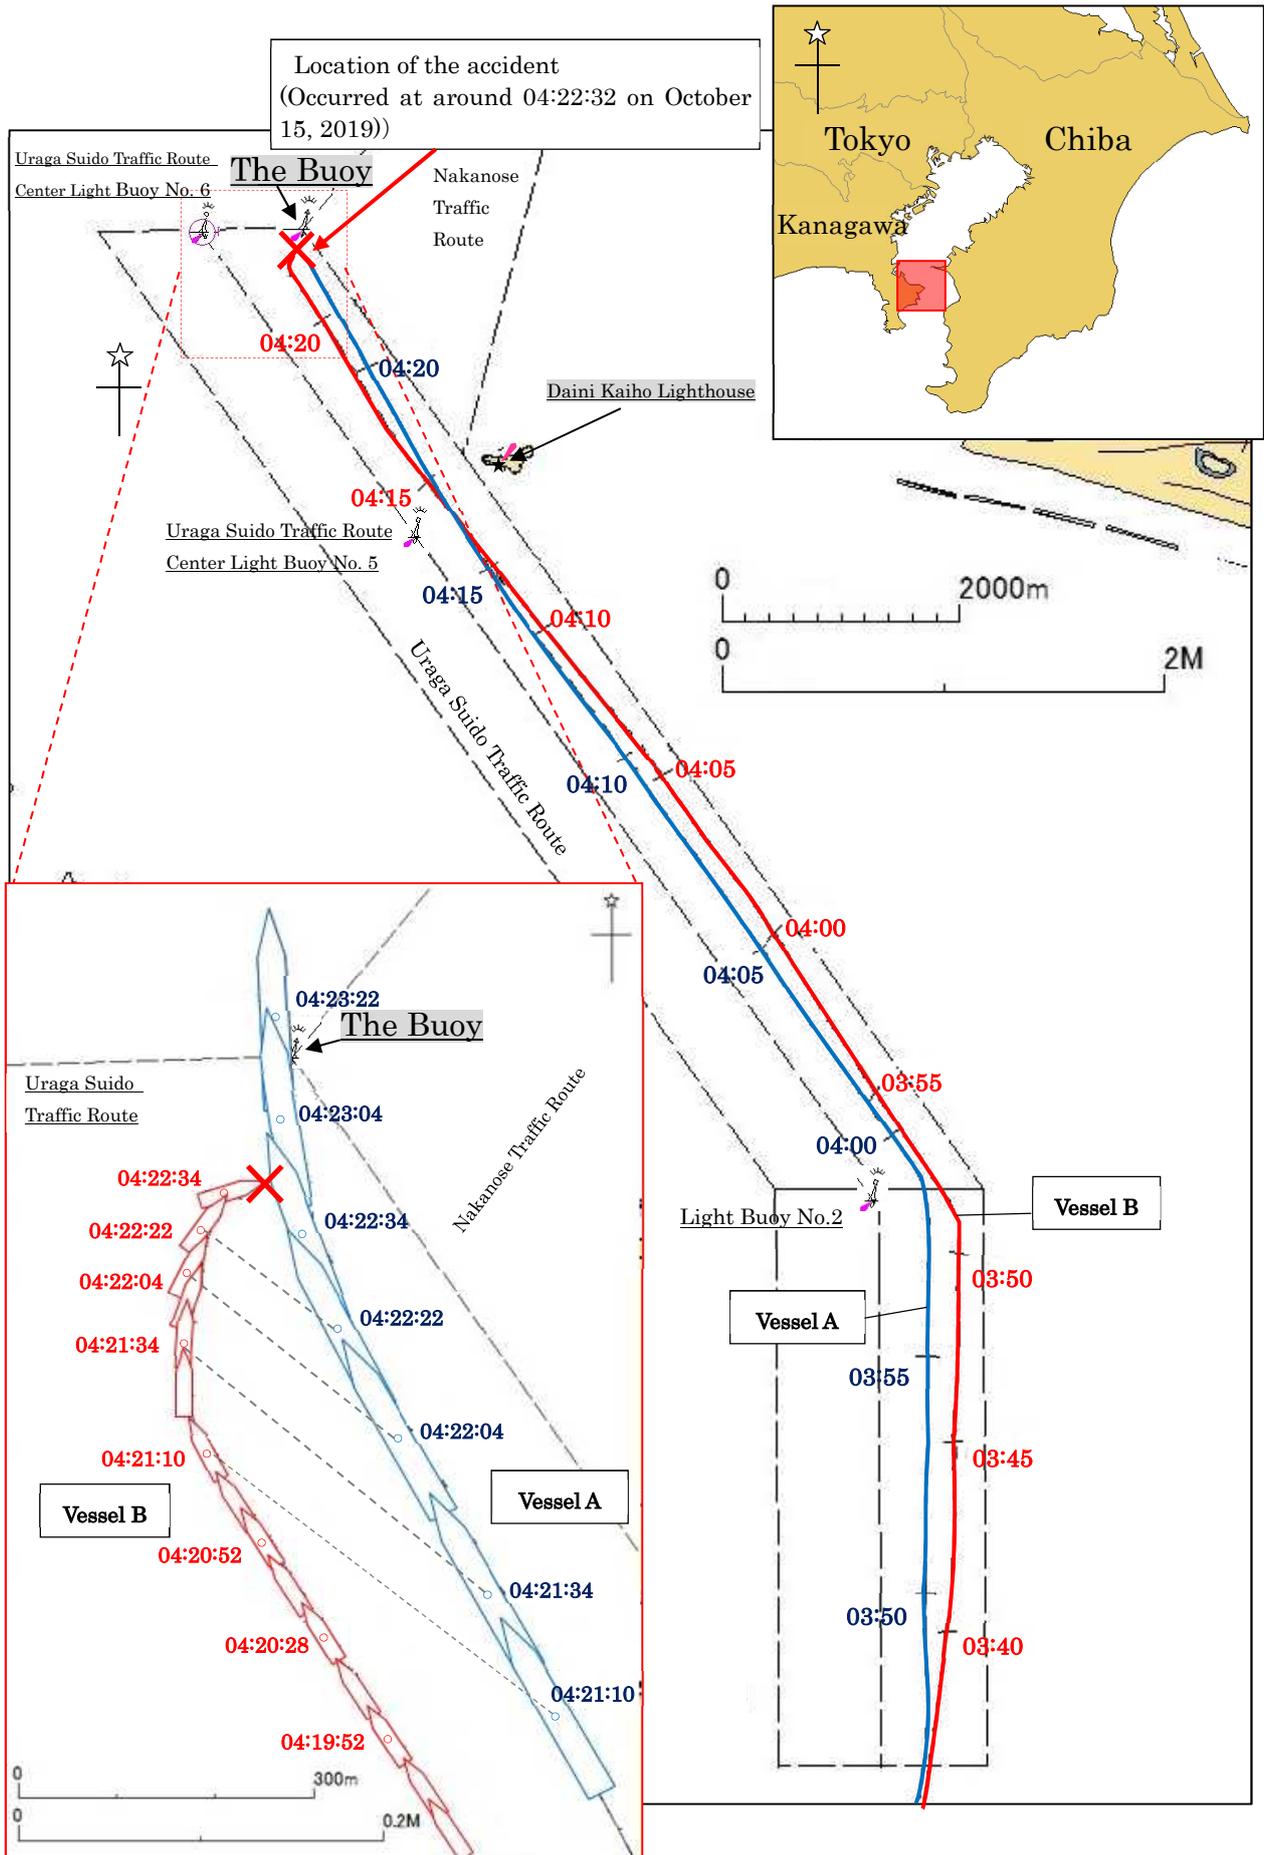
(Attached Figure 1) Estimated Navigation Routes

The date and time of occurrence of this accident were around 04:22:32 on October 15, 2019, and the location was around 317° true bearing, 1.3M from Daini Kaiho Lighthouse.
