NAVIG8 AXINITE CASUALTY INVESTIGATION REPORT

Third Engineer Fatal Injury

English Channel | 29 July 2020

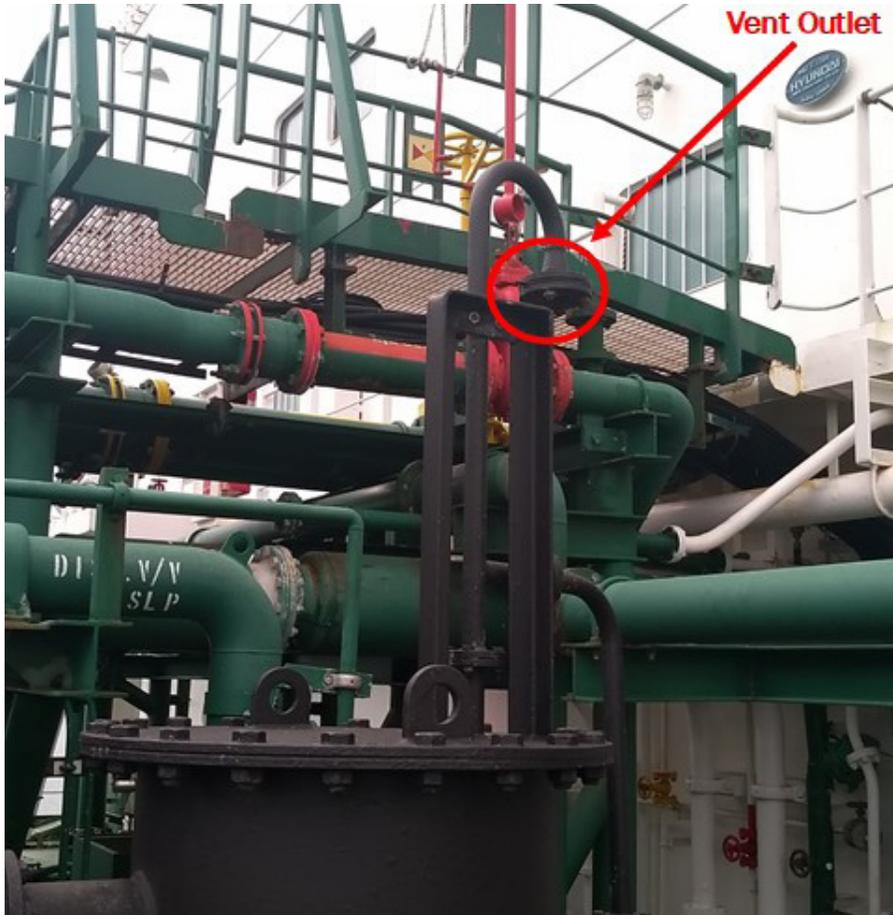
Figure 6: Condensate return line observation tank vent.

Following the incident, the vent for the observation tank was disassembled and inspected. It was found that the flame arresting screen which was supposed to be fitted at the vent discharge had been replaced with a metal blank with about a 5 mm hole in the center. This drastically reduced the venting capacity for the 25 mm pipe.

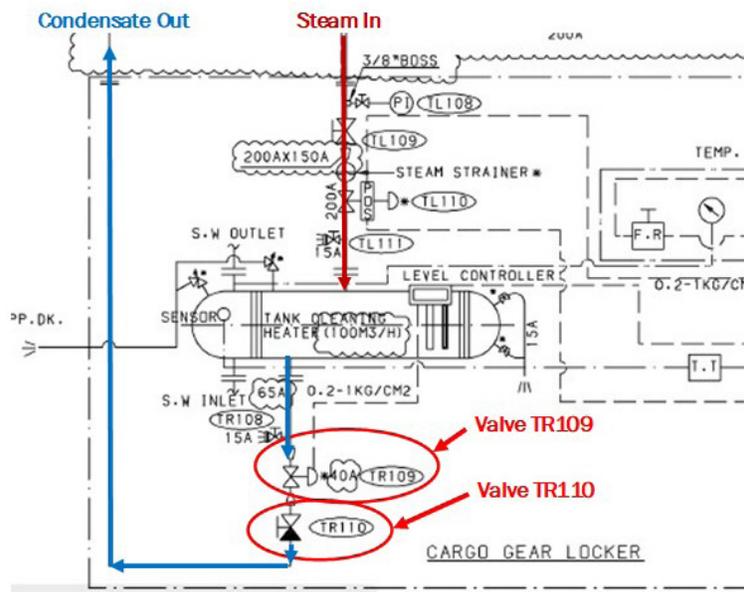
20. Further troubleshooting identified that TR109, which regulated the condensate level in the tank cleaning heater, was not working properly.⁷ The manual valve on the condensate return line (TR110), immediately downstream of the pneumatic valve was then partially closed to try to raise the condensate levels in the tank cleaning heater. This was an attempt to create a more effective heat exchange (see Figure 7).

Figure 7: Tank cleaning heater diagram showing the steam and condensate flows and location of valves TR109 and TR110.

The TR110 immediately downstream of the TR109, had been partially closed to increase the effectiveness of the heater and raise the wash water temperature (*see Figure 7*). The wash water was at the required 75°C when cleaning COT Nos. 1 and 2, port and starboard. This indicates TR109 was functioning properly when tank cleaning started. The cause of TR109's failure could not be determined.

⁷ The cause of TR109's failure could not be determined. The valve was subsequently replaced with a new valve and was operating properly.

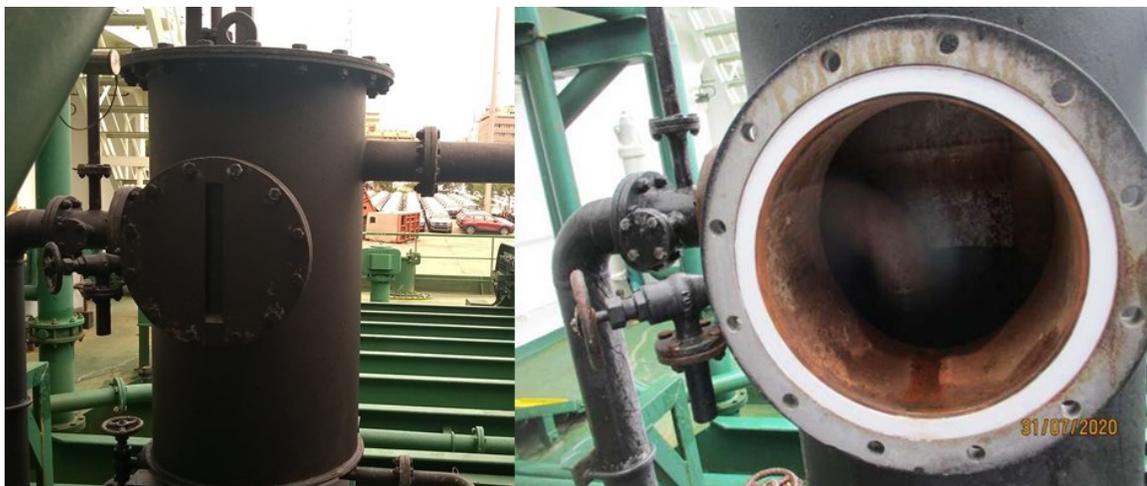
36. Following the incident, a detailed examination of the surrounding area was conducted. It was found that a large quantity of steam was coming from the observation tank because the sight glass had shattered (see Figure 8).

Figure 8: Photo of the observation tank and observation port where glass failed. The steel cover was installed after the incident occurred.

About 17 minutes after the 3/E came up from the Engine Room, a loud bang was heard by crewmembers working at the port side cargo manifold. Large quantities of steam were seen coming from the vicinity of the Slop tanks. When the crewmembers went aft to investigate, they found that the sight glass on the observation tank had failed and steam was coming from this opening.

It is likely that ineffective regulation of the condensate in the tank cleaning heater allowed excessive steam to pass into the condensate return line. This is shown by reports from the crewmembers that steam was seen coming from the observation tank vent during initial troubleshooting. However, the ability to vent the steam was severely restricted by the 5 mm hole in the metal blank fitted on the vent discharge. TR101 being closed caused pressure to increase at a rate greater than what could be relieved by the restricted vent opening. Eventually, the increasing pressure within the observation tank caused the sight glass to fail.

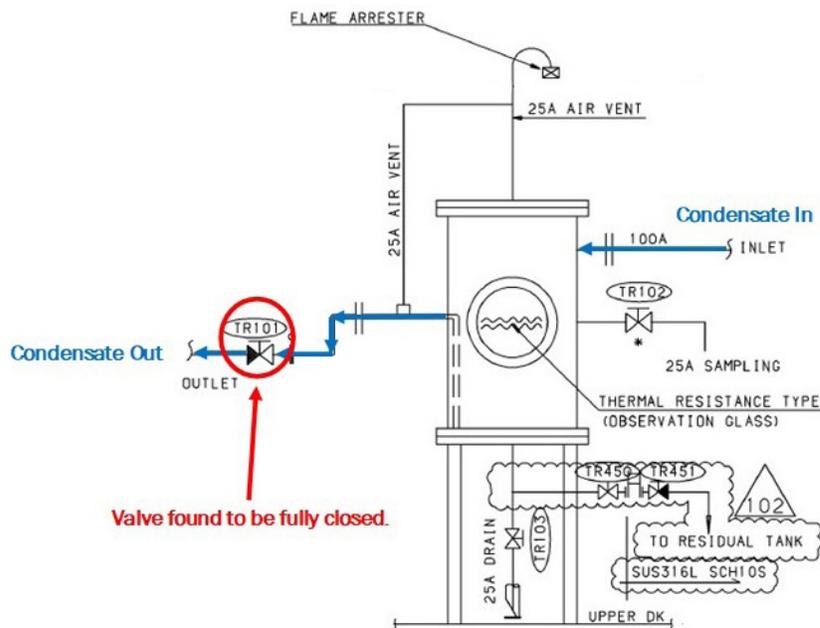
37. The TR101 on the drain line from the observation tank was fully closed when examined after the incident (see Figure 9). The manufacturer's instruction manual states this valve must always remain open when the system is in use. No warnings or other markings were present near the valve to indicate that it must remain open.

Figure 9: Condensate return line observation tank diagram showing flow and the valve which was found closed.

It was also noted following the incident that TR101 on the observation tank drain line was found fully closed. This prevented condensate from flowing back to the Engine Room. The manufacturer's instruction manual states that this valve must remain open at all times when operating the steam system. At the time of the incident, no warning or other markers to this effect were present near the valve.

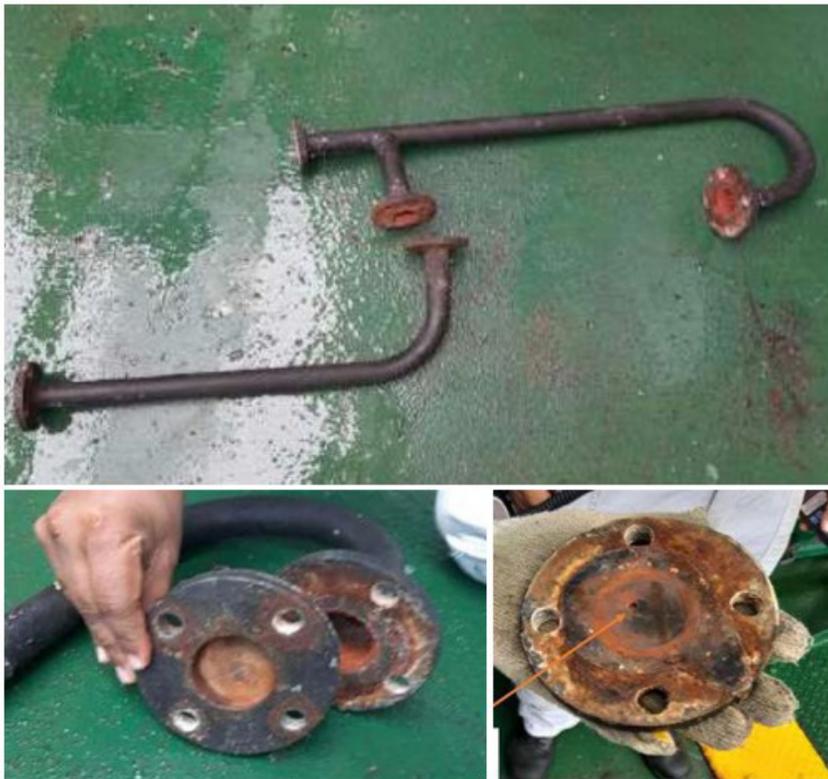
38. The vent for the observation tank was removed following the incident. When disassembled, a metal blank was found fitted in place of the flame arresting screen. This blank had about a 5 mm hole in the center (see Figure 10). The Administrator could not determine when this blank had been fitted. Neither the crewmembers nor the Company knew about the blank's existence. One of the 13 other similar type 2 ships in the Company's managed fleet had a similar blank installed on the vent.⁹

Figure 10: Photos of the condensate return line observation tank vent.
