SAFETY INVESTIGATION REPORT

REPORT NO.: 08/2021

TUGBOAT *SPINOLA* Serious injury to crew member, while berthed at Timber Wharf, Malta 13 April 2020

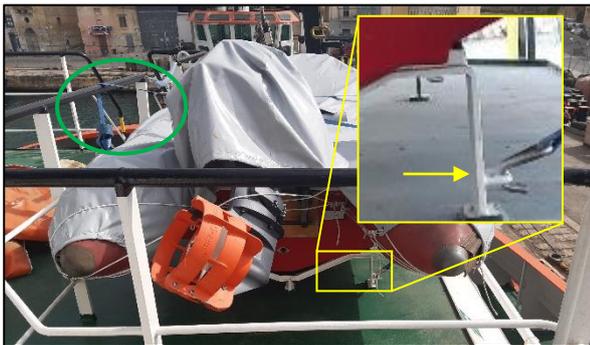
Figure 2: Lashing straps marked in green. Inset indicating the location of one of the securing for the lashing hook (the grey cover is the new cover)

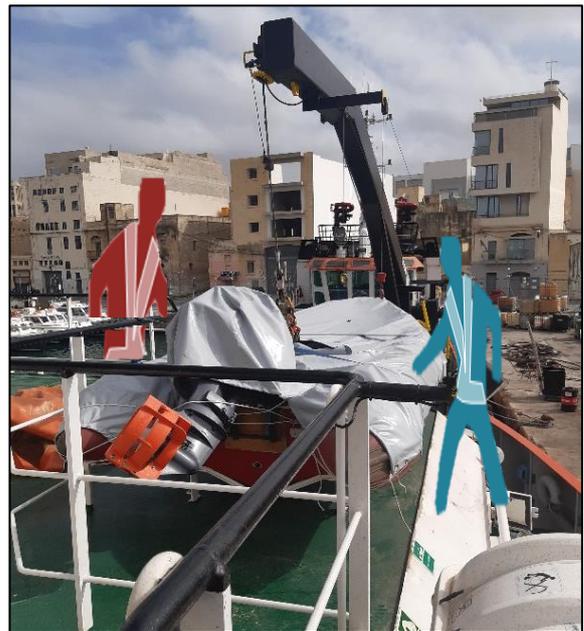
To gain access to the lashings, the GPH proceeded to the outboard side of the rescue boat and stepped on the drenching curtain pipe, which ran around the deck (Figure 3). The old cover was removed without difficulty, following which, the GPH returned to the inboard side.

The crew initially attempted to fit the new cover from the inboard side, however, they agreed that someone had to return to the outboard side to facilitate the fitting. The GPH went back onto the drenching curtain pipe to be able to proceed with the task.

Figure 3: The master's position (red) and the GPH's position on the outboard side (blue)

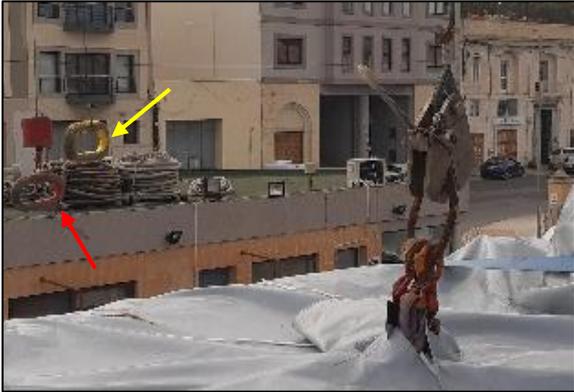
Their plan was to ease the tension on the hoisting arrangements, disengage the release hook, pass the lifting slings through the new cover's opening and then re-attach the release hook. The GPH pulled down on the remote control for lowering (Figure 4) while

the master applied weight on the lifting slings, however, they did not get any results.

Figure 4: Remote control for lowering (red) and remote control for slewing (yellow)

It was reported that the crew members thought that they had pulled on the incorrect handle to release the brake. At around 1300, the GPH then pulled the other handle and consequently, the jib's crane swung outboard with the rescue boat, dragging the GPH along with it in the process.

Given that the GPH pulled the yellow slewing handle, after he pulled the red lowering handle and observed that the wire had not slacked, the safety investigation believes that the GPH may have been unsure of the functions of the remote controls of the rescue boat. This is a typical (rule-based)⁵ behaviour, indicative of uncertainty while operating a machine/piece of equipment and an action does not lead to the expected outcome.

08/2021_R2 Fix comprehensive rescue boat launching procedures in the vicinity of the rescue boat.

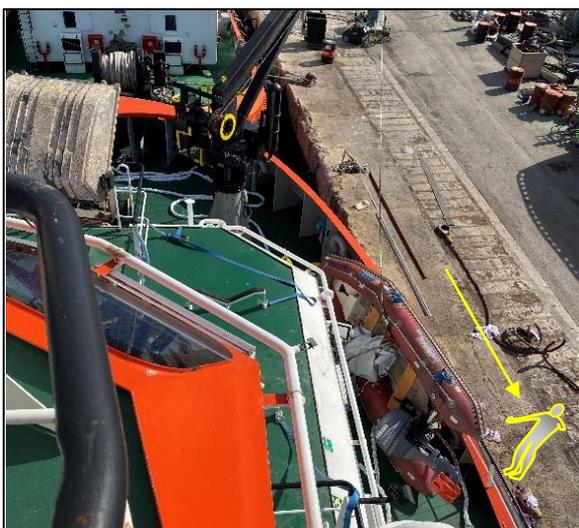
CCTV footage of the wharf, which captured the accident, indicated that the GPH was pushed horizontally with the rescue boat for a short distance and then fell onto the wharf. He was found at the edge of the wharf, close to the tug's bulwark (Figure 5).

Figure 5: Final position of rescue boat after the swing and approximate landing position of the GPH on the wharf

Although not having a bearing on the dynamics of the accident, it was noted that the rescue boat had turned on its port side when it dropped to the lower deck. This happened even though the rescue boat had four lifting slings at each corner of the hull to keep it upright.

During the safety investigation, it was revealed that the left, rear lifting sling had not been secured to the rescue boat's hull. While the reason behind this could not be confirmed, the safety investigation concluded that it had most likely contributed to the rescue boat turning to its left side before landing on the lower forecastle deck.

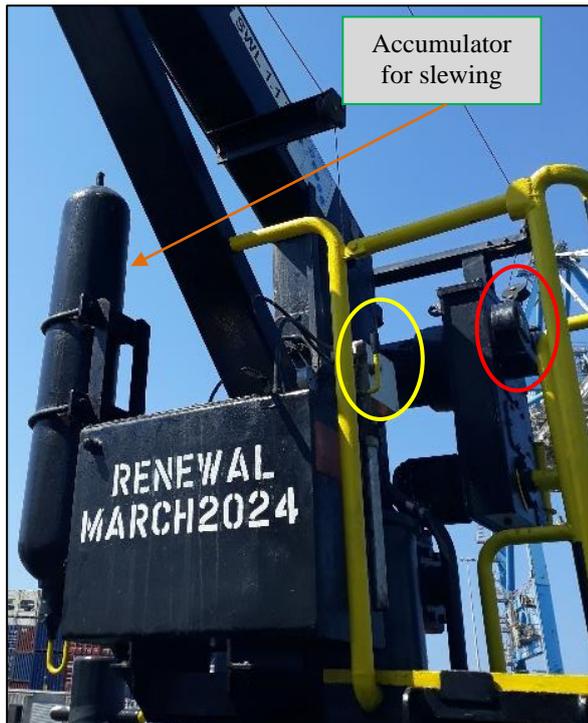
The davit's slewing movements could be operated from the local station, at the davit's control platform (Figure 6), as well as by a remote system, consisting of a yellow control handle that could be operated from the inside of the rescue boat (Figure 4).

Figure 6: Davit's local controls – slewing control in yellow and brake mechanism in red

Additionally, the slewing lever at the local control station (26)¹⁰ was found stuck in the slewing position with its dust boot damaged. A closer inspection did not reveal any mechanical damages which would have

prevented the slewing lever from operating freely. It was therefore hypothesised that the probable cause of the sticking of the slewing lever was the pulling force applied by the GPH when he was being dragged over the side by the slewing rescue boat.

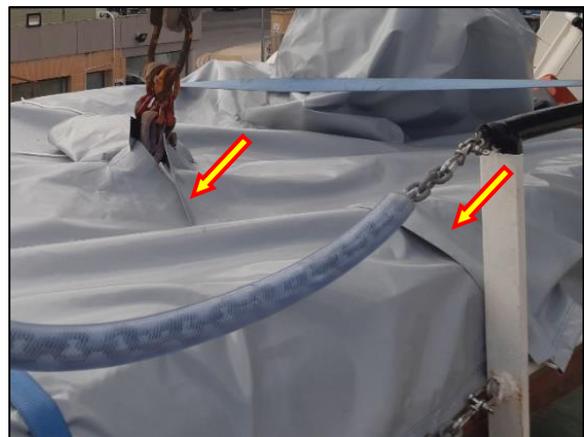
Figure 8: New cover's flap

The safety investigation believes that the crew members' understanding may have been conditioned because the zipper was covered by a flap, which was an extension of the cover (Figure 8). Consequently, the zipper went unnoticed. It may be suggested that in all probability, the crew members were not aware that the cover was identical to the one that they had already removed; this may have necessitated the crew members to improvise on a method to fit the new cover.

08/2021_R1 Apply either reflective tape or black & yellow warning tape on the cover zipper.

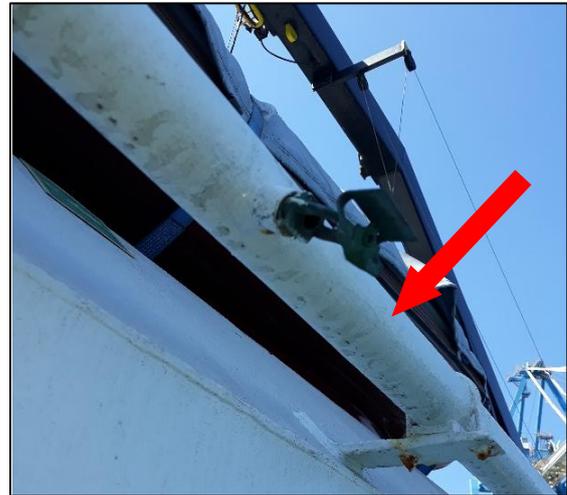
For crew members (like the GPH) who opted to walk outboard, the tugboat's drenching curtain piping served as a foothold to stand upon (Figure 9). As such, the safety investigation believes that due to the (perceived) trivial nature of this task, and the relatively short time standing on the curtain piping, wearing a safety harness was not deemed necessary by the crew members.

Figure 9: Drenching curtain piping used by crew members while on the outboard side of the rescue boat, seen from below
