REPORT

Marine 2021/05

*PART TWO REPORT ON THE COLLISION
BETWEEN THE FRIGATE
HNOMS 'HELGE INGSTAD' AND THE
OIL TANKER SOLA TS OUTSIDE THE
STURE TERMINAL IN THE HJELTEFJORD
IN HORDALAND COUNTY
ON 8 NOVEMBER 2018*

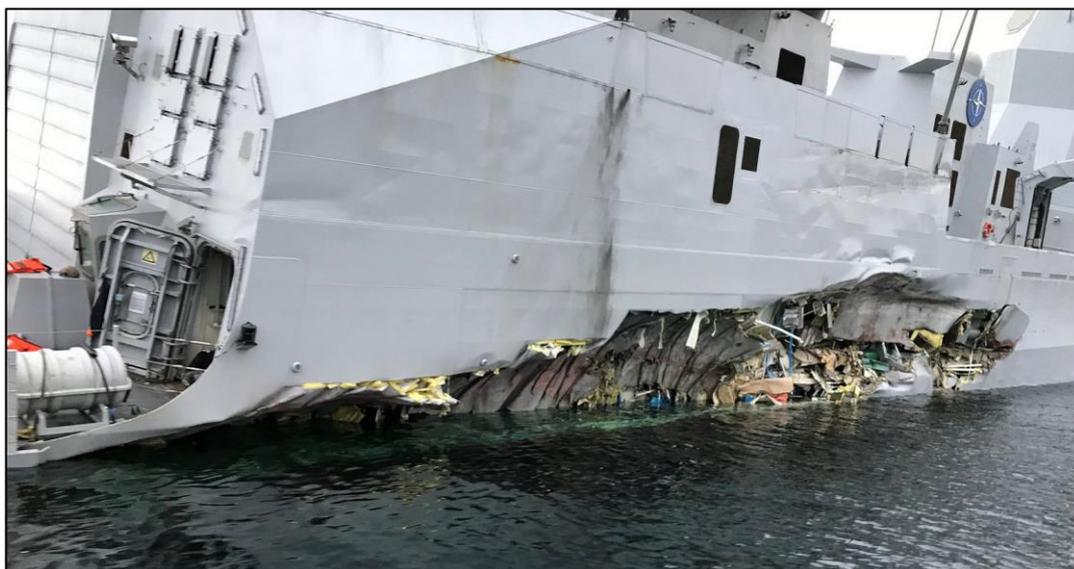
At 04:01:15, HNoMS 'Helge Ingstad' collided with the tanker 'Sola TS'. The first impact between the vessels was the tanker's starboard anchor and the area forward of the frigate's starboard torpedo magazine. The hawsepipe tore a large gash along the frigate's starboard side. As a result, parts of the frigate's side were ripped off and pushed inwards; see Figure 3 and Figure 4. The hull damage resulted in damage to and severing of a large number of cables, pipes, ductings, control panels, secondary switchboards, watertight doors, etc along the 46 m long damage area, as well as a broken seawater main.

Figure 3: Damage along the frigate's starboard side following the collision. Photo: The Norwegian Coastal Administration

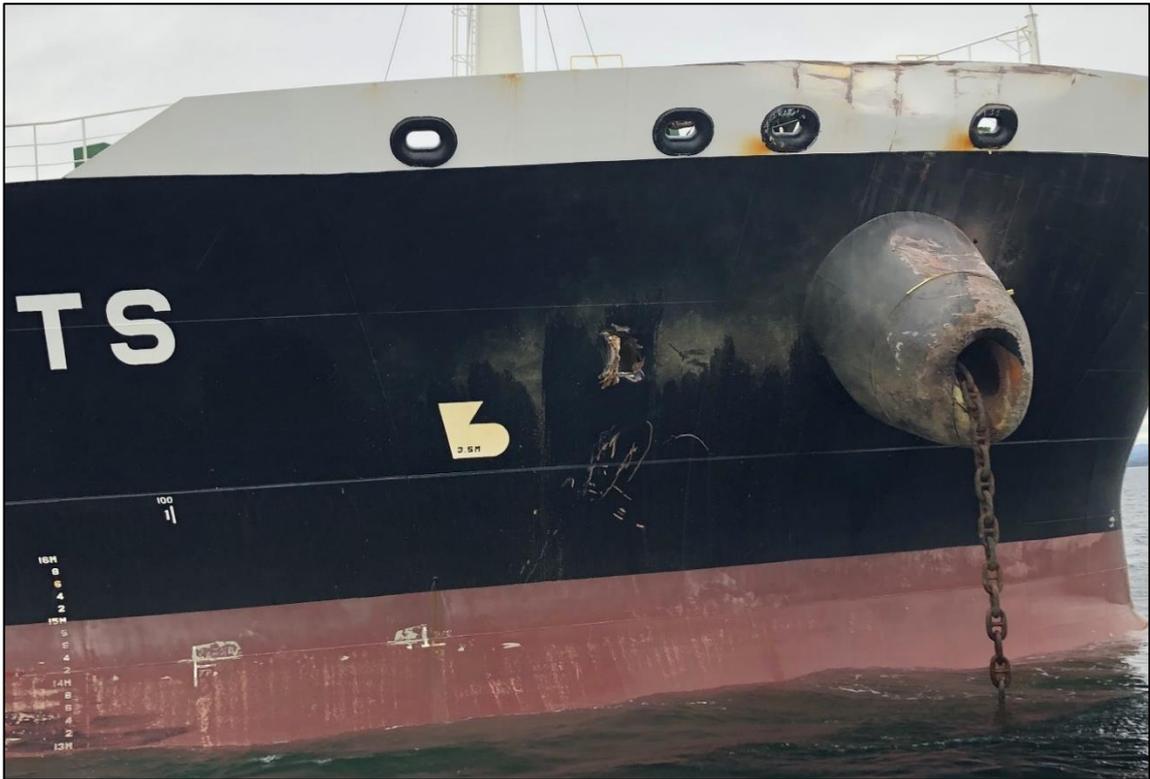
Figure 4: The hawsepipe and the damage sustained by 'Sola TS'. Photo: The Norwegian Maritime Authority

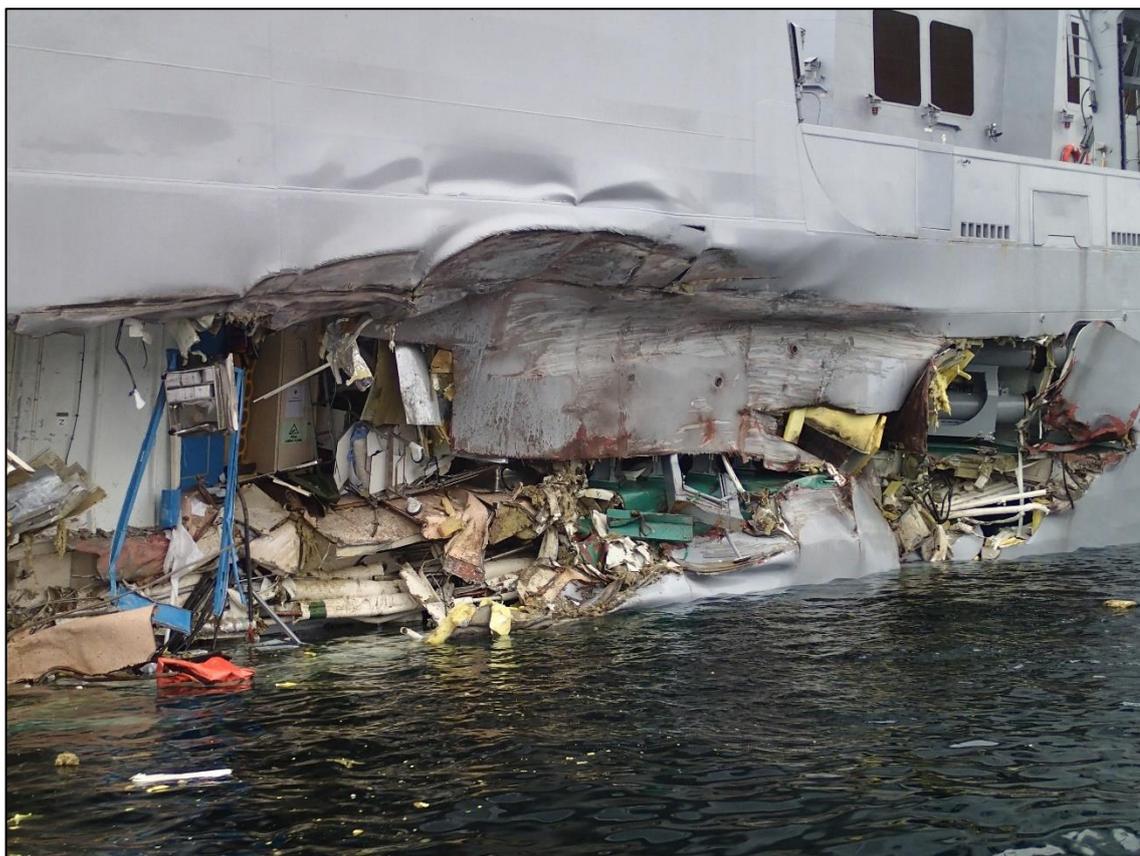
Figure 14: Parts of the damage. Photo: CGV 'Bergen'

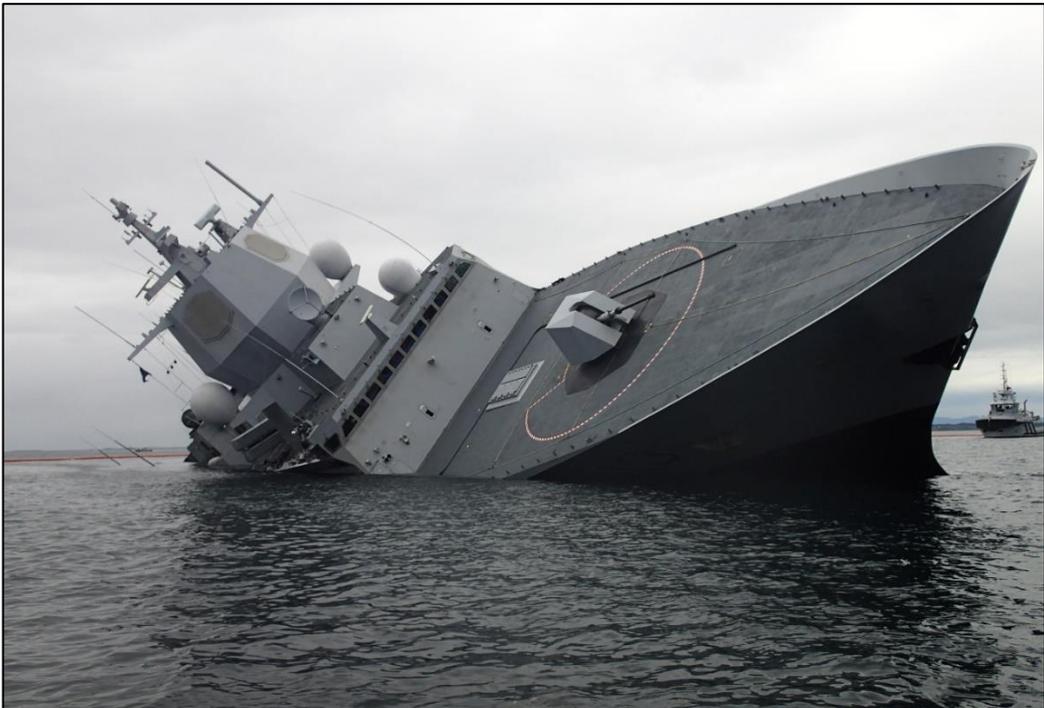
At 10:27, while the tugboats kept pushing on HNoMS 'Helge Ingstad', the frigate suddenly heeled over to starboard. The IPMS data show that the frigate ended up with a list of around 30 degrees, after which the tugboats interrupted the operation. The afterbody then sank rapidly so that the shaft/rudder was lodged on the seabed.

Figure 18: HNoMS 'Helge Ingstad' listing heavily at 11:04 after having been pushed by tugboats. Photo: CGV 'Bergen'

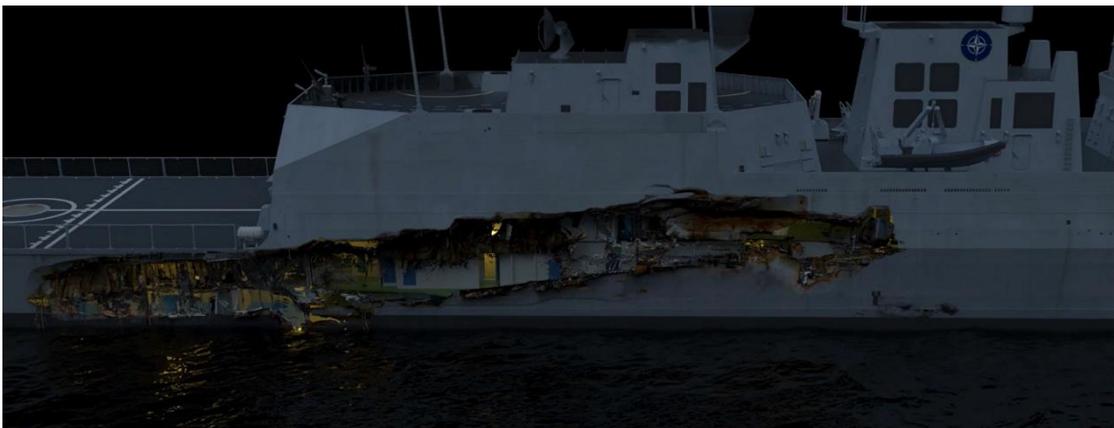
Figure 21: The damage on HNoMS 'Helge Ingstad'. Illustration: NCIS/CIAAS/NSIA

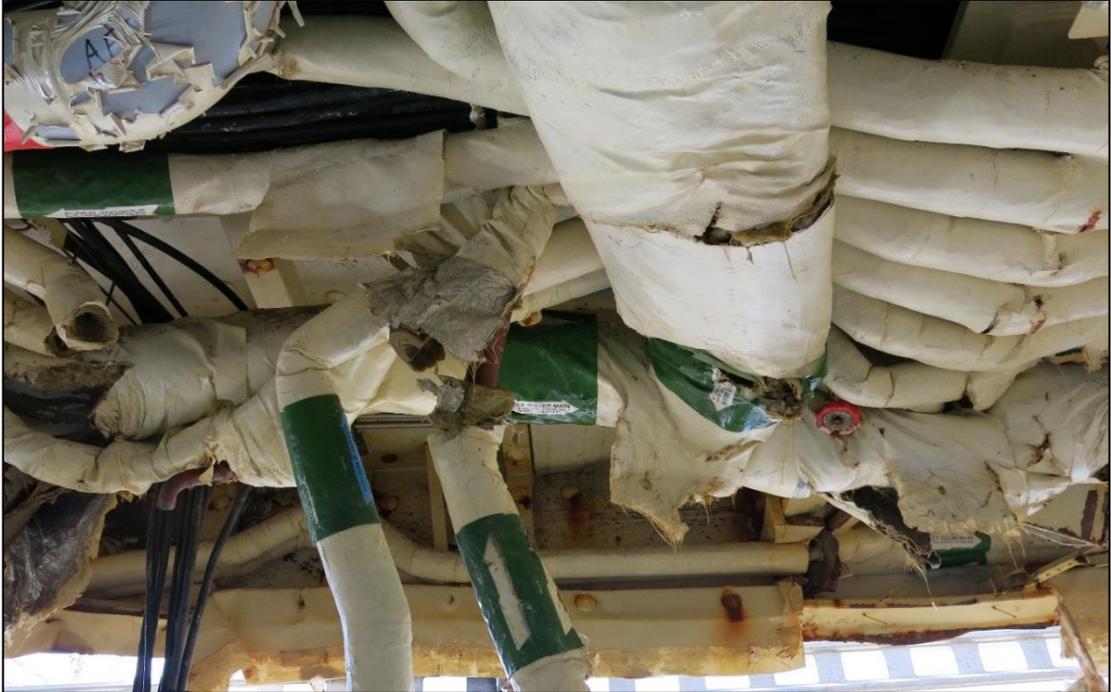
After the collision, pressure was lost on the seawater line, and an attempt was made to restore seawater pressure in order to start the stationary bilge system. At approximately 04:05, the seawater main was isolated at the aft end of the forward main engine room, as the line was broken in parts of the afterbody. At approximately 04:08, the isolation valves between the forward main engine room and the bow thruster machinery room were opened to be able to use the bilge eductors in the forebody to remove water from the aft compartments. The CCTV monitors showed that all the machinery spaces were intact, except the aft generator sets room.

Figure 22: Damage to the seawater main aft of fire zone 4. Photo: NSIA

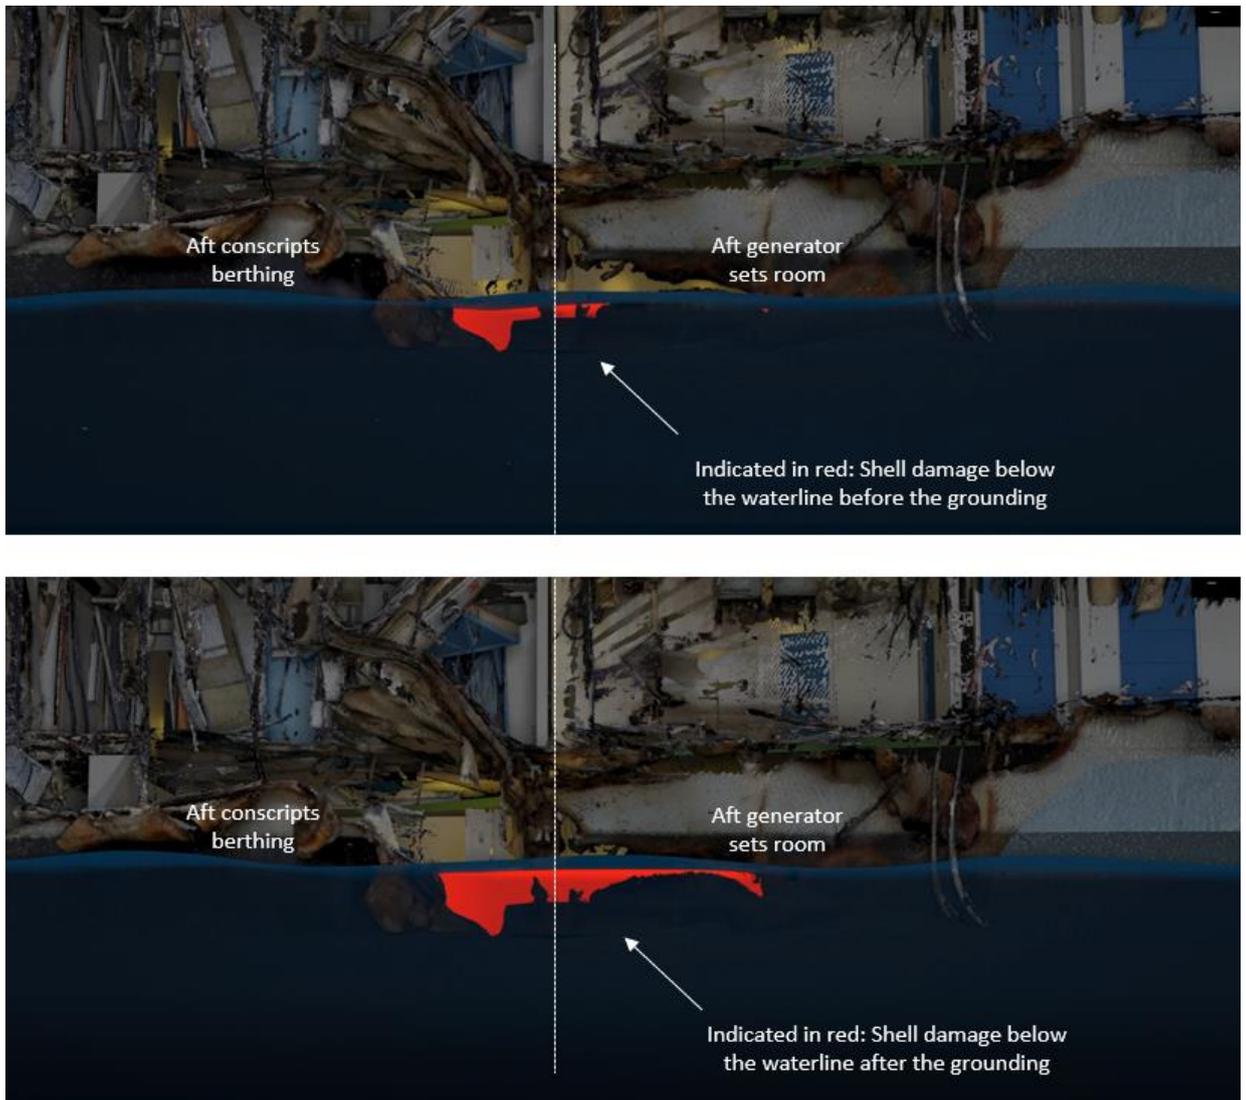
Figure 23: The shell damage below the waterline. Illustration: NCIS/CIAAS/NSIA

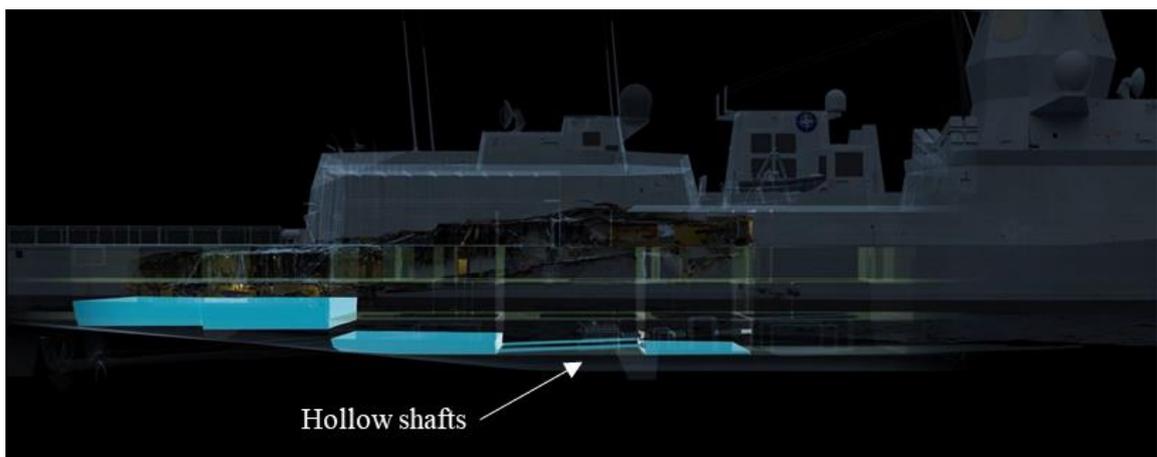
The damage sustained in the collision caused flooding of several compartments. After the frigate ran around, water also ingressed to the reduction gear room through the hollow propeller shafts. Eventually, the flooding was considered so extensive that the frigate was deemed to be lost, and it was decided to evacuate the crew. Doors, hatches and other openings in the frigate that were supposed to be closed to maintain stability and buoyancy were not closed by the crew at the time of evacuation. The frigate subsequently sank.

Figure 37: Water flowing via the aft generator sets room into the gear room through the flexible coupling. Illustration: CIAAS/NSIA

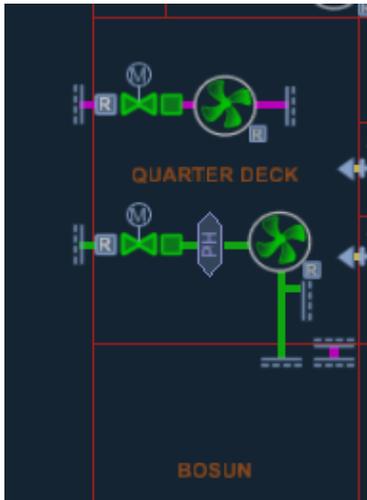
Figure 53: Extract from a screenshot from IPMS before the collision showing open ventilation ducts from the Q-deck. Screenshot: The Navy/NSIA

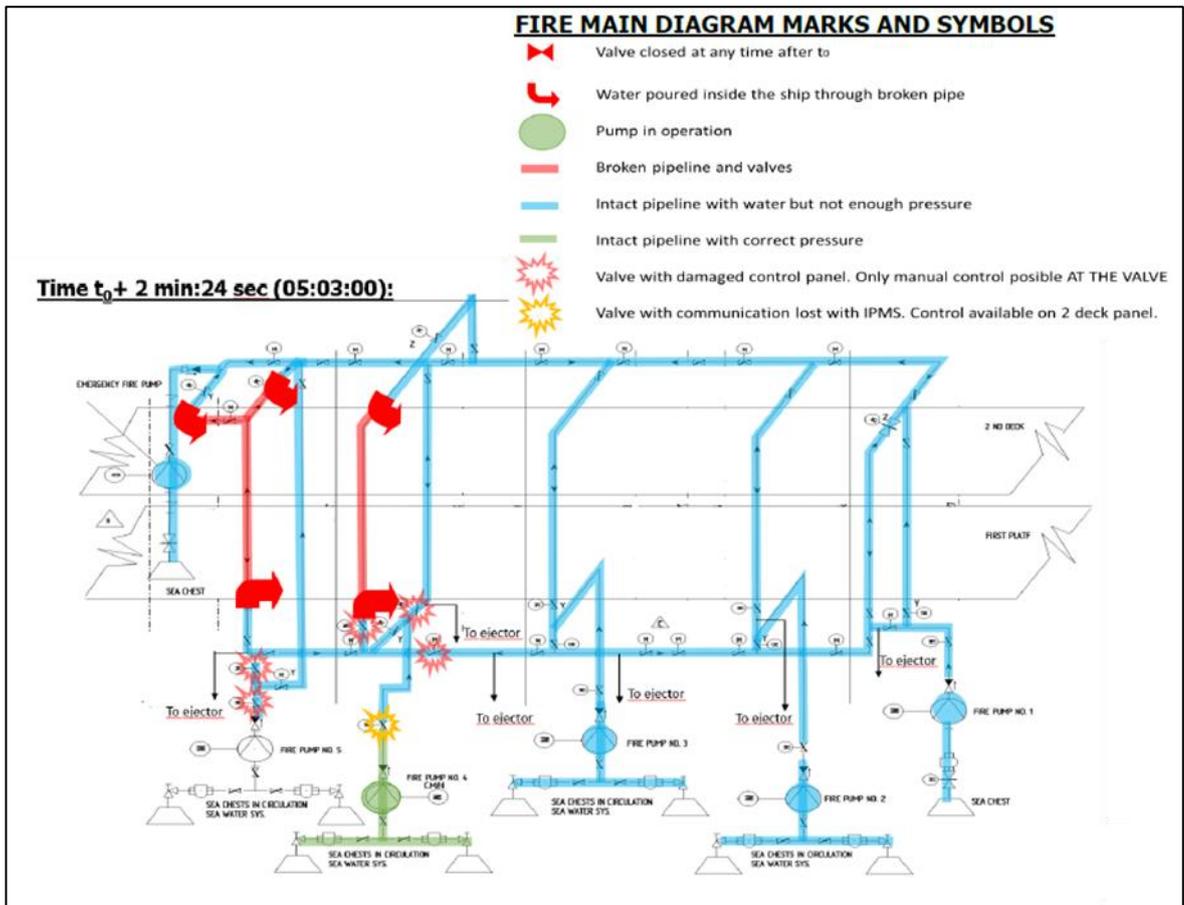
Figure 58: Schematic diagram⁷⁷ showing how water was being pumped into the ship as a result of failure to isolate the seawater main. Schematic: IPMS report, Navantia, modified by the NSIA

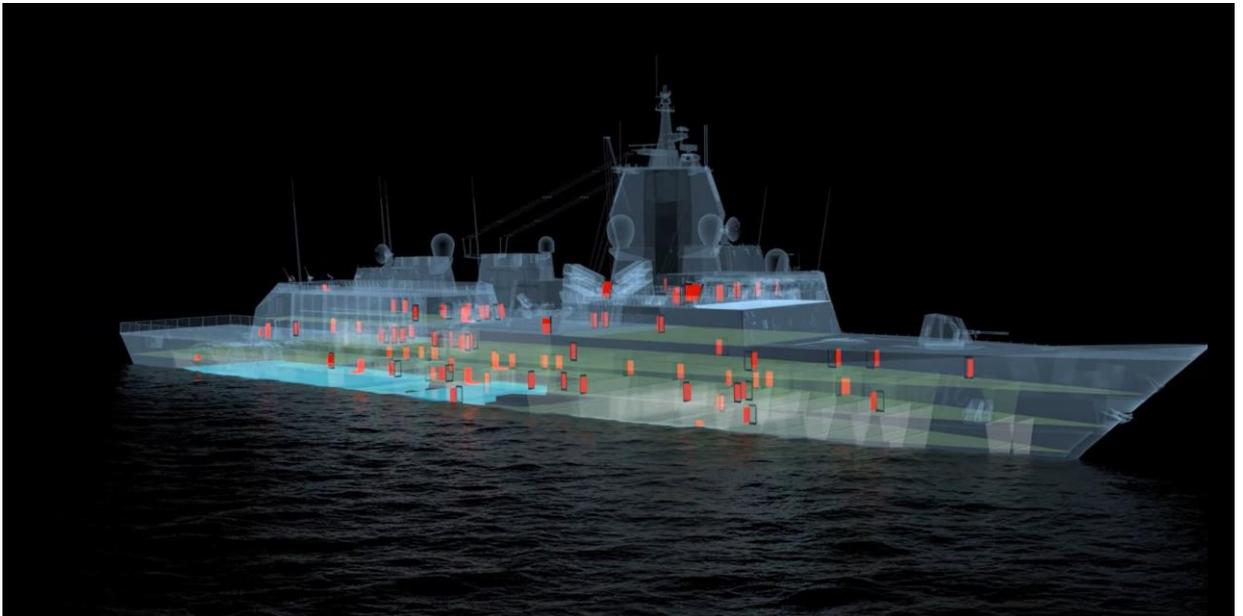
Doors, hatches and other openings in the frigate that were supposed to be closed to maintain stability and buoyancy were not closed at the time of evacuation. A shutdown of the frigate could have prevented her from sinking. In this context, stability calculations show that neither the grounding nor the flooding through the hollow propeller shafts was a decisive factor in causing the frigate to sink, as the failure to shut her down would have caused her to sink in any case.

Figure 67: Doors and hatches that were open when the vessel was evacuated. Illustration: CIAAS/NSIA

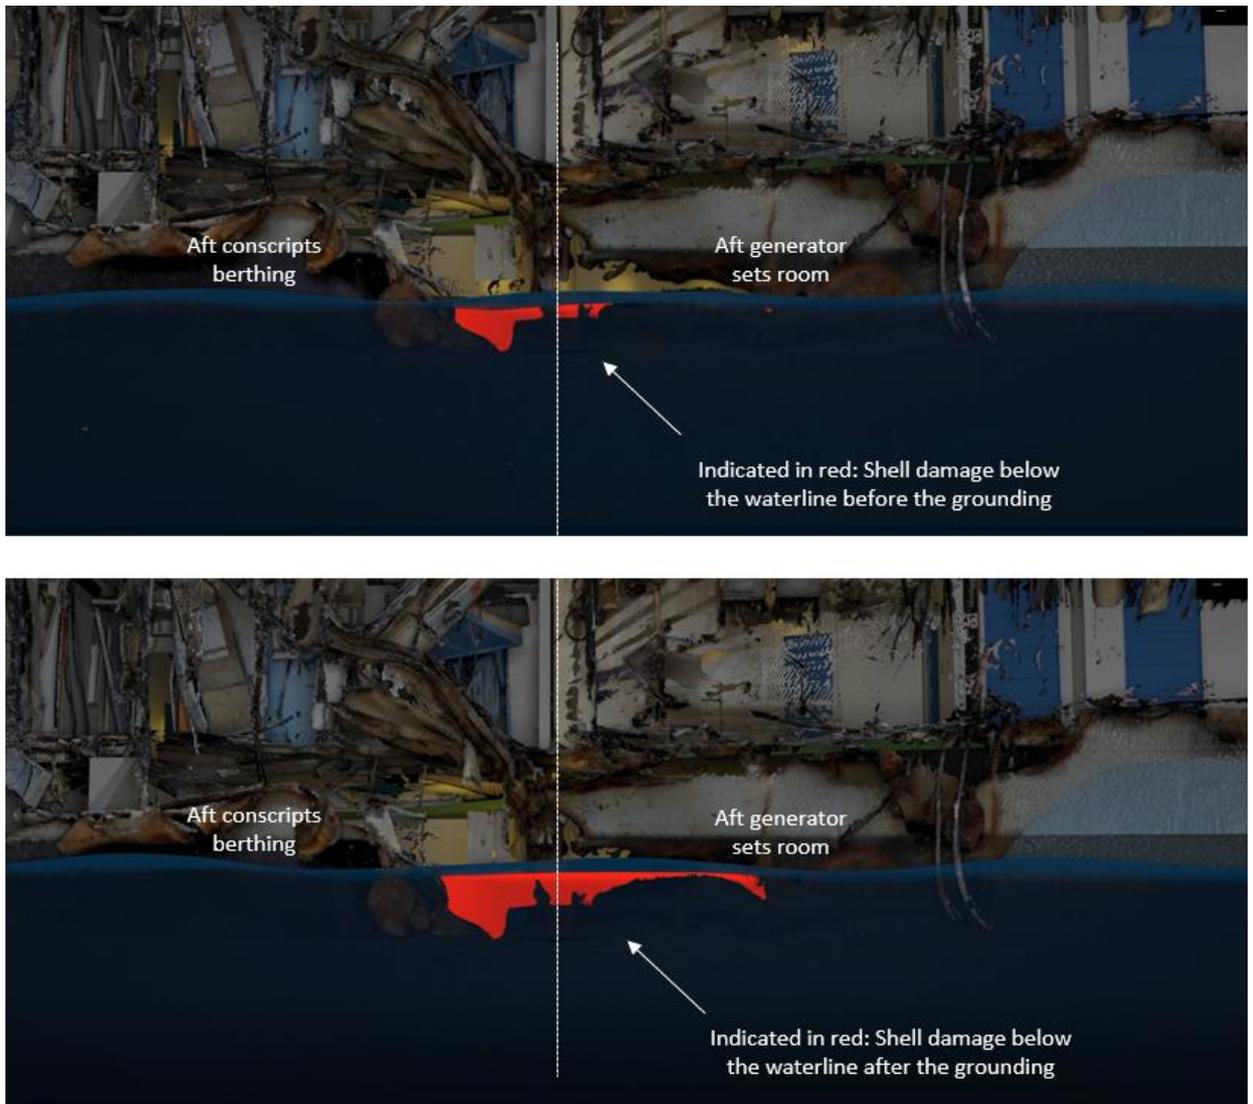
Figure 68: Shell damage relative to the waterline before and after grounding. Illustration: NCIS/CIAAS/NSIA

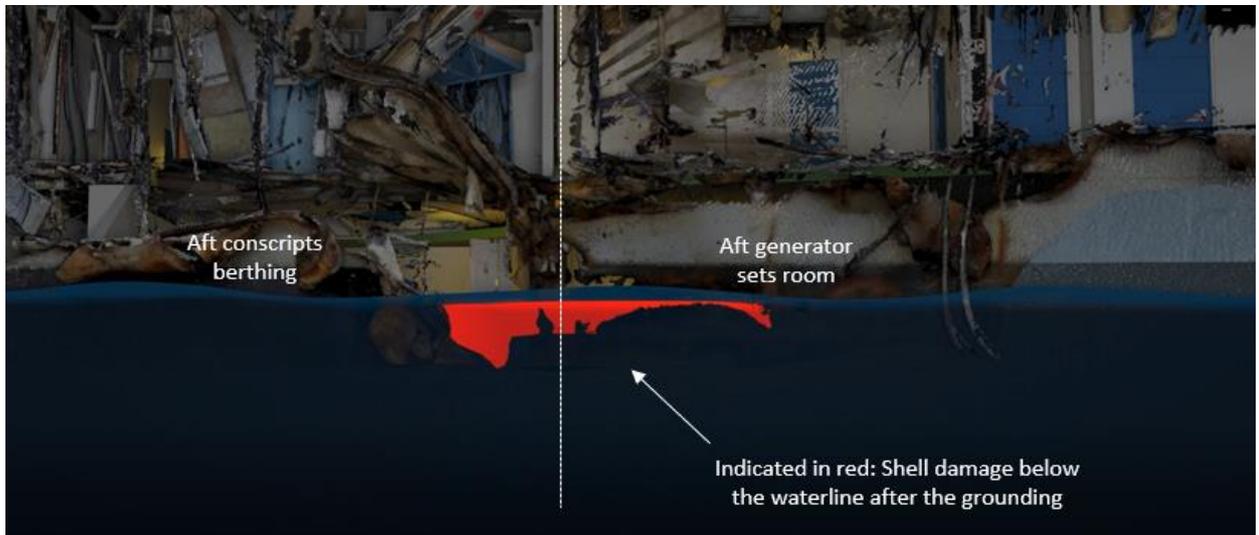
Figure 75: Shell damage below the waterline. Illustration: NCIS/CIAAS/NSIA

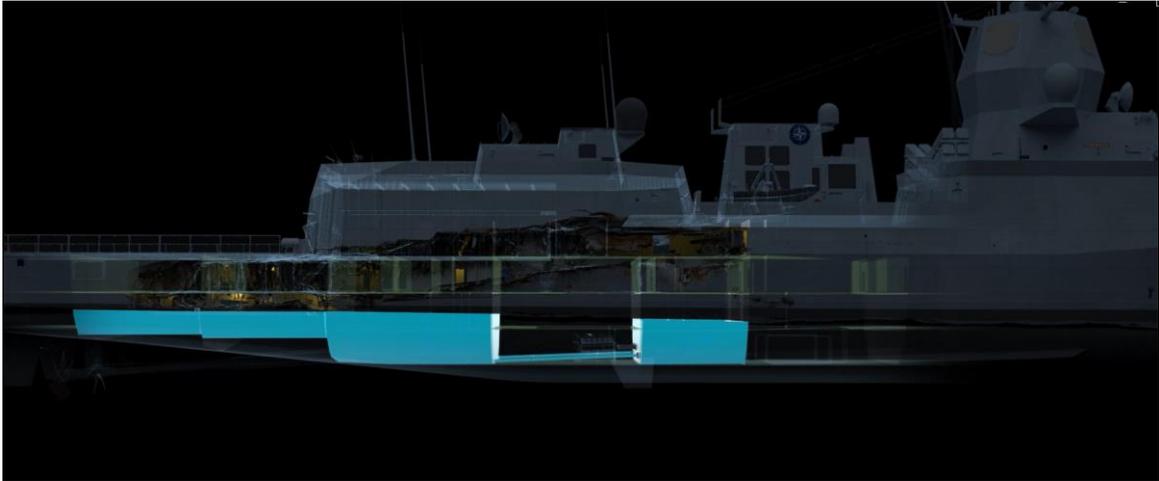
Figure 76: Water filling from aft generator sets room via hollow shafts to the reduction gear room. Illustration: CIAAS/NSIA

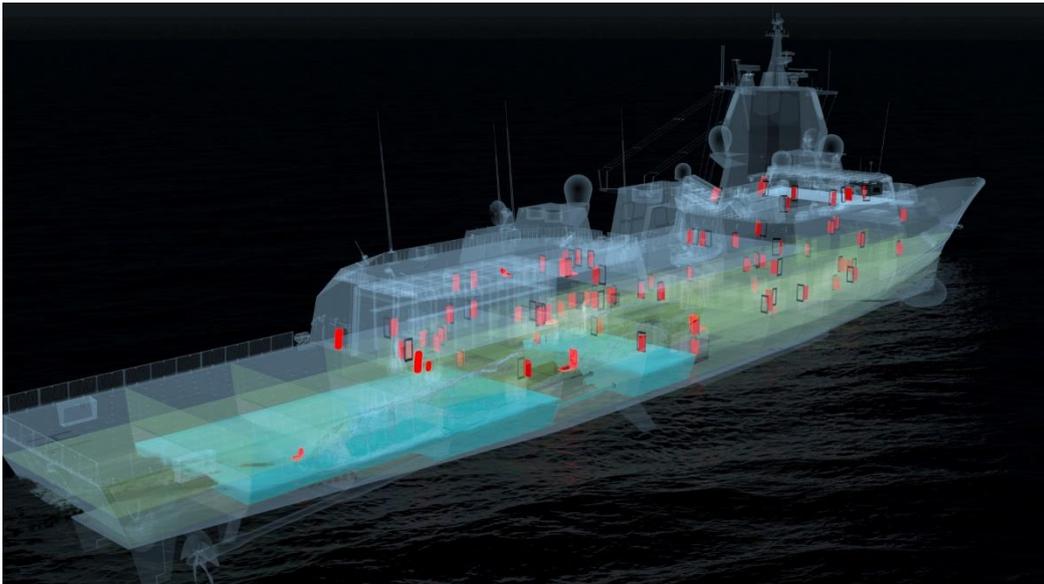
Figure 78: Breaches in watertight integrity on board. See Appendix C (R) for a complete overview of shutdown state. Illustration: CIAAS/NSIA

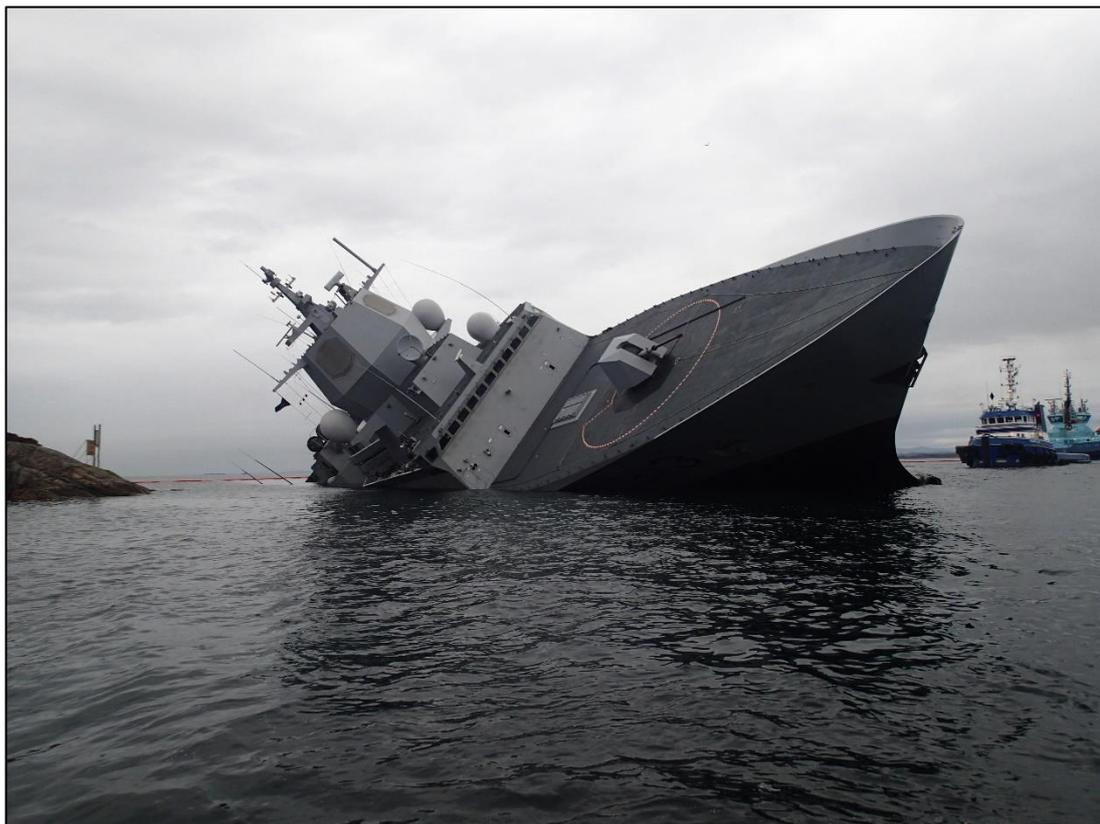
Figure 80: HNoMS 'Helge Ingstad' listed heavily to starboard at approximately 10:27, as a result of being pushed by the tugboats. Photo: CGV 'Bergen'

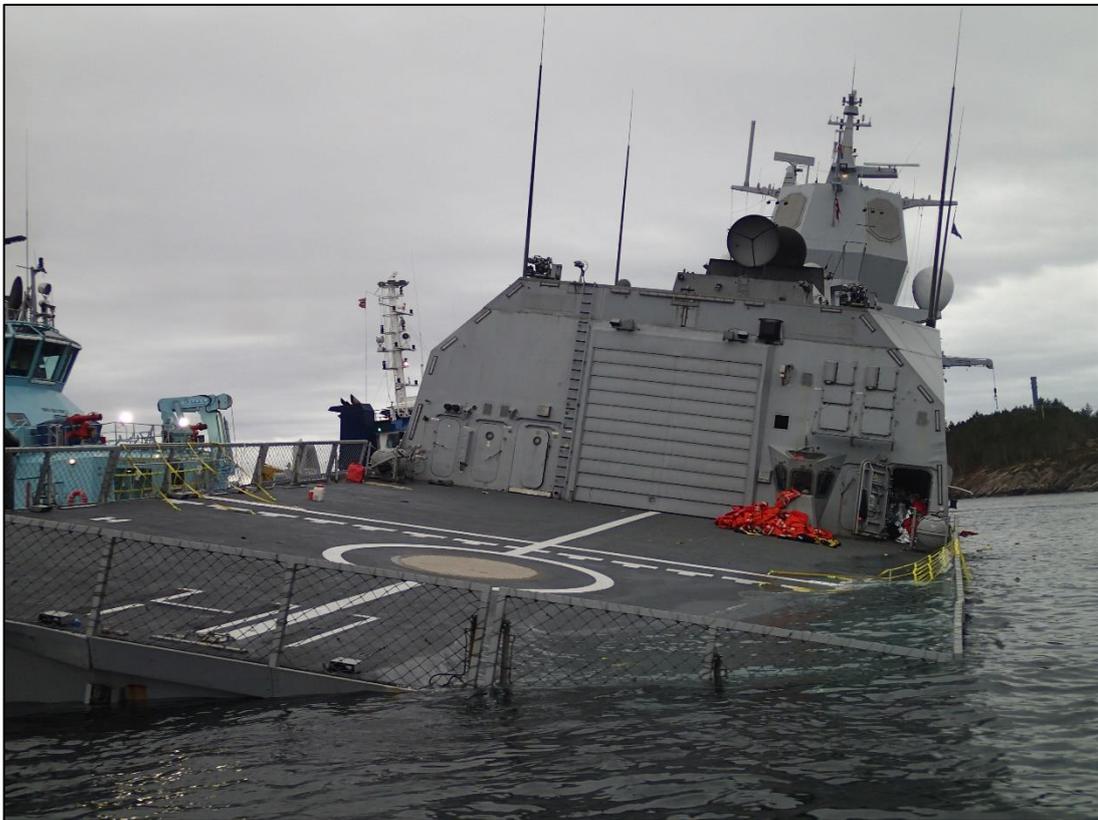
Figure 81: The helideck at HNoMS 'Helge Ingstad' under water on starboard side. Photo: CGV 'Bergen'
