# Fire on board *Iron Chieftain*

Port Kembla, New South Wales, on 18 June 2018

## **ATSB Transport Safety Report**

MO-2018-011

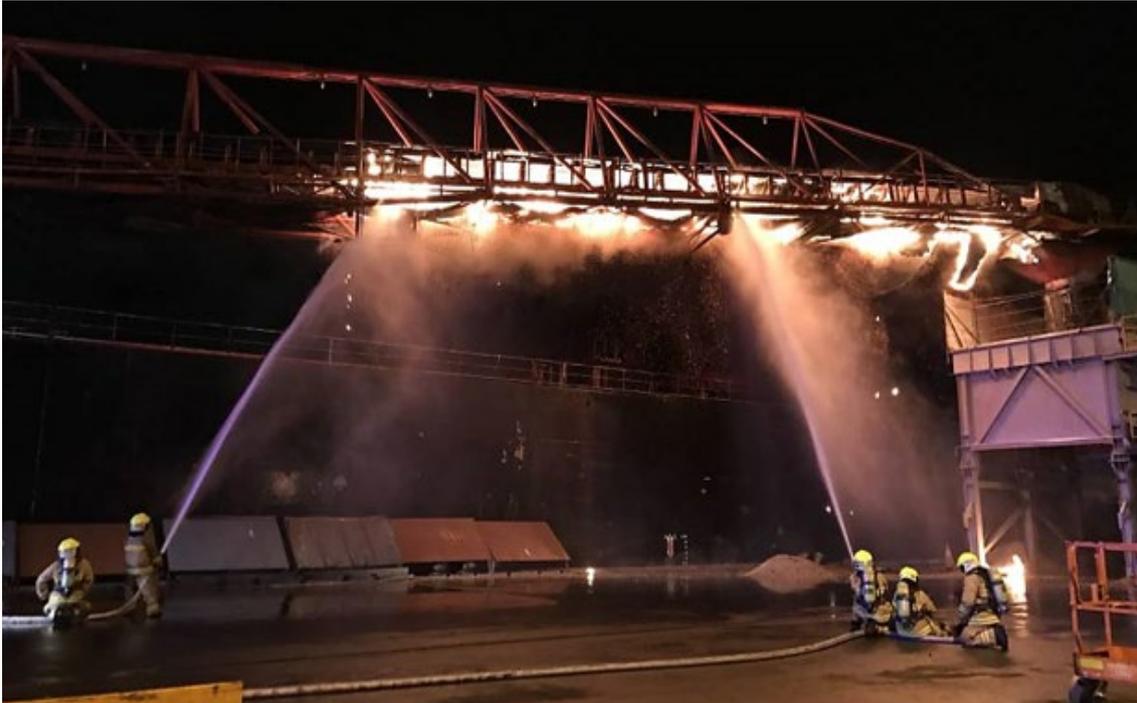
**Figure 5: Boom conveyor on fire**

By this time, the discharge boom conveyor belt on deck was alight, with the fire spreading rapidly (Figure 5). FRNSW firefighters on scene advised that it would be a protracted response and requested additional resources. The firefighters then focused on extinguishing the visible fire on the discharge boom. FRNSW noted that 22 people, including the ship's crew, and the master's family, had been evacuated from the ship. Over the following days, members of the ship's crew, often including the master and chief engineer, returned to the ship to assist firefighting efforts and assessment activities, including making entry to the C-Loop casing with FRNSW firefighters.

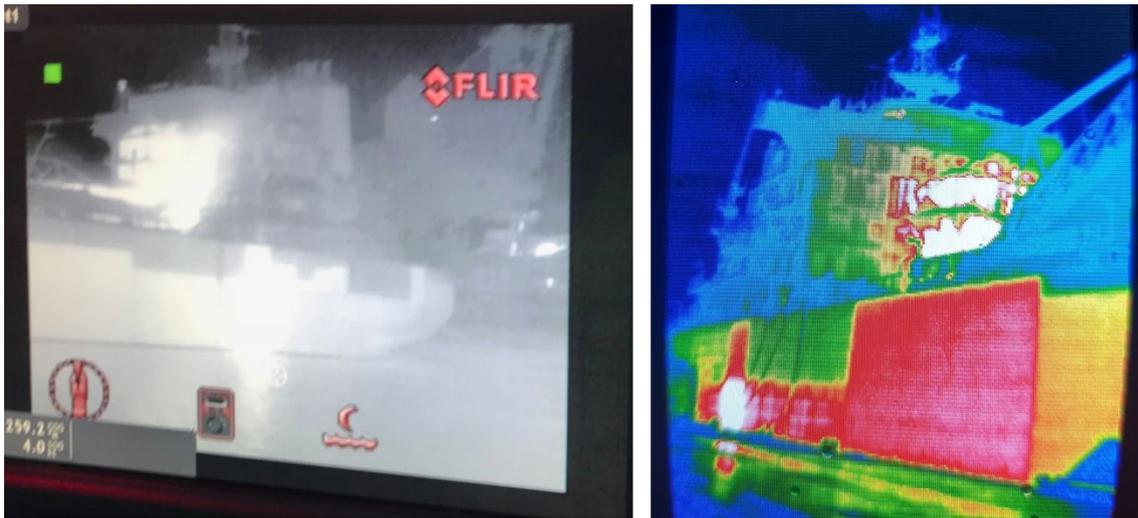
**Figure 8: Infrared imagery on 18 June**

At 2106 that night, firefighters attempted to gain access to the SUL system spaces through the C-Loop casing door but reported that access was too dangerous for firefighting operations. Infrared imagery indicated that the fire was active in the C-Loop space and aft sections of the tunnels (Figure 8).

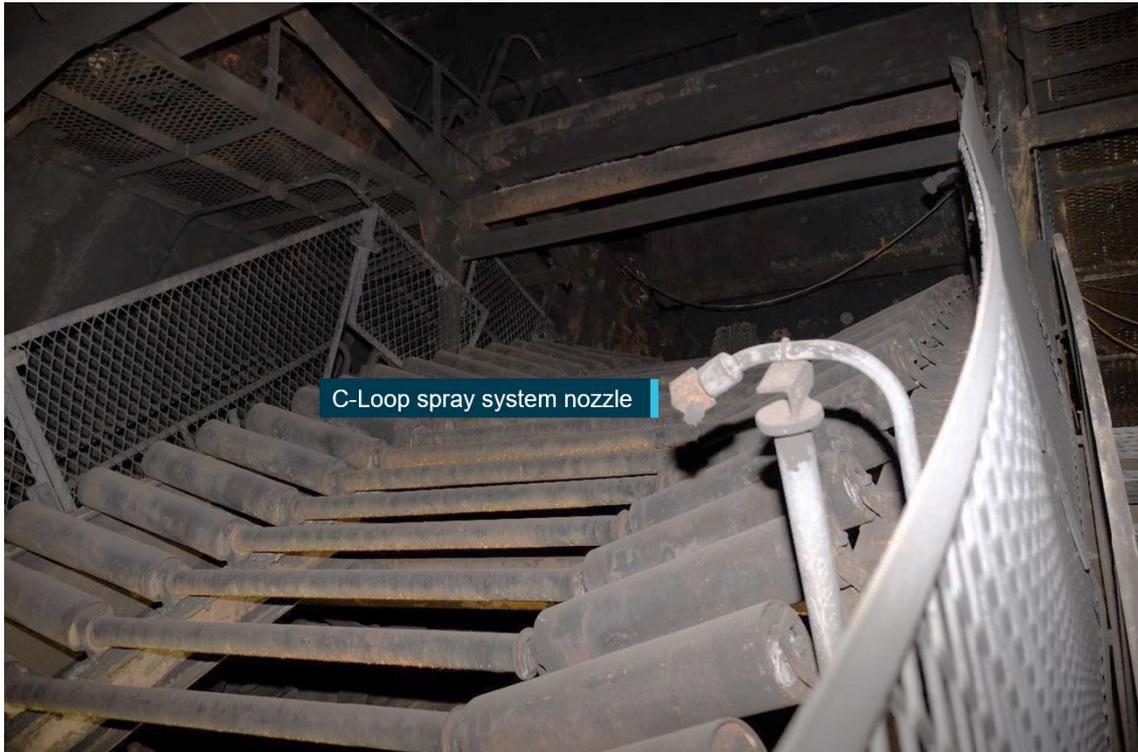
**Figure 14: C-Loop spray system nozzle**

At 2149, the initial estimate of foam required to fill the C-Loop space was revised to 2500 m<sup>3</sup>. By this time, the C-Loop spray system had been stopped because the spray nozzles were found to be completely ineffective.

*A C-Loop dust suppression spray system nozzle directed at where the conveyor belt would normally be. Note the exposed idler rollers of the C-Loop elevator belt system.*  
Source: MTD

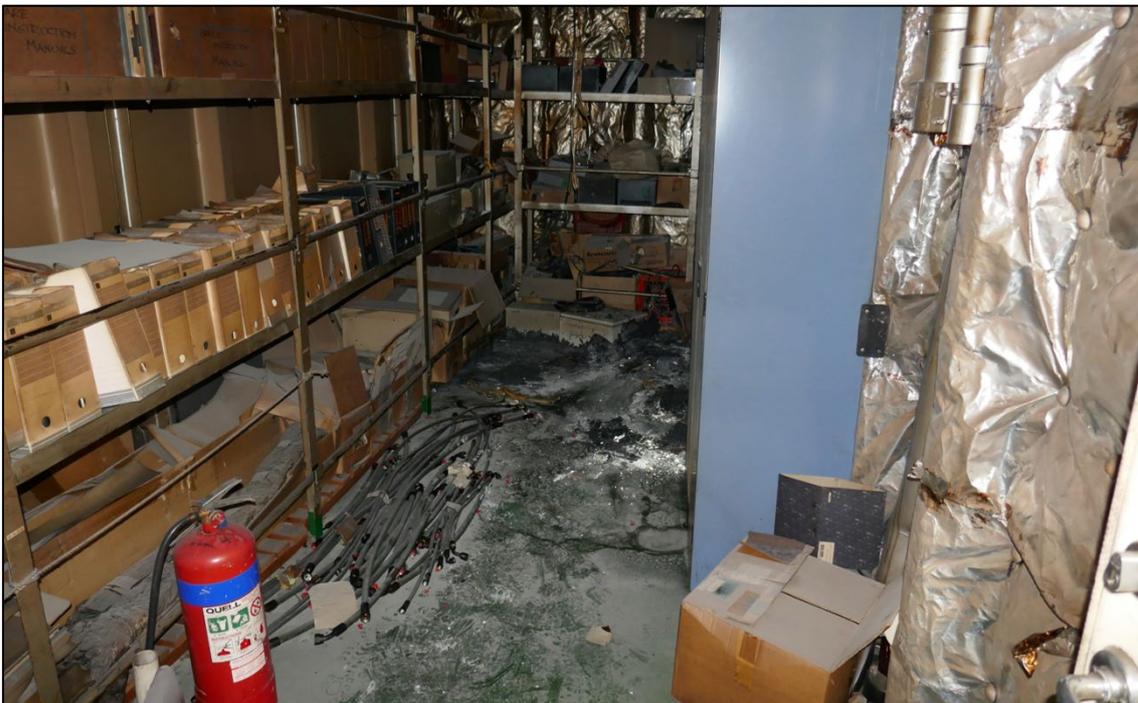
**Figure 15: Locker in the ship's accommodation adjacent to the C-Loop space**

The evidence suggested that the fire did not originate in any of the accommodation spaces or compartments surrounding the C-Loop casing.

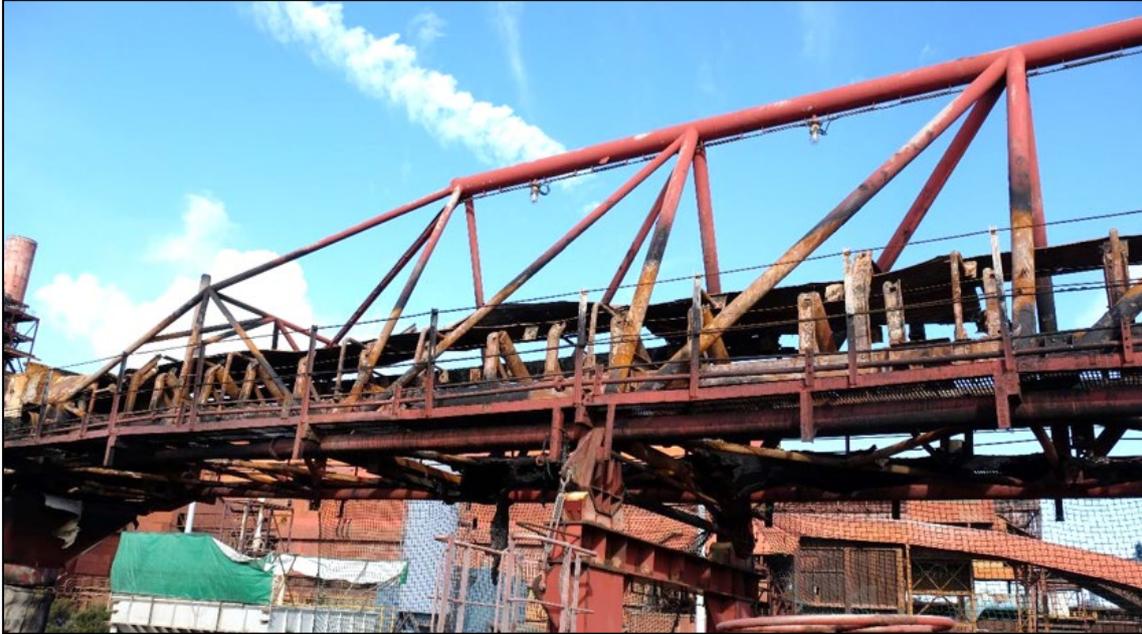
**Figure 16: Fire damage to the SUL system boom**

The SUL system components and spaces bore the brunt of the fire damage. The boom was significantly damaged with parts of the conveyor belt and associated structures destroyed. In the C-Loop space, the drive motors, pulleys, idlers and associated belt equipment showed varying degrees of fire, heat and smoke damage. The inner and outer conveyor belts that comprised the C-Loop elevator were destroyed. There was also significant structural damage to support members resulting in the collapse of several conveyor rollers. At the bottom of the C-Loop space, in addition to the fire damage, there was also HFO contamination and water. It was estimated that a total of about 507 m<sup>3</sup> (approximately 456 t) of HFO was lost from the port and starboard HFO tanks into the C-Loop space and tunnels. The aft ends of the port and starboard tunnels sustained fire damage to conveyor belts and associated structures and fittings.

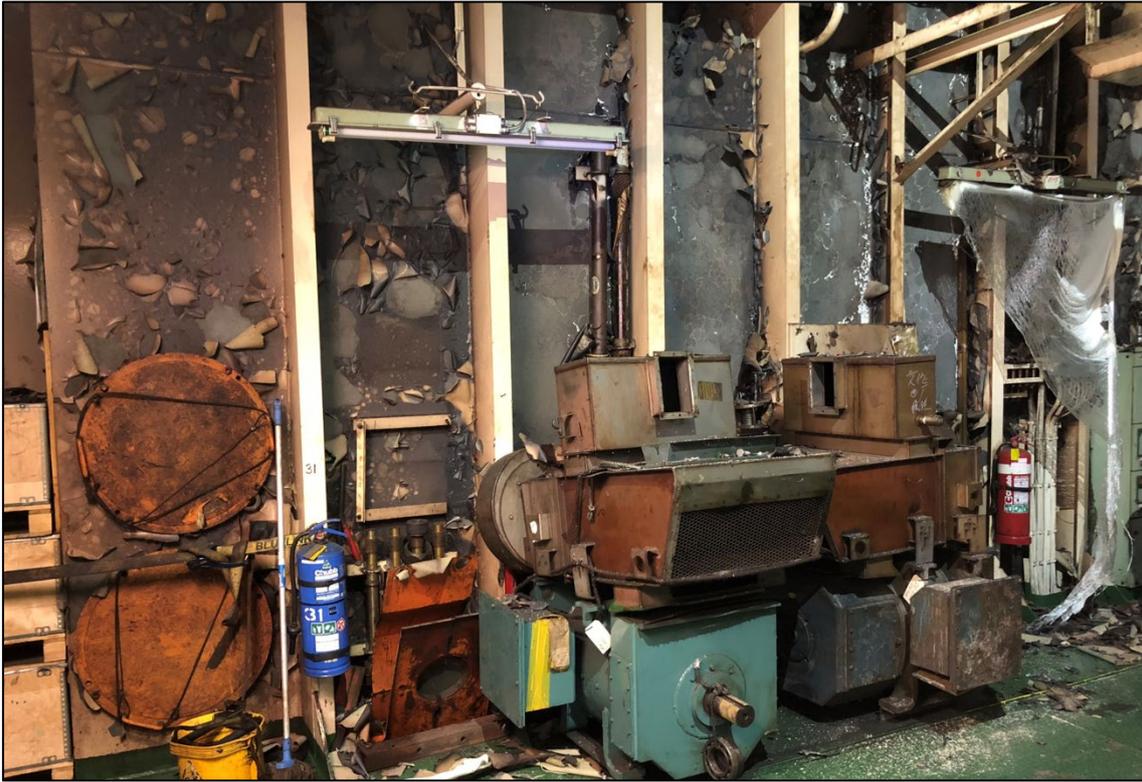
**Figure 17: Heat damage to engine room forward bulkhead**

The engine room showed widespread smoke damage and evidence of heat conduction and damage to the forward bulkhead that separated it from the C-Loop space. The forward bulkhead and the deck head above showed signs of burnt paint, deformation and heat damage to fittings and machinery in the vicinity (Figure 17). The evidence indicated that the heat had been directed from within the C-Loop space and both investigations assessed that the fire did not originate in the engine room.

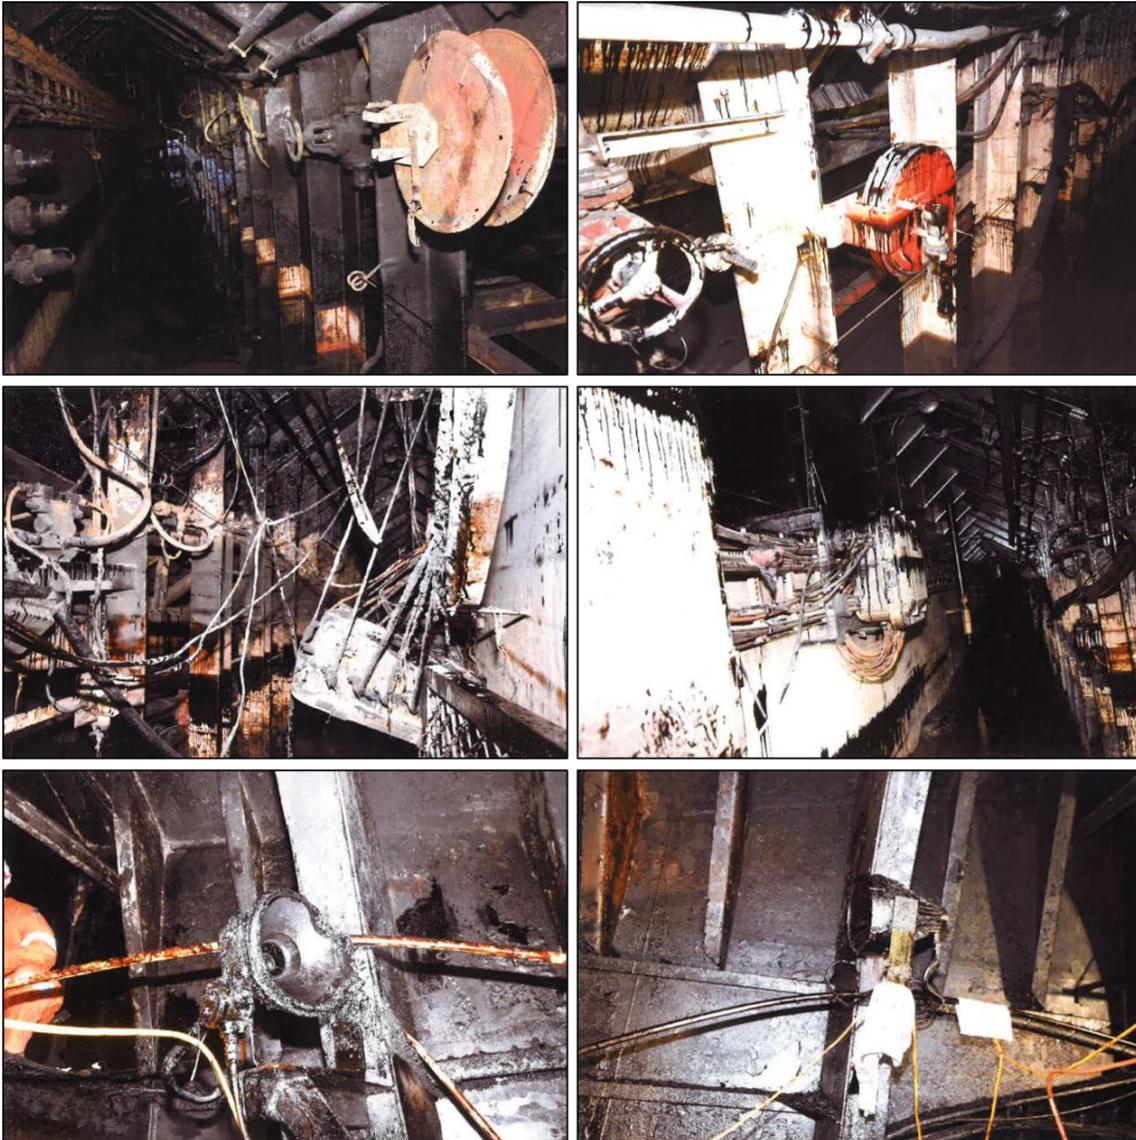
**Figure 18: Disparity in fire damage between port tunnel (left) and starboard tunnel (right)**

greater airflow in the port tunnel due to the open or partially open access hatches that were used to lower fire hoses down to the tunnels.

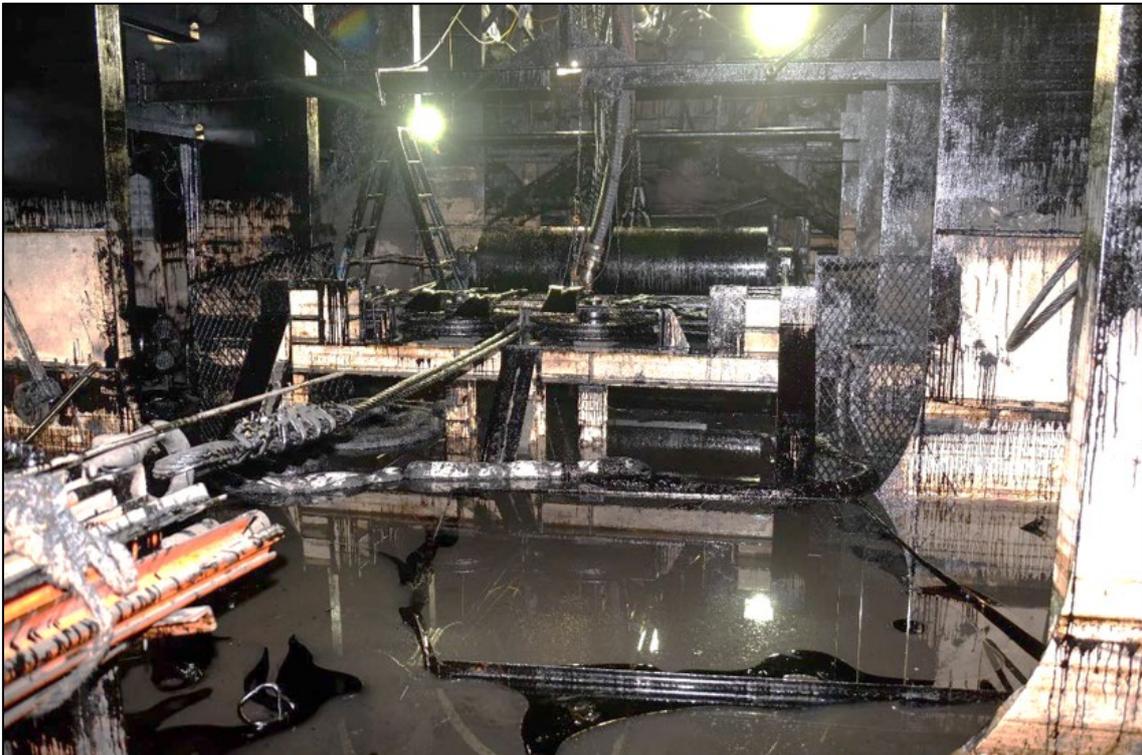
**Figure 19: Bottom of C-Loop space, looking aft**

Further down, near the bottom of the C-Loop space, in addition to the fire damage, there was also HFO and water contamination (Figure 19). There was also clear evidence of the further tensional structural damage to ship's support members. There were remnants of the burnt conveyor belts as well as displaced idlers that had fallen from above.

*Note HFO coating on bulkheads at height above the deck.  
Source: MTD*

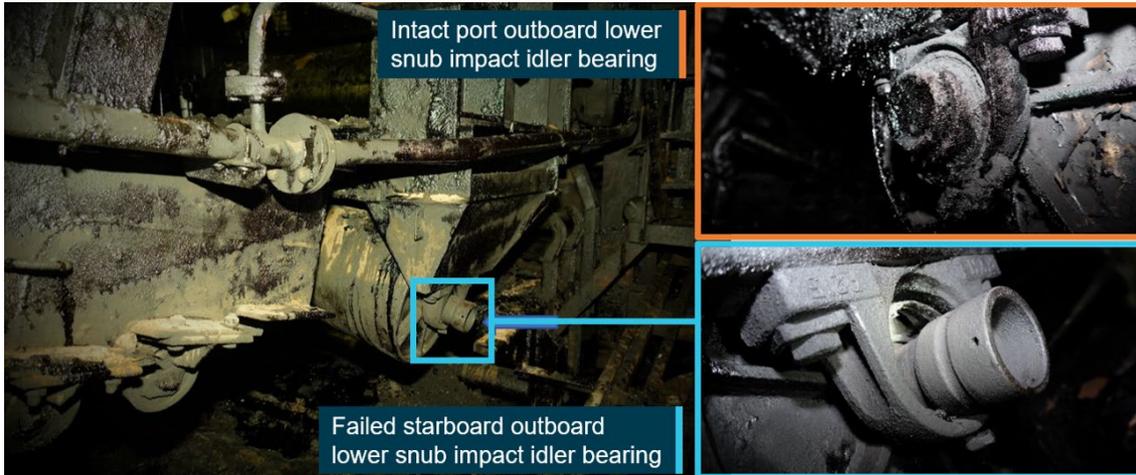
**Figure 21: Failed starboard outboard bearing of lower snub impact idler and intact bearing on port side (for comparison)**

The ATSB investigation concluded that the fire originated in *Iron Chieftain*'s C-Loop space and was likely the result of a failed bearing in the ship's conveyor system which created the heat necessary to ignite the rubber conveyor belt. The ATSB also determined that the ship did not have an emergency contingency plan for responding to fire in the ship's SUL spaces and that there were technical failures of the ship's alarm systems during the emergency response to the fire. Furthermore, some aspects of the shipboard response likely aided the fire's development while others increased risk by removing shipboard capability.

The forward component comprised an impact idler covered with rubber impact discs which remained intact, although fire damaged. The aft component consisted of five idlers and served the inner belt of the C-Loop. The bearings of the port side outboard idler showed no signs of mechanical failure, nor did the central idlers. However, the bearing of the starboard side outboard idler and most of its metal components were destroyed (Figure 21). The degree of damage was considered highly unlikely to have been the result of fire damage and was not observed at any other bearings.

Visual examination of the damaged bearing indicated that the bearing shaft was displaced laterally from the bearing housing by about 35 mm. There was also visible damage to the idler shaft as well as evidence of erosion of the inner surface of the idler-shaft interface (Figure 22).
