# REPUBLIC OF THE MARSHALL ISLANDS

### SFERA CASUALTY INVESTIGATION REPORT

#### Occupational Fatality Due to Fall from Height

Philippine Sea | 10 June 2020

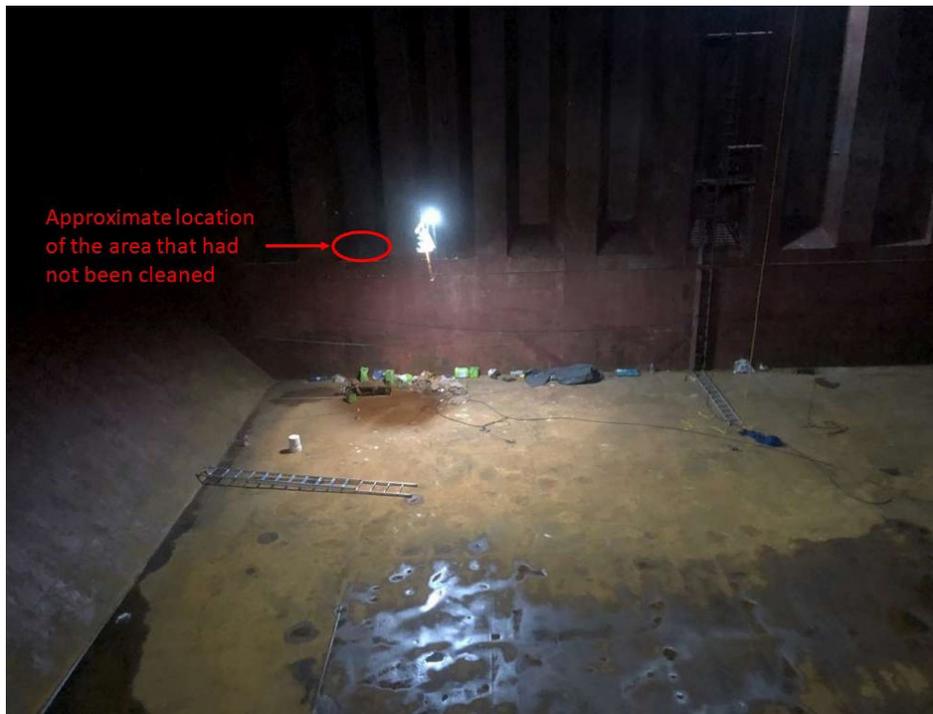
23. Sometime after 1400, the Bosun and ASD1 noticed a portion of the forward bulkhead just above the lower stool that had not been cleaned the previous day (9 June 2020). This area was about 3.5 m above the tank top (*see Figure 1*).

Figure 1: Cargo Hold No. 2 showing the approximate location of the area that had not been cleaned. The portable ladders had been left in the hold when the crew finished work on 9 June 2020.

24. The Bosun stated they were unable to clean this area from the tank top and that the ASD1 decided to use a portable ladder that was left in the hold when the crew finished working on 9 June 2020. The Bosun also stated he told the ASD1 not to use the ladder, but that he went ahead and set it up anyway.

25. According to the Bosun's statement, the ASD1 picked up the wand for the high-pressure washer, climbed up the ladder, and washed the dirty area. It was reported that the ASD1 used both hands to hold the wand while cleaning the dirty area. The Bosun also stated that the ladder had not been secured, but that he had held it steady for the ASD1.

26. The Bosun stated that the ASD1 slipped and fell to the tank top from a height of 3-3.5 m as he was climbing down the ladder. He also stated that the ASD1 was carrying the wand in one hand and using his other hand to hold the ladder when climbing up and down the ladder.

Based on the Bosun's statement, after washing a portion of the forward bulkhead that had not previously been cleaned inside Cargo Hold No. 2, the ASD1 slipped and fell about 3-3.5 m to the tank top while climbing down a portable ladder.

The ladder rungs may have become wet from using the high-pressure washer to clean the dirty area. This would have increased the potential for someone climbing on it to slip. As previously noted, this is also a hazard

The Bosun stated that the ASD1 was carrying the high-pressure washer wand in one hand and was holding onto the ladder with the other, both when he climbed up and when climbing down. The Company's procedures require keeping both hands on the ladder while climbing up and down to maintain three points of contact. Not maintaining three points of contact would have increased the potential of falling due to slipping or misplacing a foot.
