SAFETY INVESTIGATION REPORT

REPORT NO.: 12/2021

MT MED TUNCER **Electrical fire inside the lifeboat** **in the port of Antwerp, Belgium** **14 May 2020**

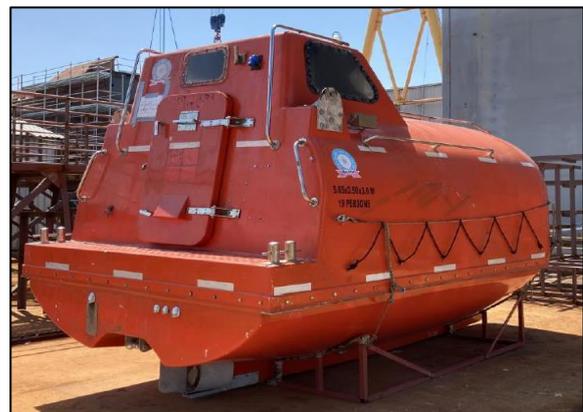
Med Tuncer was fitted with one 5.05 m totally enclosed freefall lifeboat, stowed aft on a cradle / ramp (Figure 1). The lifeboat, type BD-FFT505, was manufactured of plastic reinforced fiberglass and fire-retardant polyester by Balden Denizcilik, Turkey.

Figure 1: *Med Tuncer* lifeboat after the accident

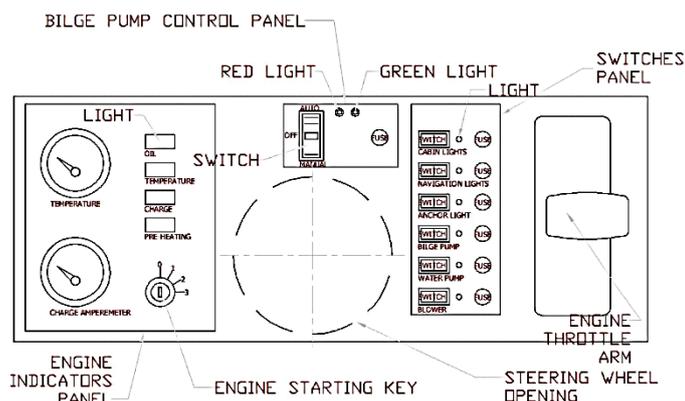
Figure 2: Lifeboat control panel

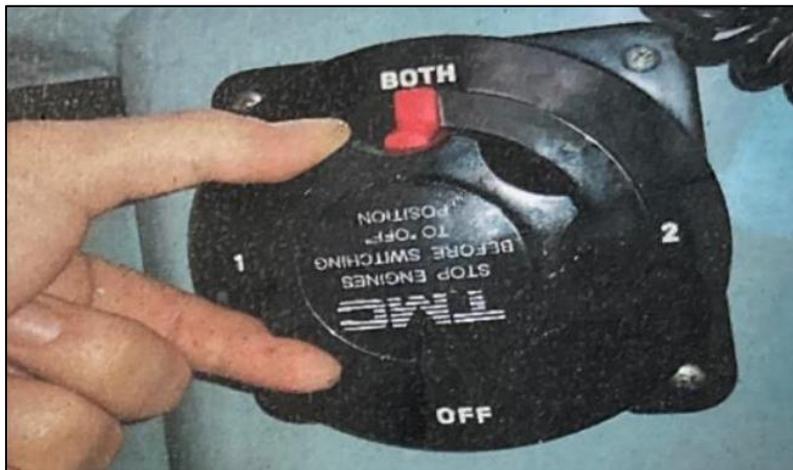
Figure 3: Battery changeover switch

The high (short-circuit) currents, which had been generated must have also welded the internal contactors of the changeover switch, to an extent that the electro-technical officer would have been unable to turn to the 'off' position.

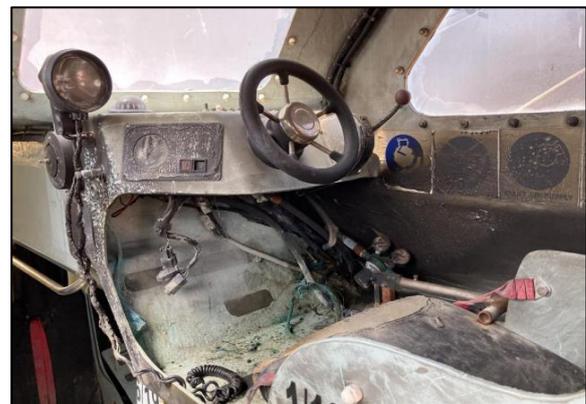
The intensity of the heat, fire and smoke caused damage to the interior of the lifeboat. The control panel, power cables, hydraulic pump at bilge level, battery casing and pipes were damaged to different extents. The helmsman's seat was gutted and several of the crew seat cushions had melted or smoke affected (Figures 5, 6 and 7).

Figure 5: Control panel damage

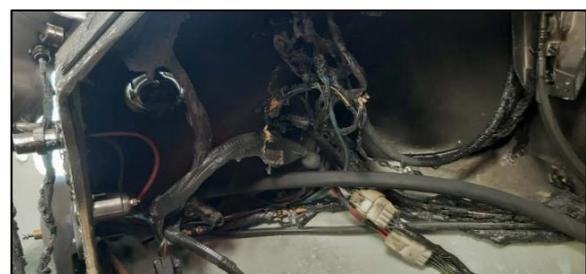
Figure 6: Damaged power cables under control panel

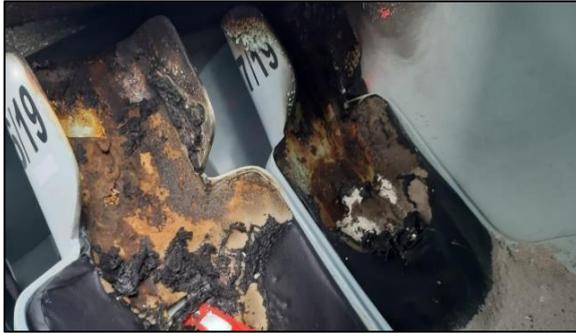
Figure 7: Fire / smoke damage to the seat cushions

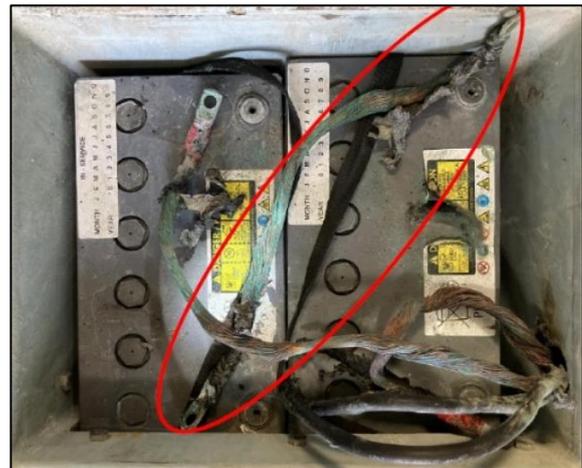
The safety investigation could not establish whether main power supply to the lifeboat charging system (which had remained plugged during the battery tests) had contributed to the fire. However, post-accident inspections of the scorched electrical cables suggest an inadvertent connection of battery terminals in series⁴, resulting in sudden spike in circuit current as soon as the battery changeover switch was turned through position marked both to access position 2 (Figure 8).

Figure 8: Cable in the suspecting short-circuit loop position

At that point, a short-circuit loop was created within the wiring system, generating extremely high short circuit currents, overheating the electrical cable, insulation and associated components beyond its designed rating⁵. Figures 9a and 9b represent two schematic circuit drawings, showing the system cables as designed and as reconnected, respectively.

- Testing of the lifeboat engine will be carried out by two crew members;
- Battery charging cables will be disconnected when not in use and all cable connections checked during every lifeboat inspection;
- An IR thermometer will be used during the testing to monitor the temperature of the cable;
- Testing will be suspended immediately should an increase in temperature be detected;
- An additional portable CO₂ fire extinguisher will be kept readily available during the testing of the lifeboat engine;

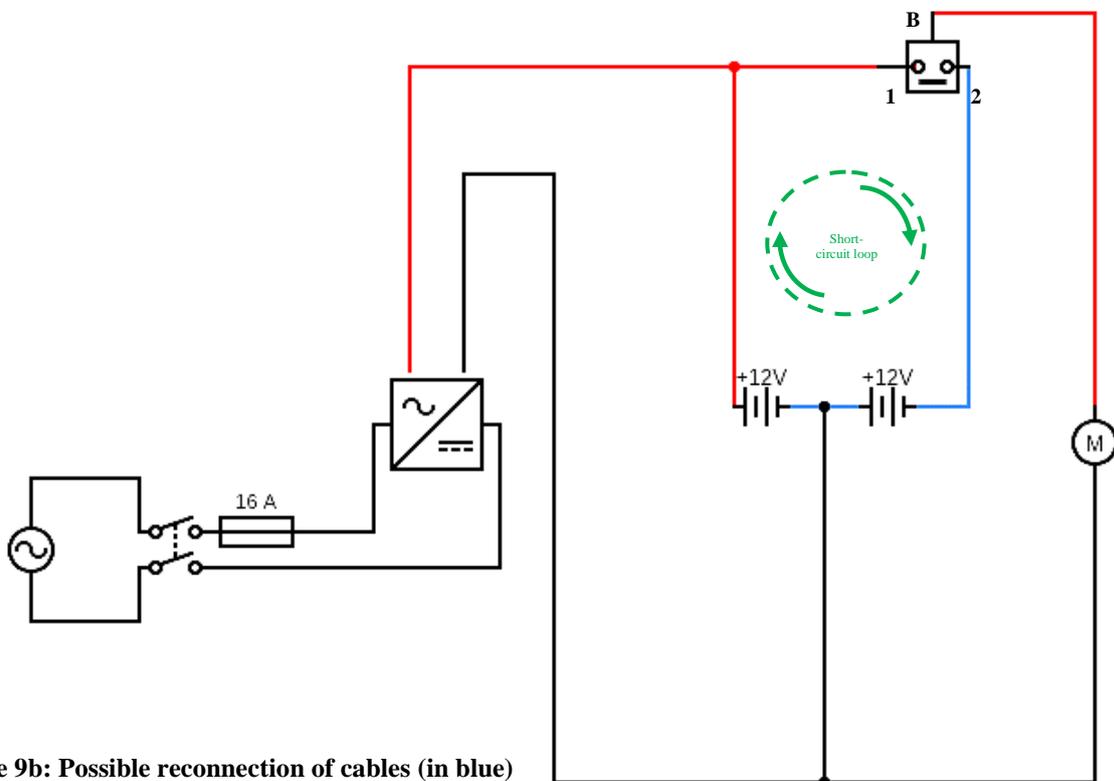
Figure 9b: Possible reconnection of cables (in blue)

1. In all probability, the cause of the fire was a very high short circuit current within the batteries;
2. Post-accident inspections revealed that the cables may have not been reconnected as designed;
3. The battery changeover switch in the 'both' position created a short circuit loop, overheated the wires and welded the switch in mid-position;
4. The actual cables had not been marked prior to disconnection and therefore may have been confused during reconnection.

- A wiring diagram will be posted inside the lifeboat's battery chest.
