SAFETY INVESTIGATION REPORT

REPORT NO.: 10/2021

MT MOUNT EVEREST

Serious injury to a crew member, during mooring operations in the port of Marsaxlokk, Malta 08 May 2020

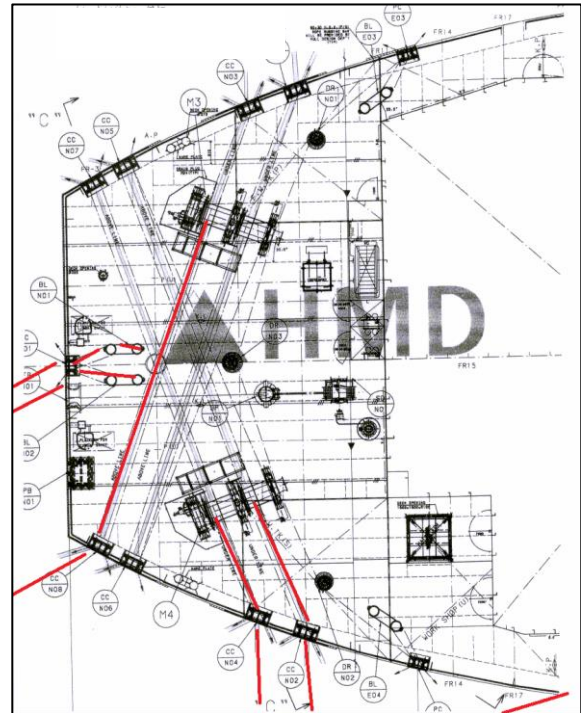
Figure 6: Aft mooring configuration intended by the master

The master stated that he had advised the third officer to send two loose mooring ropes through the centre fairlead and one mooring rope from the port side mooring winch, through the starboard quarter fairlead, as stern lines (Figure 6).

It was not excluded that the crew members would have found it difficult to execute the intended mooring configuration.

Since the vessel was fitted with a single pedestal fairlead along its centre line on the poop deck, the crew members would not have been able to heave up and tighten the two loose mooring ropes, simultaneously.

An assessment of the vessel's mooring equipment layout and plan further suggested that, if the aft mooring team were to heave up any one of the two loose mooring ropes, along with the rope passed from the mooring winch, they would have faced difficulty in equalizing the tension in these two ropes. The two ropes (one loose rope and one from the winch) would cross each other at near equal heights which, besides increasing the risk of friction between them, would have made it difficult to tighten them equally.

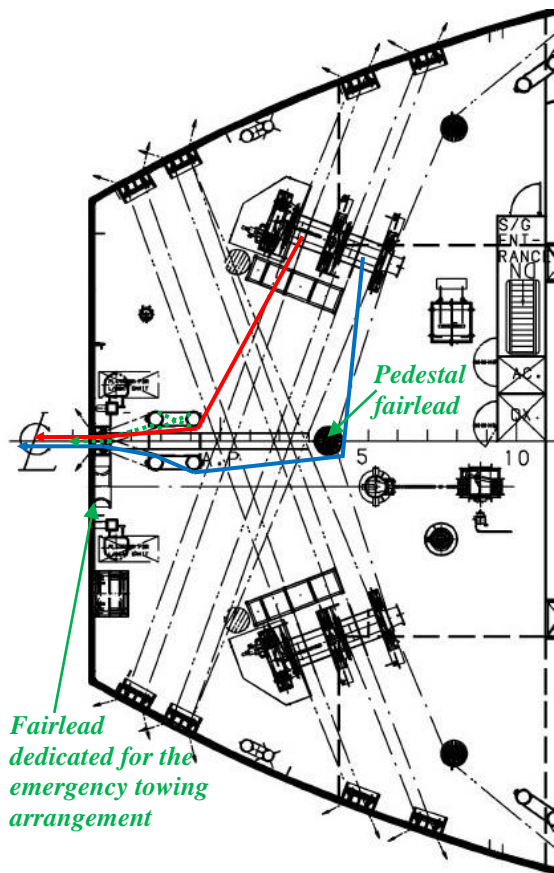
Figure 8: The stern lines (red, blue, and dashed green), as passed to the mooring buoys prior to the accident

Two of the three stern lines were passed from the port mooring winch (Figure 8), while the third stern line was a loose mooring rope, which was lightly wound around a mooring bitt (dashed green line in Figure 8), after it was secured on the mooring buoy. All three lines were passed through the centre fairlead on the vessel's poop deck (Figure 9). The master was not aware of the stern lines' configuration since it was neither visible from the bridge, nor was it reported to him by the third officer.

Whilst the crew members at the aft mooring station were heaving up on the two stern lines, which were on the twin split-drums, they noticed that these two lines bore unequal tension, with the aftermost line (red line in Figure 8) being tighter than the forward line (blue line in Figure 8).

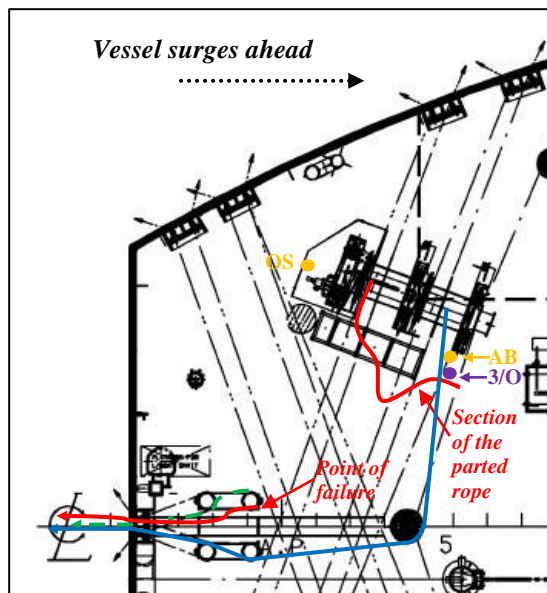
Figure 10: Dynamics of the accident

At around 1355, the section of the parted rope, which was spooled on the split-drum, snapped back towards the third officer (Figure 10), striking him first on his left forearm, followed by the left side of his head.

The third officer suffered serious injuries after one of the stern mooring lines parted and struck him during its snap-back.

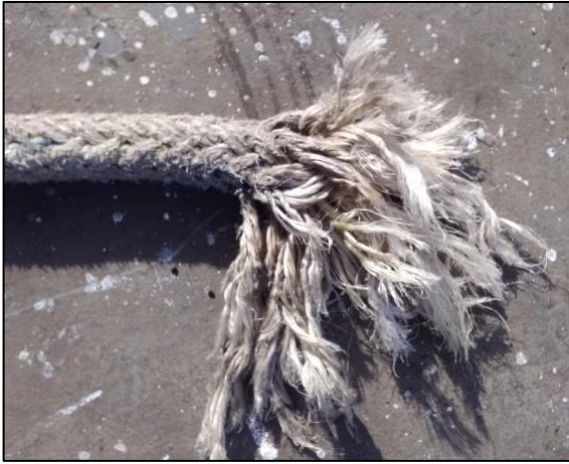
Figure 12: A section of the failed mooring rope

The mooring rope which had parted (Figure 12) had been received on board *Mount Everest* on 05 March 2015. The safety investigation was informed that following the receipt, this rope was stored in the vessel's forecabin storage space (Figure 13) and was first used in October 2019. It was kept on the same split drum of the aft mooring winch, until it parted.

Following the accident, a 15-metre-long section was sent to the rope's manufacturer for a breaking strength test. The test results revealed that this section of the rope had parted after approximately 188 seconds, when the test load had reached about 302 kN (30.8 mt).

Since no further tests or analysis (say, a microscopic analysis) were conducted on the failed mooring rope, the safety investigation was unable to ascertain the exact cause(s) of its failure. Nonetheless, the MSIU hypothesized that the strength of the mooring rope may have been reduced due to eventual deterioration of its external and/or internal fibres.

In view of the above, the MSIU is of the opinion that the deterioration of the mooring rope's external fibres may have not been accurately assessed by the crew members on board *Mount Everest*. Hence, it was not excluded that the extent of deterioration of the mooring rope's external fibres (probably miscalculated by the crew members) due to abrasion, contamination, or a combination of both, may have contributed to this accident.

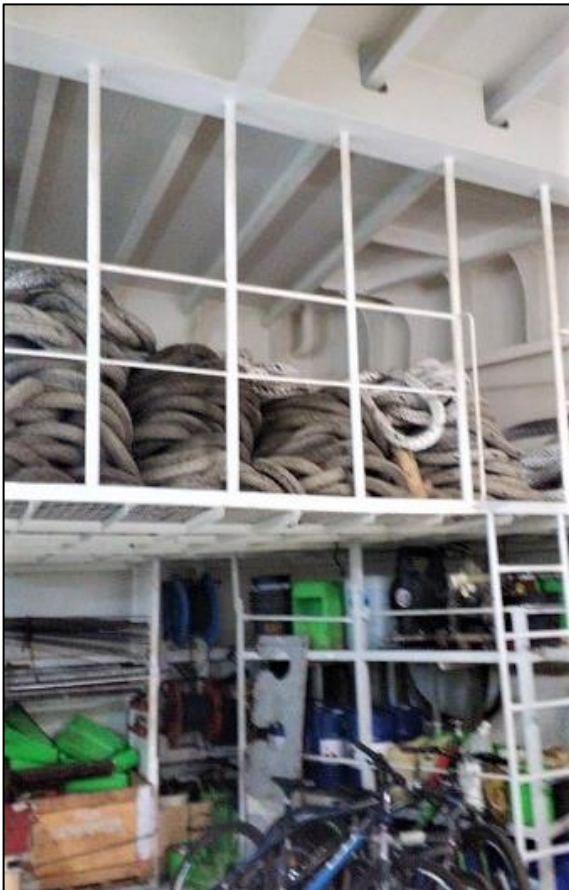
Figure 13: Storage space of the mooring ropes

Contamination by chemicals, whether combined with abrasion or not, may also deteriorate the condition of the rope's external fibres, resulting in reduction of the rope's strength. While the storage space on board
