SAFETY INVESTIGATION REPORT

REPORT NO.: 11/2021

MV SEAFARER **Fatal injury to a crew member** **in position 37° 29.60' N 012° 21.60' E**

12 May 2020

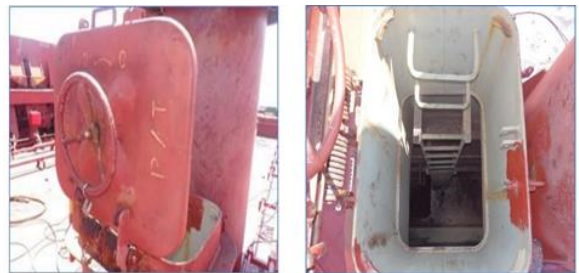
There were also three access trunk hatchways located on the main deck, between cargo hold nos. 1 and 2 (Figure 2), 5 and 6, and 8 and 9. Vertical ladders inside the access trunks led to the pipe tunnel. The vertical ladder arrangement was divided into five sections. Each section had a small platform in between with fixed lights at platform A and platform D (Figures 3 and 4).

Figure 2: Access trunk hatchway and vertical ladder leading to pipe tunnel

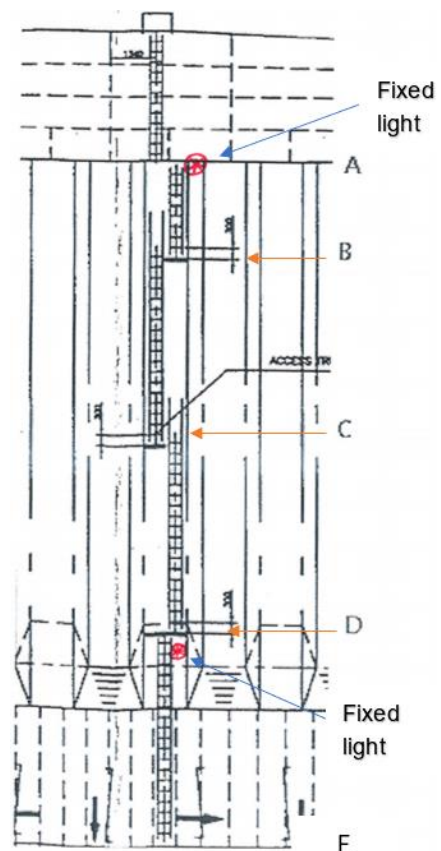
Figure 3: The vertical ladder and fixed lighting system, and the position of platforms A, B, C, D and E in the access trunk

Indications of scratch marks on the bulkhead suggested a fall between platforms B and C. The crew member was found on platform E, about 16.0 m from platform B. Given that effective natural light into the access trunk hatchway only reached platform A, the likelihood of missing a step, grip or balance whilst going down the ladder in darkness between platforms B and C, was not ruled out by the safety investigation.

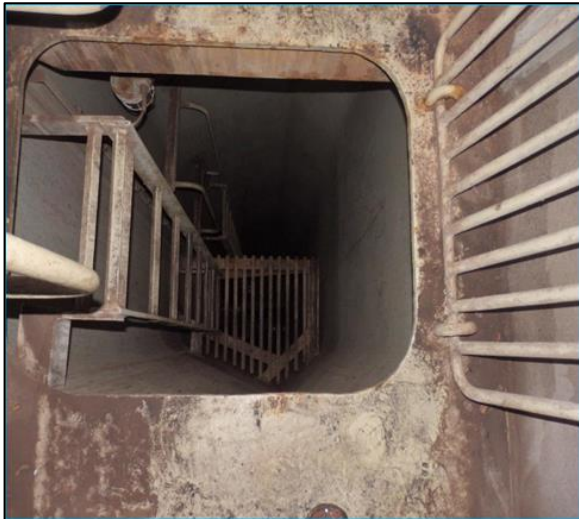
Figure 4: Photo showing platform A and vertical ladder leading to platform B

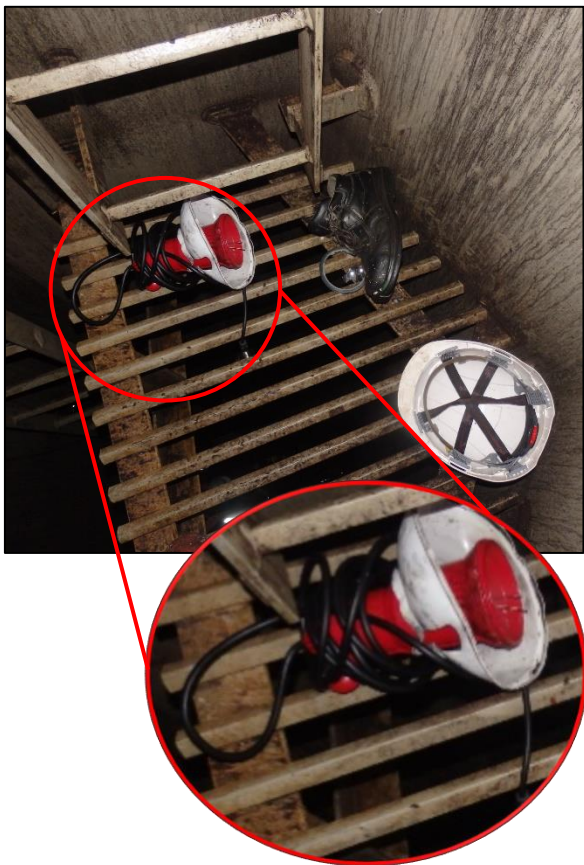
Climbing down the vertical ladder, the master observed a safety helmet, a broken portable light and one shoe on platform C (Figure 5).

Figure 5: Portable light, safety shoe and safety helmet as found on platform C

He also noticed fragments of the portable light on platform D. Further down on platform E, he saw the ETO rating, lying motionless. The chief engineer and the repair team, who were working close-by in the pipe tunnel, were called-in by the master. No vital signs were detected.
