Interim report on the investigation of the collision between the high speed passenger craft *Seadogz* and a navigation buoy resulting in one fatality in Southampton Water on 22 August 2020

The aim of this interim report is to inform operators of small high speed passenger craft and UK port authorities of the circumstances of the accident and MAIB’s initial findings so that appropriate actions can be taken ahead of the boating season. A full report will be published when the investigation is complete.

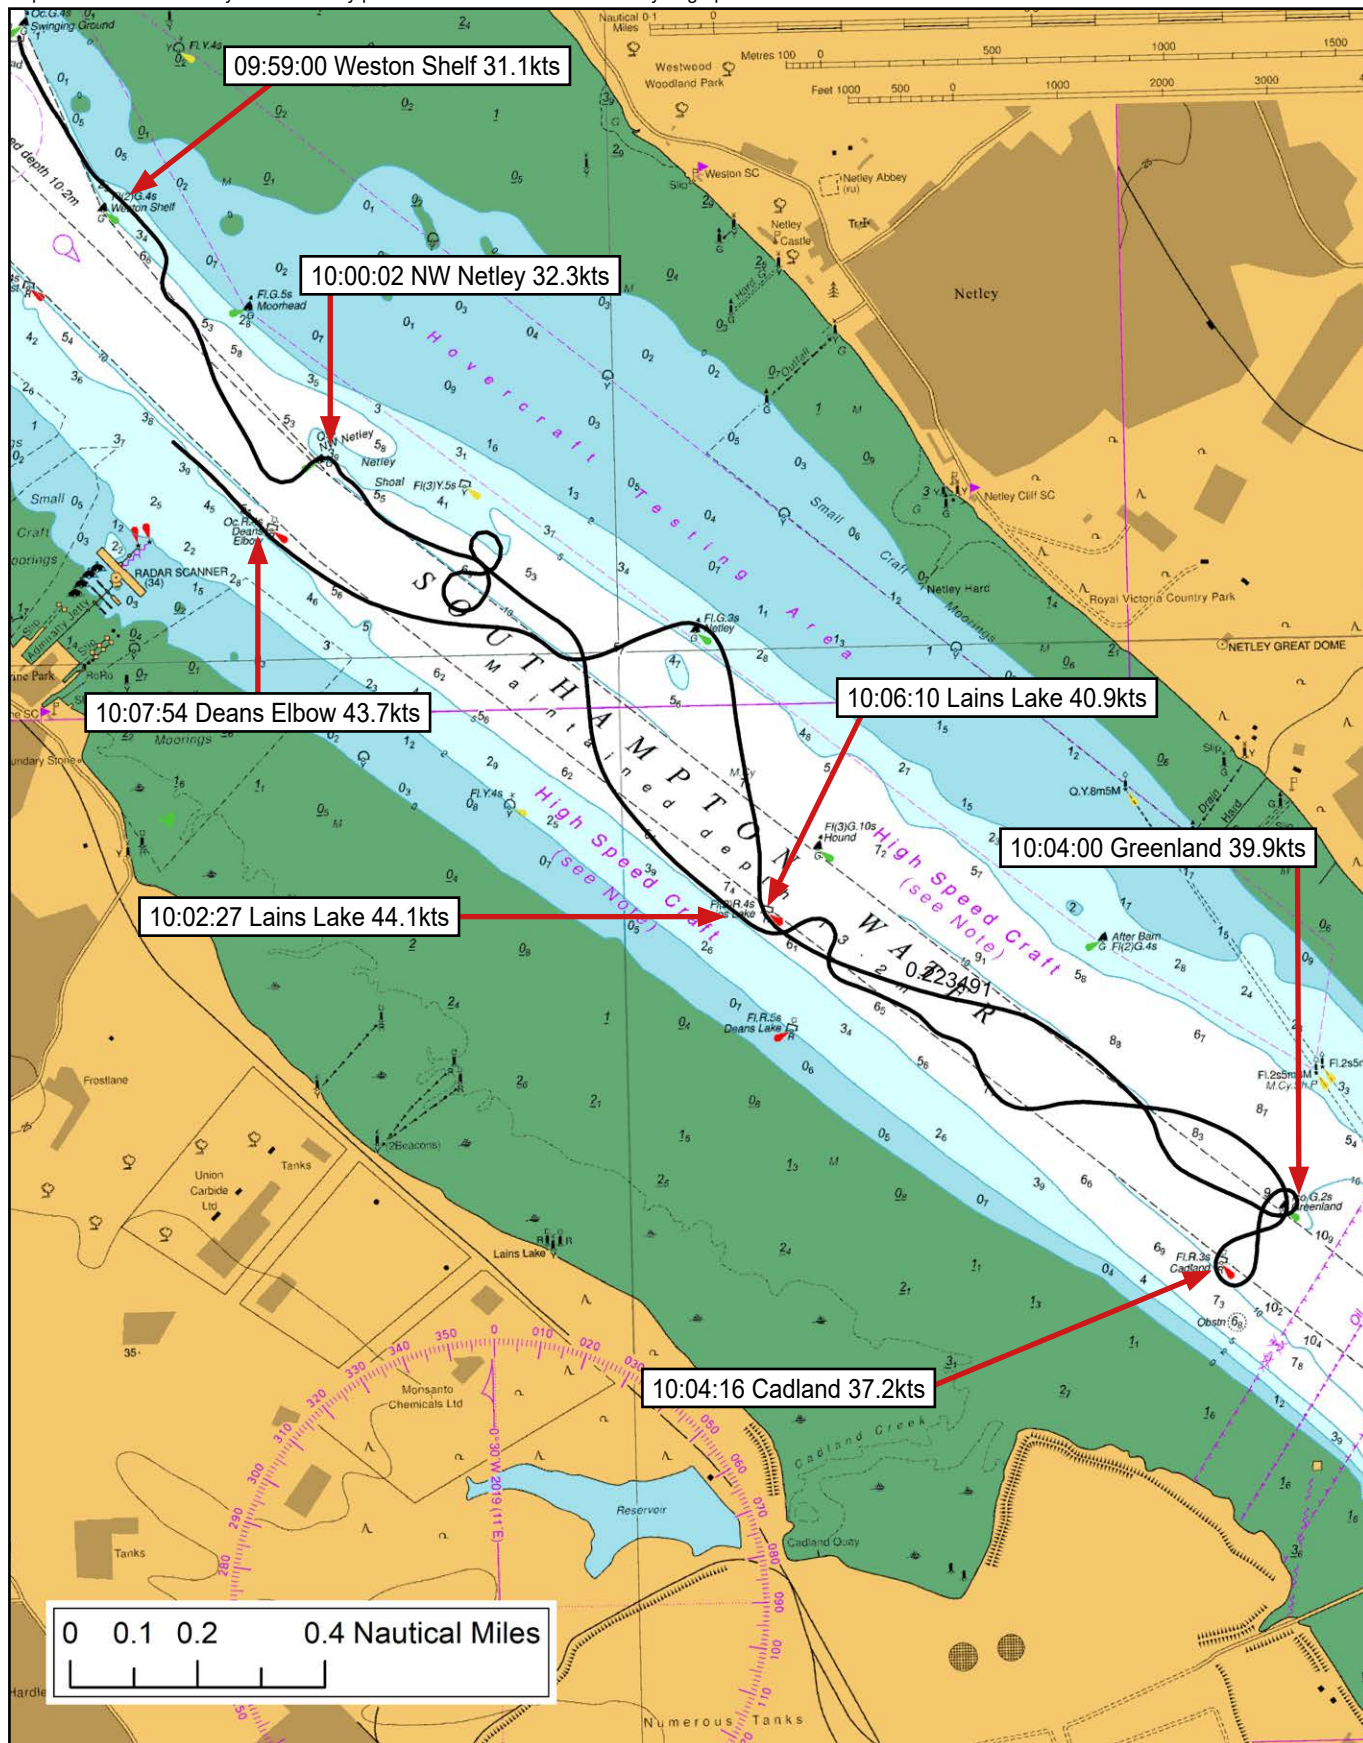
Figure 3: Still from MAIB MADAS replay showing route and speeds

At 0959, *Seadogz* passed the Weston Shelf buoy (**Figure 2**) at a speed of about 33.1kts. Once clear of the buoy, the skipper put on some loud music and increased to speeds between 30kts and 40kts. During the next 12 minutes *Seadogz* carried out high speed manoeuvres up and down Southampton Water, zig-zagging across the main channel, passing close to navigation buoys and conducting figure-of-eight turns in order to cross its own wake (**Figure 3**).

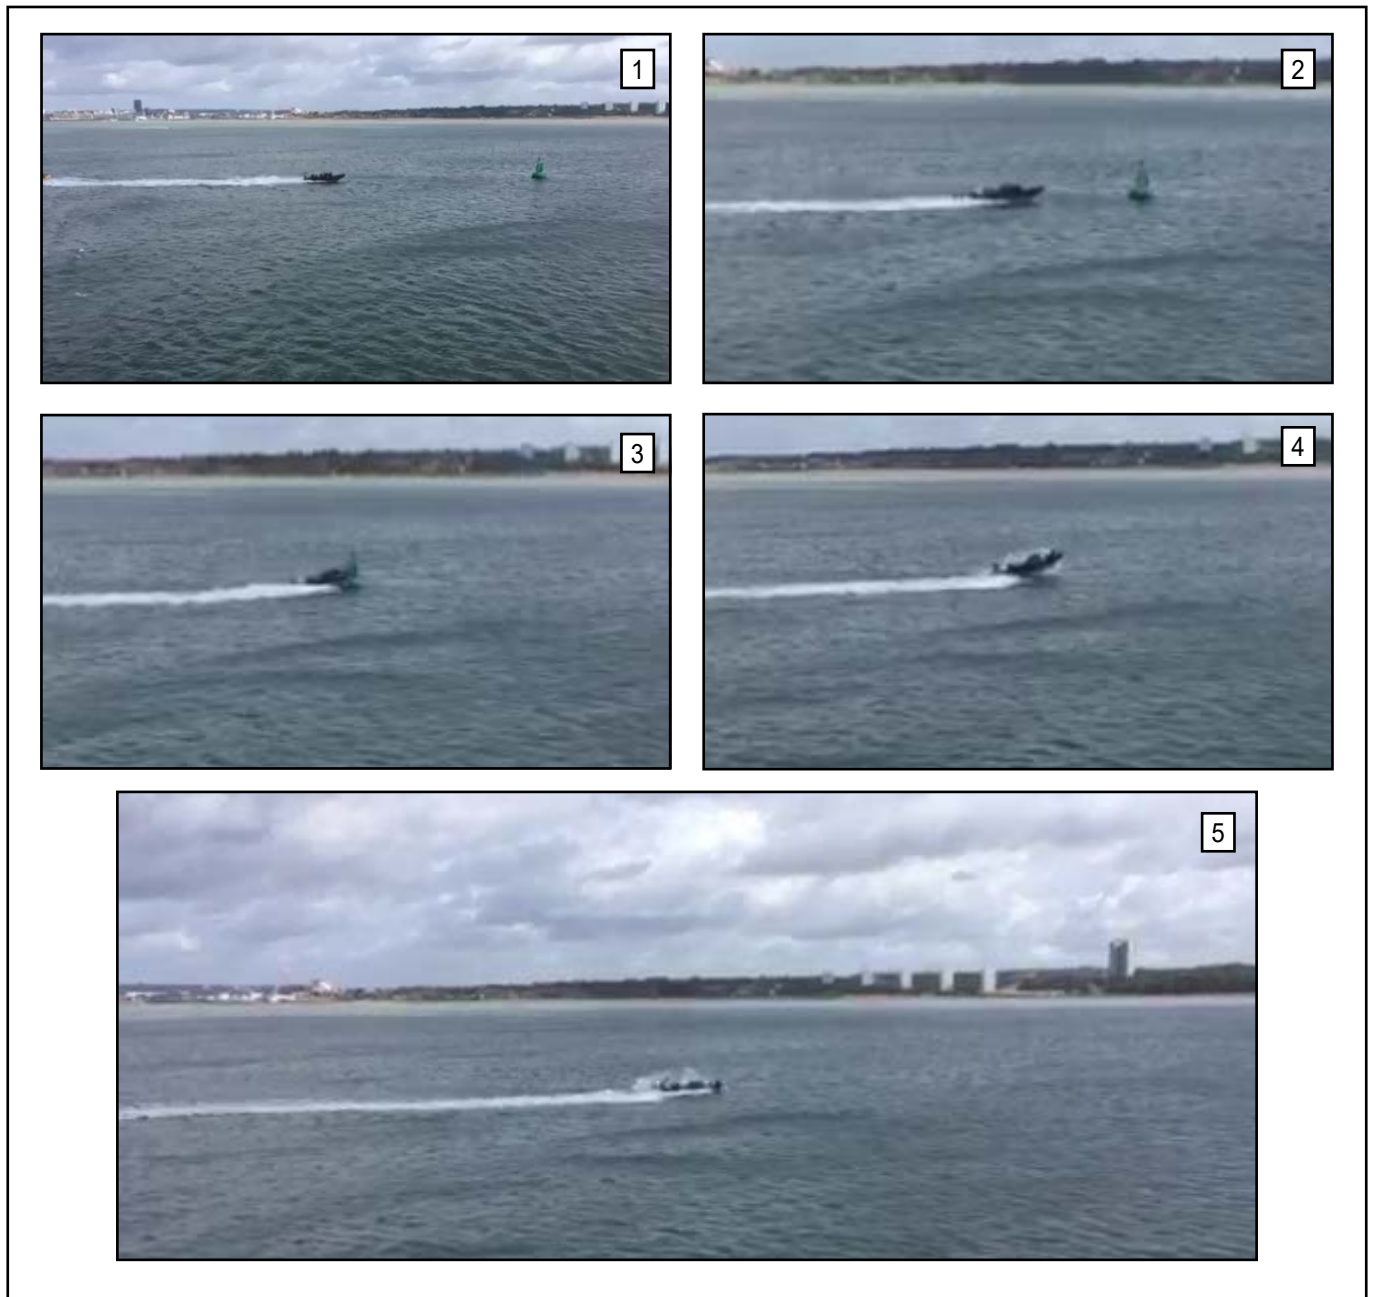
Figure 4: The collision

At 1008, *Seadogz* passed the car ferry *Red Falcon*, which was proceeding on a south-east course down Southampton Water. This offered the skipper an opportunity to drive *Seadogz* across, and so to jump over the ferry's wake. As *Seadogz* passed astern of *Red Falcon* for the fifth time the RIB accelerated on a steady easterly heading for 10 seconds until, at 1011:09 and at a speed of 38.4kts (44.2mph), it collided with the North-West Netley starboard hand buoy (**Figure 4**).

The force of *Seadogz's* head-on impact knocked the buoy over to an almost horizontal position and threw the RIB's bow upwards. The impact and abrupt deceleration forces caused all on board to be thrown violently forward from their seats. Two of the passengers seated in the front row of jockey seats were thrown out of the boat and into the water where their lifejackets inflated automatically.

Seadogz collided with the North-West Netley buoy because the RIB's skipper was concentrating on conducting high speed manoeuvres in close proximity to another vessel and did not see the fixed navigational mark in time to take avoiding action. The reasons why the skipper did not see the buoy and the factors that contributed to the tragic consequences of the collision will be discussed in detail in the full investigation report.
