DCV Safety Alert: 01/2021

RECOMMENDATIONS FROM THE INVESTIGATION INTO THE FIRE AND LOSS OF THE PASSENGER VESSEL *CONCEPTION*

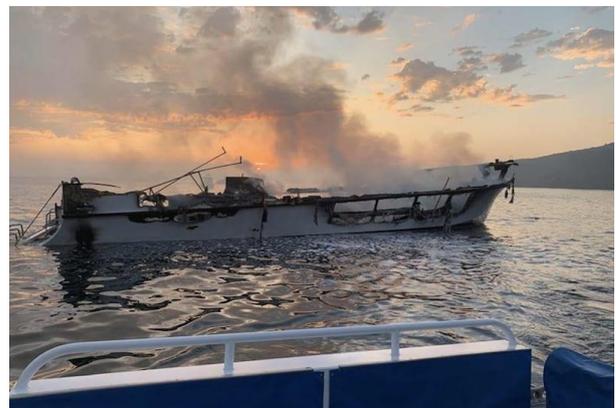
The passenger vessel MV *Conception* at sunrise prior to sinking, September 2, 2019. (Source: Ventura County Fire Department)
