Report on the investigation
into a fatal accident
on board **mv ATLANTIC PROJECT II**

in the port of Antwerp
with the decease of one crew member
on February 8th 2021.

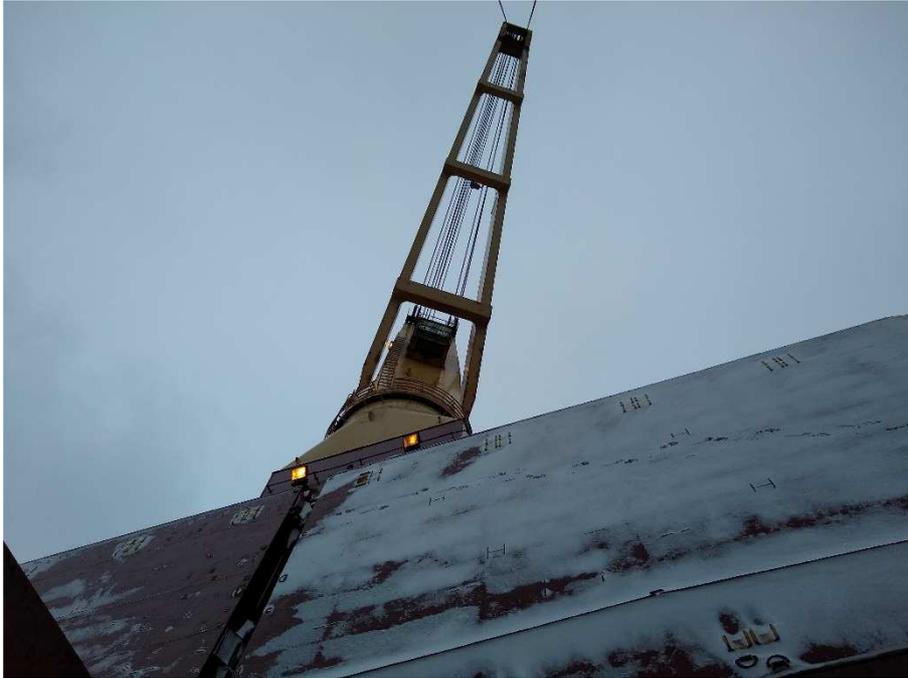
Figure 2 - Deck crane used for shifting pontoons.

The bosun was assigned to operate the crane. The deck crane shown in Figure 2, was used for this job. The crane lights were ignited, but the top light was not working.

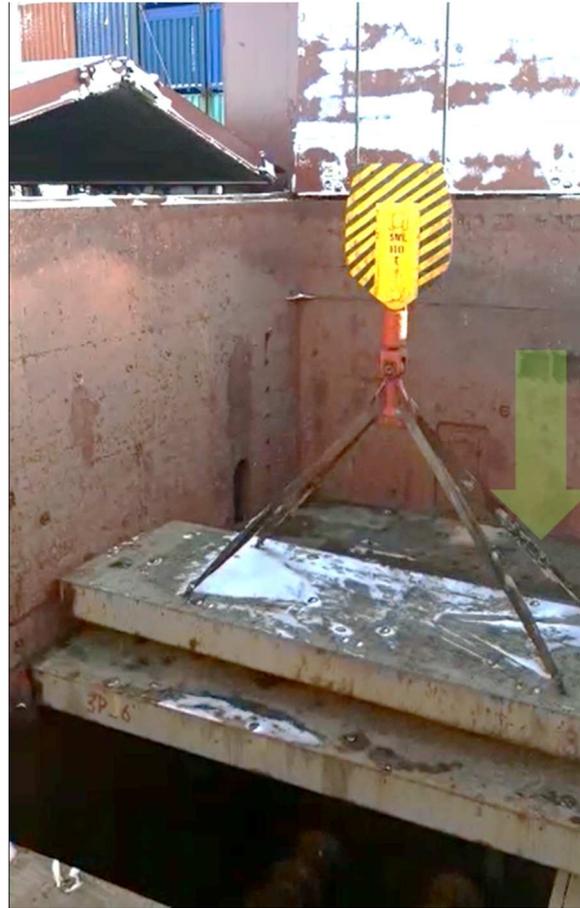
Figure 4 - Pontoon N°5 lifted

Pontoon N°5 had to be put against the bulkhead in the aft of the cargo hold, as indicated by the green arrow.

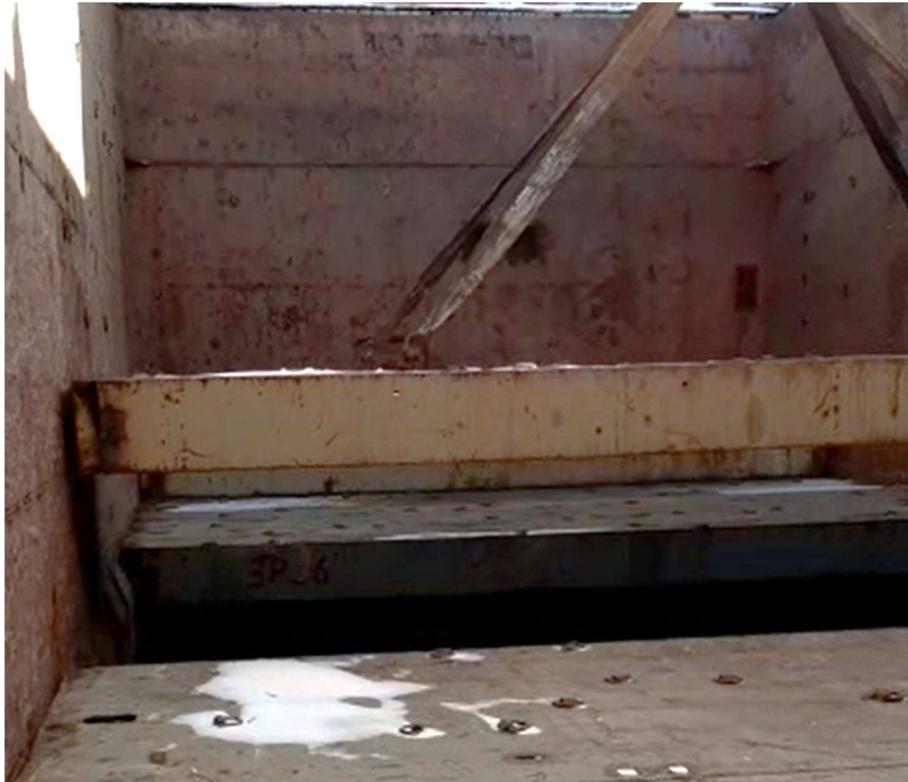
Figure 7 – Lifted pontoon in the cargo hold

The side of the cargo hold shown in Figure 7 was observed by the signal man. The manhole was on the same side but was located behind the pontoon in this picture.

The view of the signal man was obstructed by the lifted pontoon, as indicated in

Figure 7.

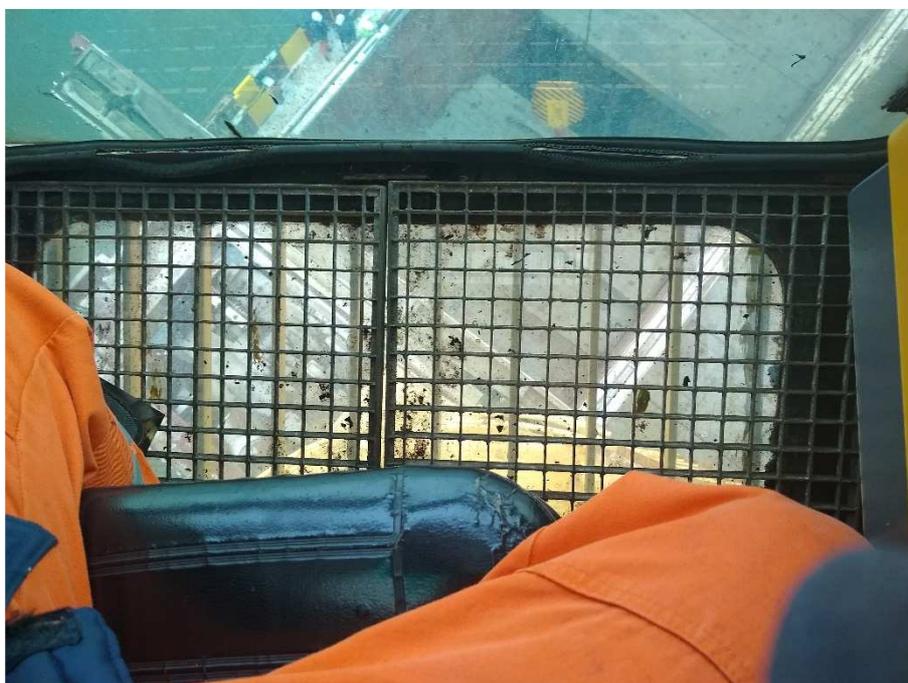
Figure 9 - View from the crane cabin

The crane operator could not oversee the complete aft part of the cargo hold from his location in the crane cabin, as seen in Figure 9.

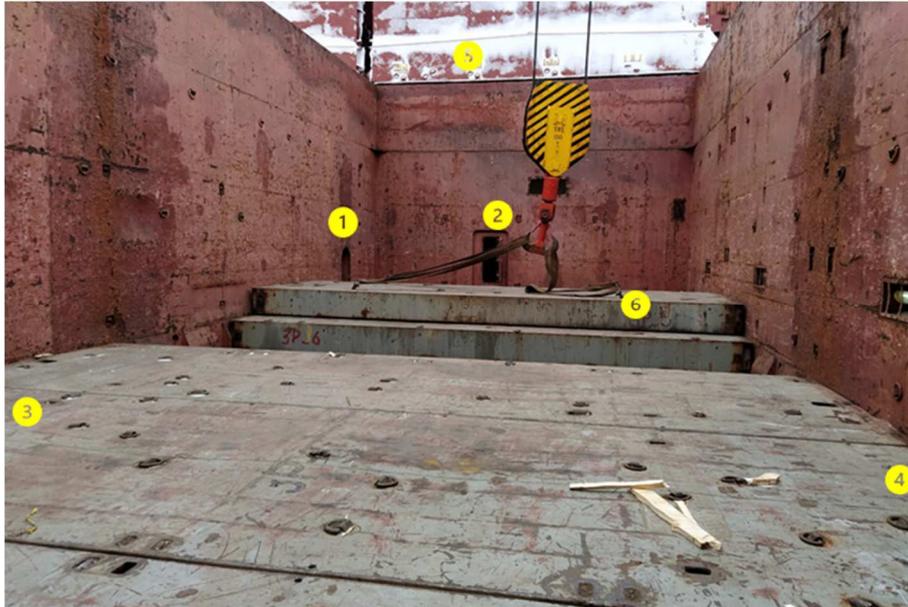
Figure 10 - Overview of the scene

Reportedly, nothing unusual was heard or seen until the signal man saw that the OS who was in the aft of the cargo hold space was fallen on deck, in front of the door in the aft bulkhead, as indicated in Figure 10.

- 1: The manhole, the safe location where the OS in the aft was last seen by the signal man*
- 2: The door in the aft bulkhead where the OS was hit by the pontoon cover*
- 3: Location of the signal man, observing the bulkhead and the edge of the pontoon*
- 4: Location of the OS that assisted the signal man, observing the bulkhead and the edge of the pontoon*
- 5: The crane operator was in the crane cabin*
- 6: The pontoon that was lifted approximately 1,5 m above deck*

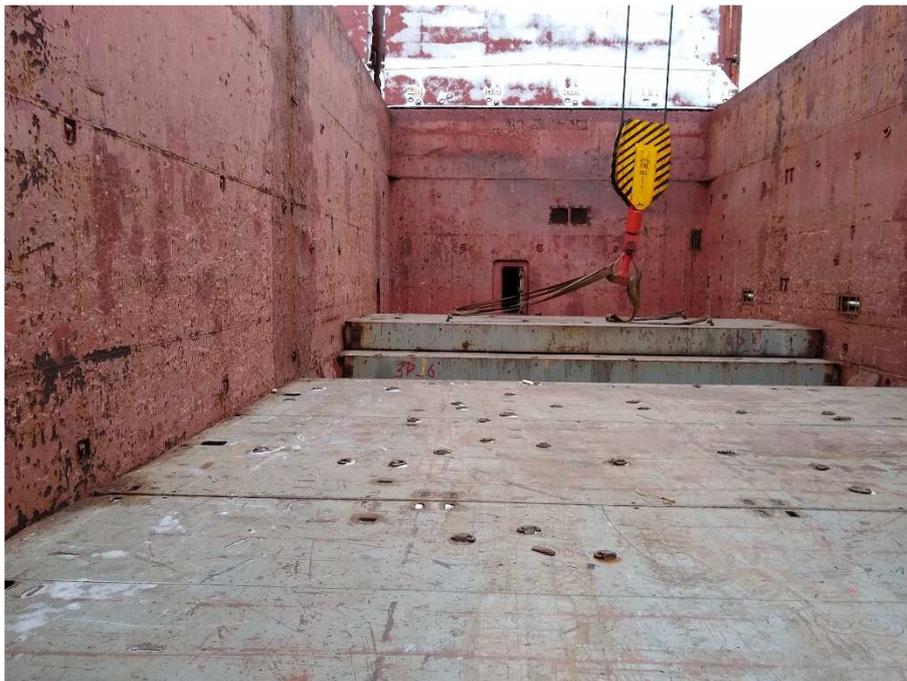
Figure 13 - Open door in aft bulkhead

It could not be confirmed that the door in the aft bulkhead was properly closed. An open door could be damaged by the pontoon when it was laid down against the bulkhead.

As indicated in Figure 13, a wide-open door was visible from the other side of the cargo hold. The difference between a slightly opened door or a closed door could not be observed from this distance.

When the pontoon had to be laid down against the bulkhead, even a slightly opened door could be damaged by the pontoon.

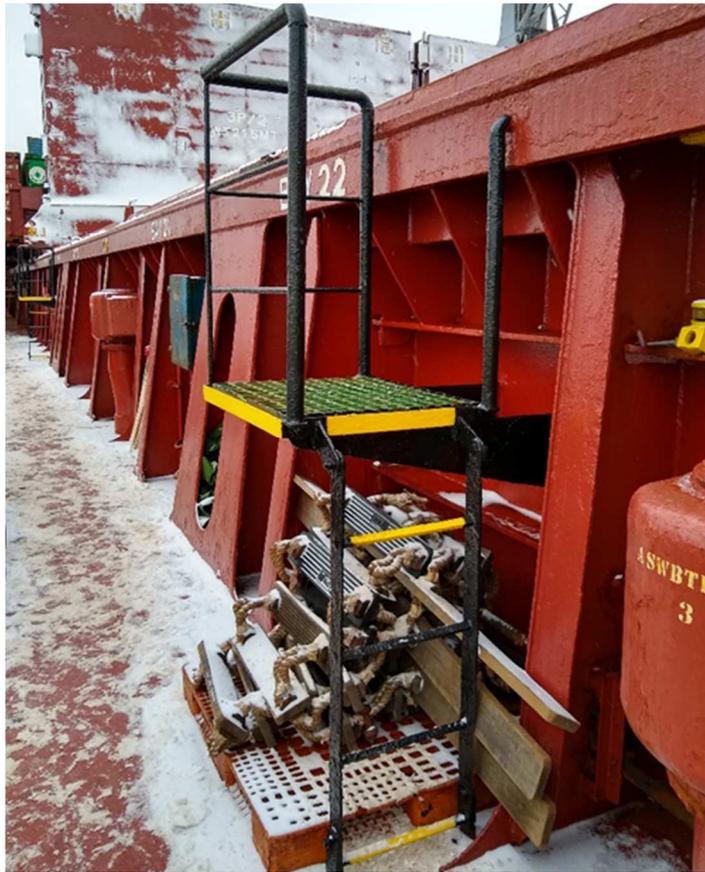
Figure 14 - Observation post on the weather deck

On the weather deck, observation posts were installed to observe cargo operations in the cargo hold, as shown in Figure 14.

All vessels must mark observation areas, or signal areas, on deck. The dedicated areas should be clearly marked and highlighted. Crew must be instructed about the use of signal man positions.

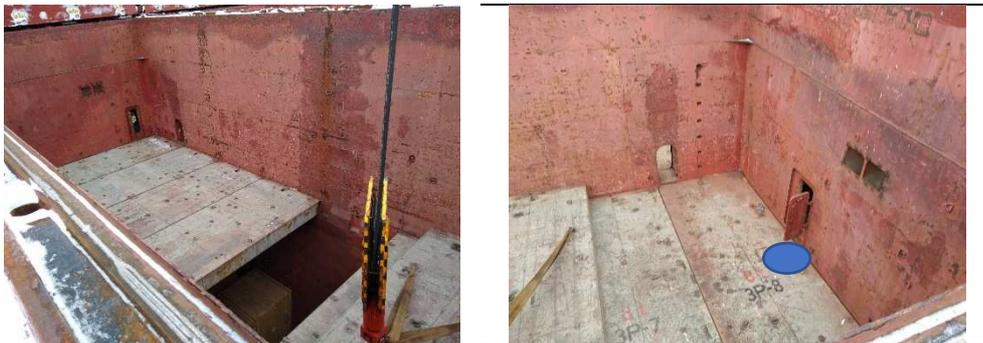
From this observation post, a complete overview of the path of the hoisted pontoon could be kept, as shown in Figure 15.

Figure 15 - View from the observation post in the cargo hold
The blue circle indicates where the OS was hit by the pontoon.
