# National Transportation Safety Board

## Marine Accident Brief

### Barge Breakaway and Contact with Interstate 10 Bridge

<b>Accident type</b>	Contact	<b>No.</b> DCA19FM052
<b>Vessel names</b>	<i>CBC 193, CBC 1403, CBC 1406, IB9123, IB1954, IB1960</i>	
<b>Location</b>	San Jacinto River Fleet, San Jacinto River, Channelview, Texas 29°47.57' N, 95°3.73' W	
<b>Date</b>	September 19, 2019	
<b>Time</b>	2338 central daylight time (coordinated universal time – 5 hours)	
<b>Injuries</b>	None	
<b>Property damage</b>	\$5.46 million est.	
<b>Environmental damage</b>	None reported	
<b>Weather</b>	Scattered clouds, visibility 10 miles, winds from southeast at 7 knots, air temperature 76°F, water temperature 77°F, sunset 1921. Tropical Storm Imelda brought heavy rains and caused flooding in the Houston, Texas, area.	
<b>Waterway information</b>	The Interstate 10 bridge crosses the San Jacinto River about 16 miles east of Houston, Texas. <sup>1</sup> The waterway connects the San Jacinto River to the Houston Ship Channel and is transited by towing vessels, barges, and other small craft.

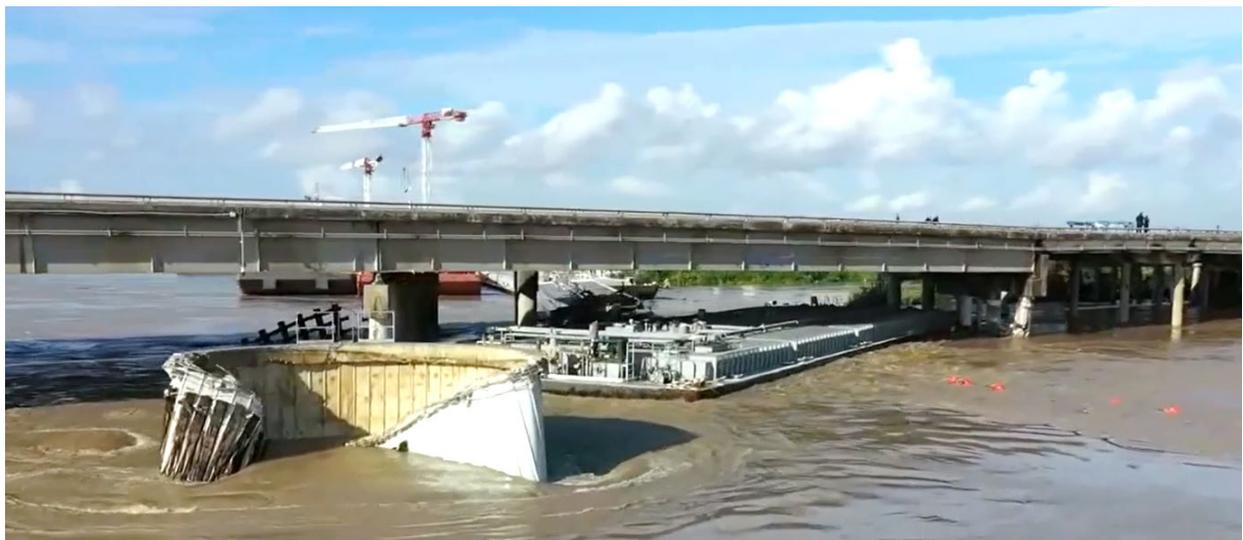
**Barges *CBC 193* and *CBC 1403* resting against I-10 bridge pilings after striking and damaging a protective cell. (Source: KJRH-TV)**

The protective cells absorbed most of the barges' momentum. Damage to the western cell just outside of the channel consisted of crushed and splintered wooden fendering, a collapsed cap, and fractured concrete exterior on the northeast side that caused the cell to crumple and fold inward. Erosion from floodwaters removed the interior dirt that helped anchor the protective cell and provide absorbing energy from impacts. Damage to the eastern cell closest to the channel consisted of crushed and splintered wooden fendering and exterior fractures on the northwest side, including an inward-collapsed concrete bulkhead. The entire cell also shifted from the impact, and erosion occurred around the base.

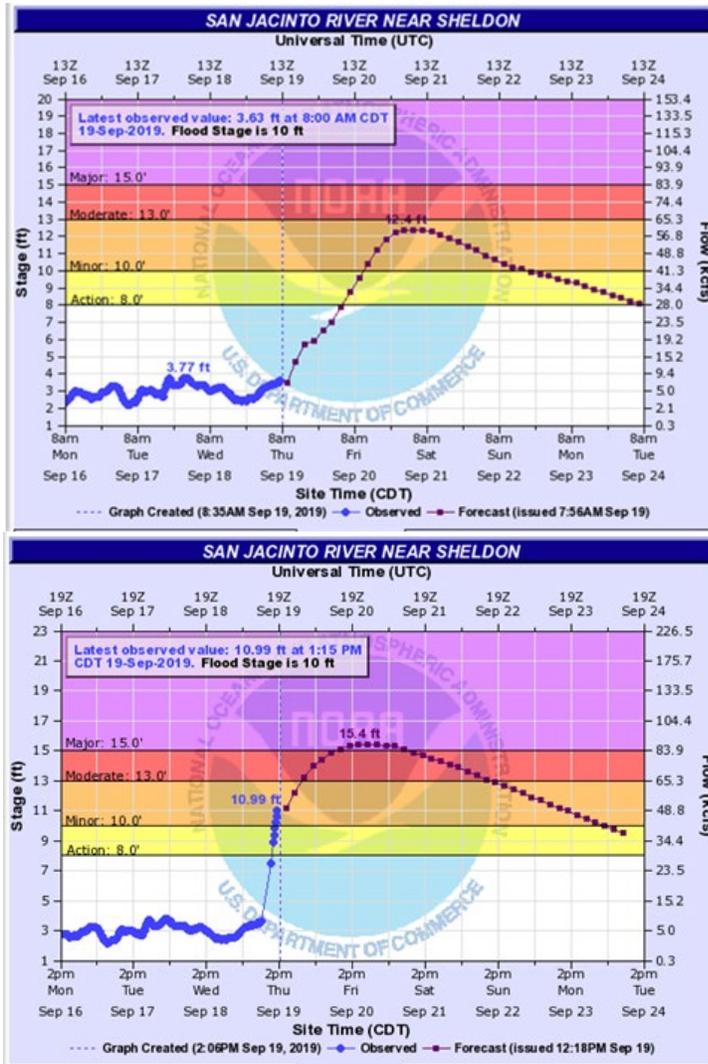
NOAA's observed water levels and flood stage predictions for the San Jacinto River near Sheldon, Texas, on September 19, 2019. On top, the 0756 flash flood warning predicted river level rising to a minor flood stage; on bottom, the 1218 warning reflected a steep rise in river level since the previous forecast and predicted a major flood stage. (Source: NOAA)

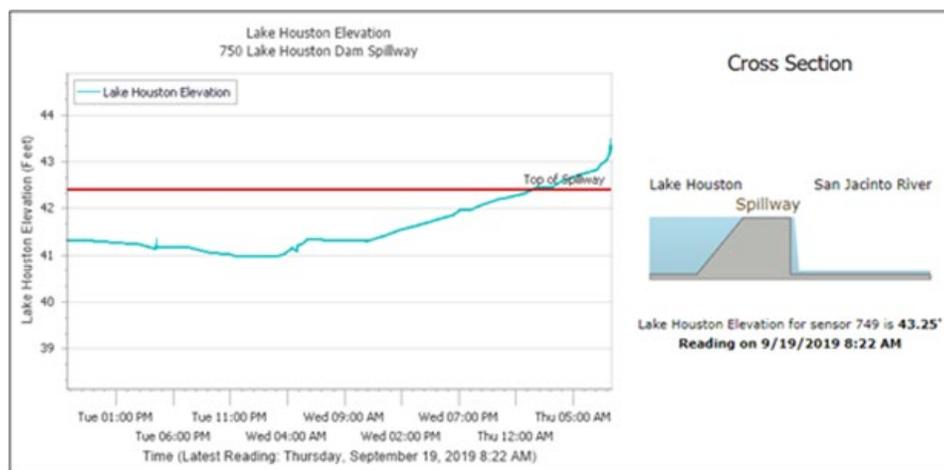
Graph of Lake Houston elevation at 0822 on September 19, 2019, showing that Lake Houston's maximum level was exceeded. The red line at 42.38 feet was the level at which water flowed uncontrolled over the dam's spillway. (Source: CWA)

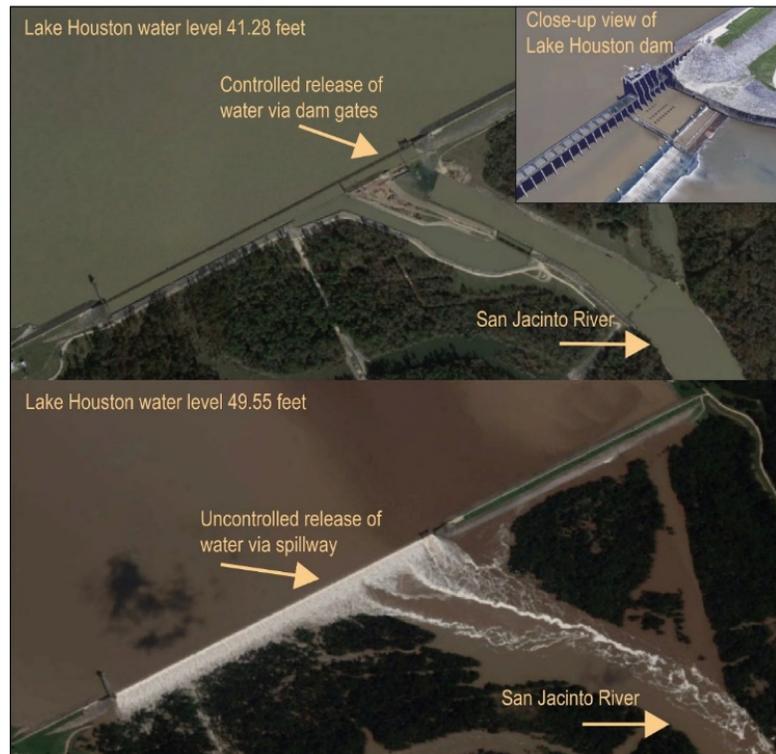
over the dam's 3,000-linear-foot spillway and enter the San Jacinto River. According to the CWA, observed water level at Lake Houston during Tropical Storm Imelda recorded a peak of 48.08 feet, with about 6 feet of water going directly over the uncontrolled spillway. The highest discharge rate was recorded at 171,705 cubic feet per second (cfs) at 0552 on September 20. At this peak rate, 18,394 cfs (11 percent) flowed through the Lake Houston dam's fully opened tainter and flashboard gates into the San Jacinto River, while 153,311 cfs (89 percent) of water flowed over the uncontrolled spillway directly into the San Jacinto River. As a result, 4 miles downriver the San Jacinto River gage height rose to 19.5 feet in Sheldon, Texas, a 14.5-foot increase over 24 hours.

**Comparison between the Lake Houston dam during normal conditions and during flooding conditions. (Background source: Google Earth)**

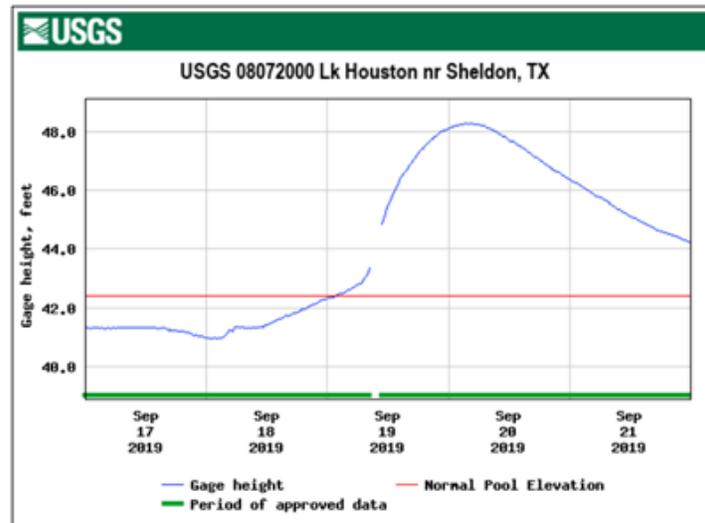
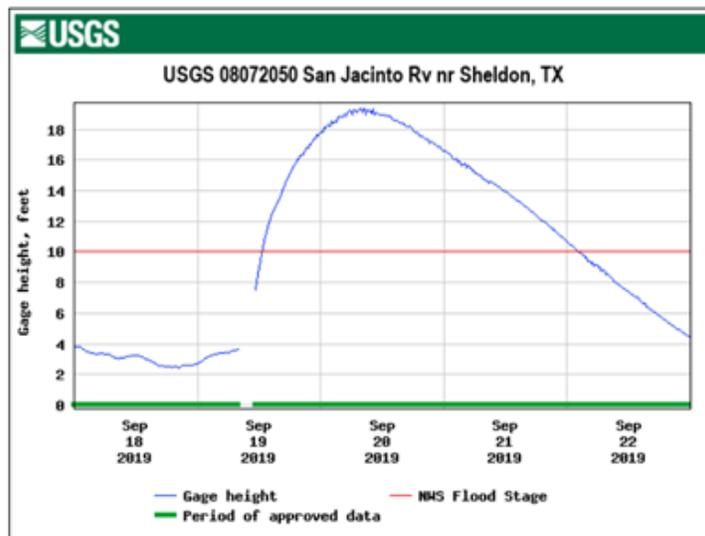
USGS graphs of Lake Houston and San Jacinto River recorded gage height during Tropical Storm Imelda. On September 19, the day of the accident, Lake Houston's gage height was several feet above normal pool elevation and the San Jacinto River near Sheldon, Texas, was above flood stage and increasing. (Source: USGS)

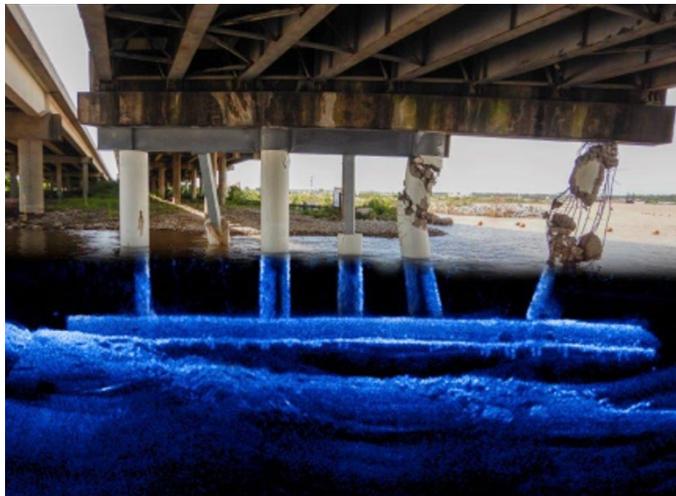
Dive surveys and damage assessments determined that only the westbound bridge had been significantly impacted as a result of the September 19, 2019, breakaway barge contact. Bent 26 (a row of pilings) had the three northern columns, a steel stud (from a previous repair), and the cap severely damaged. Bent 28 had the northern column and cap damaged.

**Multibeam sonar images overlaid with above-surface photograph illustrate the damaged columns postaccident (sonar survey taken September 27) on the westbound span of the I-10 bridge. (Source: TxDOT)**

The westbound bridge reopened on January 19, 2020. The eastbound bridge reopened to its original capacity on February 15, 2020, nearly 5 months after the accident. The cost to repair the bridge structure and provide temporary traffic control until the bridge reopened and capacity was restored was \$5,110,296.

One of the sets of columns damaged by the barge contact on September 19, 2019, had previously been struck by a barge on February 11, 2019, causing \$1.56 million in damage.<sup>2</sup> TxDOT has planned a \$14 million construction project for summer 2021 to replace the protective cells and fender systems for the I-10 bridge at the San Jacinto River. In addition to replacing the protective cells and fender system, TxDOT is working on strategies to deliver a project that will replace the existing I-10 bridge structures at the San Jacinto River. The new bridge could potentially reduce or eliminate bridge bents and columns in the water, minimizing the likelihood of similar strikes in the future.
