# National Transportation Safety Board

## Marine Accident Brief

### Contact of *Old Glory* Tow with Peter P. Cobb Memorial Bridge

<b>Accident type</b>	Contact	<b>No.</b> DCA20FM025
<b>Vessel names</b>	<i>Old Glory, Cole</i>	
<b>Location</b>	Intracoastal Waterway, Indian River, mile 965, Fort Pierce, Florida <sup>1</sup> 27°27.46' N, 080°19.01' W	
<b>Date</b>	August 19, 2020	
<b>Time</b>	0251 eastern daylight time (coordinated universal time – 4 hours)	
<b>Injuries</b>	None	
<b>Property damage</b>	\$646,000	
<b>Environmental damage</b>	None	
<b>Weather</b>	Visibility 10 miles, clear skies, winds light and variable, air temperature 75°F, water temperature 86°F	
<b>Waterway information</b>	The Intracoastal Waterway is used by commercial light-draft vessels, tows unable to navigate long stretches in the open ocean, and recreational craft. The project depth at the accident site is 10 feet.

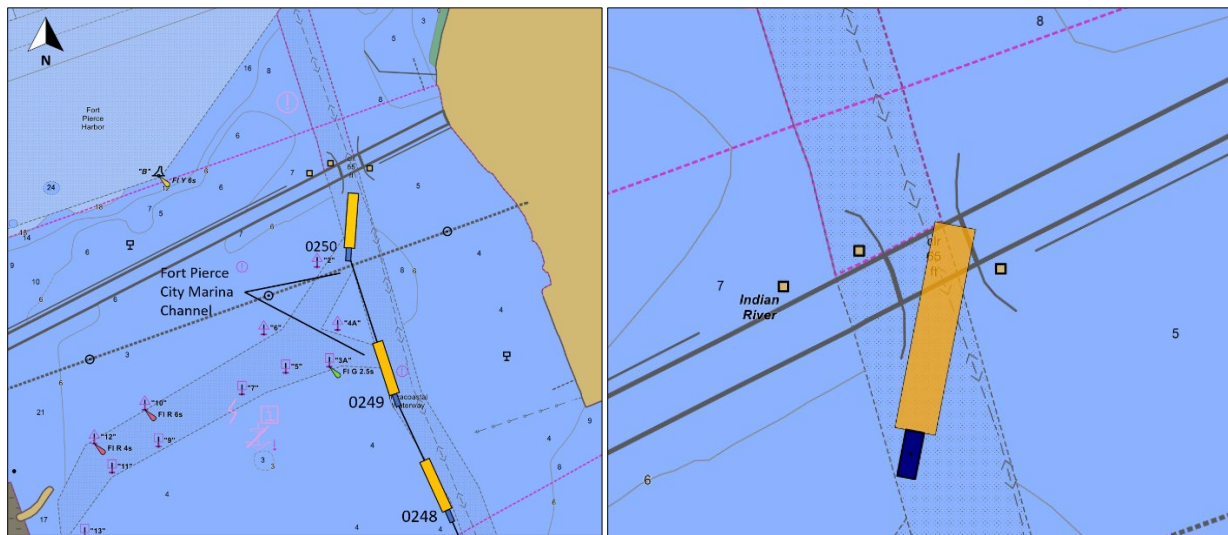
Recognizing that the alignment was poor, the relief captain, believing the tow could not safely pass beneath the bridge, steered the head of the tow into the bridge’s east fendering, which he considered the safest place for the barge to strike since it did not affect any of the bridge structures. At 0251, the port side of the barge touched up against the west-side fendering, and its starboard bow struck the eastern fender wall in the middle, damaging a 55-foot section under the bridge. The starboard-side face wire (wire that connects to a barge from the towboat’s bow to keep the barge securely against the vessel) also parted during the contact.

**Left: AIS trackline of the *Old Glory* and *Cole* outside of and alongside the western boundary of the ICW. (Source: Portvision) Right: The approximate position of the tow after striking the protective fendering system under the Peter P. Cobb Memorial Bridge. (Source: National Oceanic and Atmospheric Administration [NOAA] electronic navigation chart USFL88M)**

At the time the tow was approaching the bridge in darkness, the relief captain said he slowed the vessel, which in turn reduced the maneuverability of the tow while the current pushed the tow to the western limit and then outside of the channel. He said he corrected for the current by steering to starboard to bring the vessel back into the channel, but AIS information showed the tow remaining on the west side of the channel. Just short of the bridge entrance, the relief captain described that the head of the tow "started bogging down" as if it hit a sandbar. This was likely when the stern of the tow crossed into the northern entrance to the 6.5-foot-deep Fort Pierce City Marina channel, a depth less than the tow's reported 7-foot draft. From that point, efforts to line up the tow to pass through the bridge were unsuccessful.

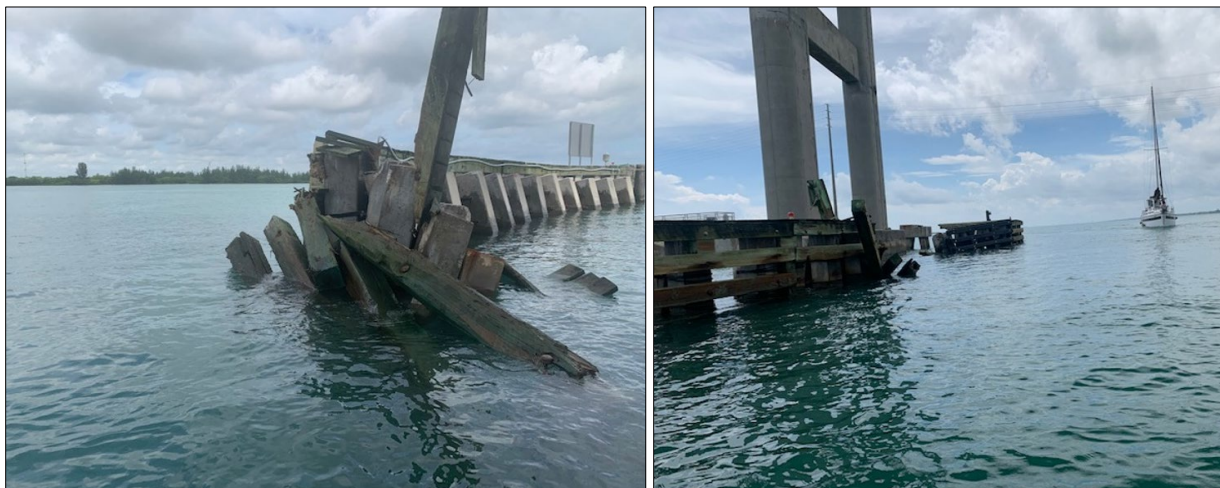
The Peter P. Cobb Memorial Bridge structure was inspected and determined to be safe. The east bridge protective fendering system had 4 of its 11 sections either damaged or destroyed and its navigation lighting electrical system damaged. Permanent repairs were completed on the east fendering on January 23, 2021. The total cost of the repairs was \$641,000.

**Left:** Postaccident damage to the eastern fendering of the bridge looking to the north.  
**Right:** Postaccident damage to the eastern fendering of the bridge looking to the south. (Source: Coast Guard)
