SAFETY INVESTIGATION REPORT

REPORT NO.: 14/2021

MV ALULA **Serious injury to crew member** **while operating a lathe machine** **in Qingdao anchorage area,** **10 June 2020**

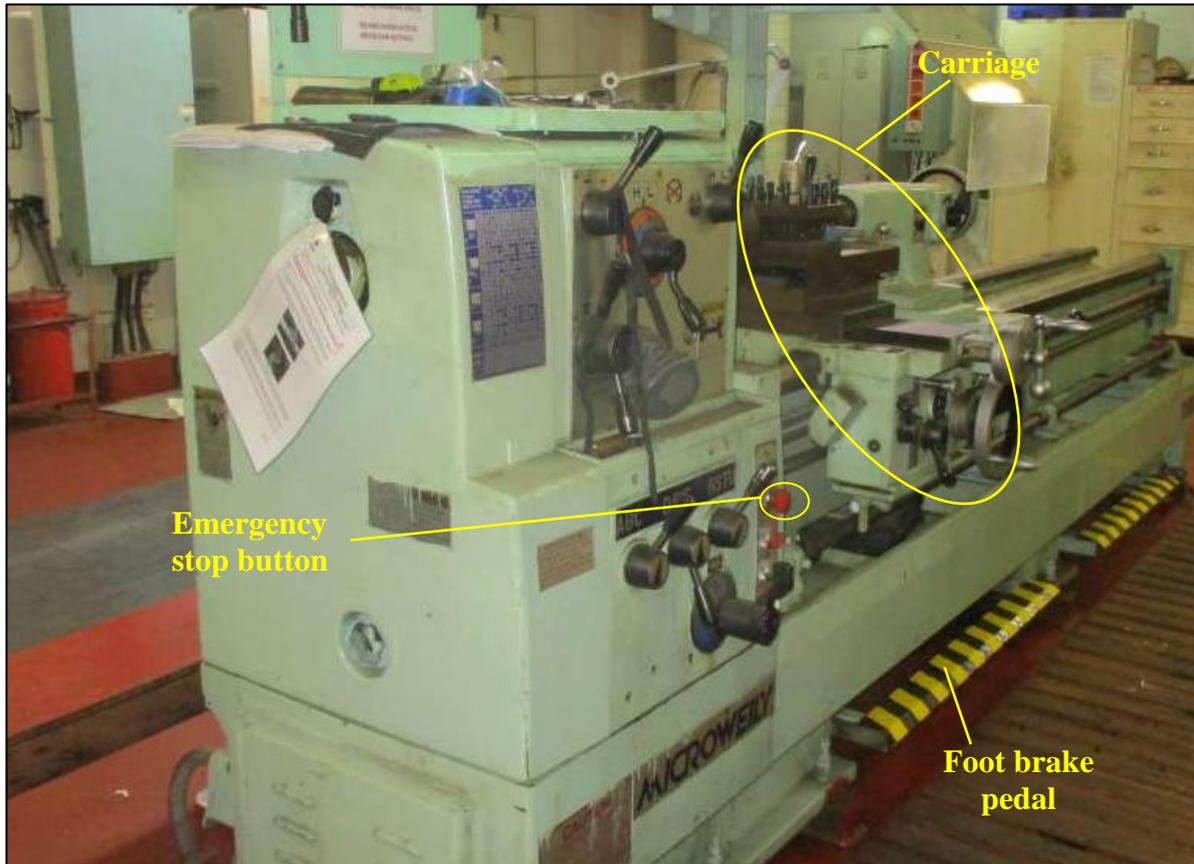
Figure 2: Lathe machine on board Alula

The lathe machine on board *Alula* (Figures 1 & 2) was fitted at the centre of the engine-room workshop. An Instruction and Parts Manual was provided on board. The Manual included a section on operator safety guidance. The section listed several safety precautions and operation hazards.

14/2021_R2 install a guard over the chuck of the lathe machine and instruct the operators in its use.

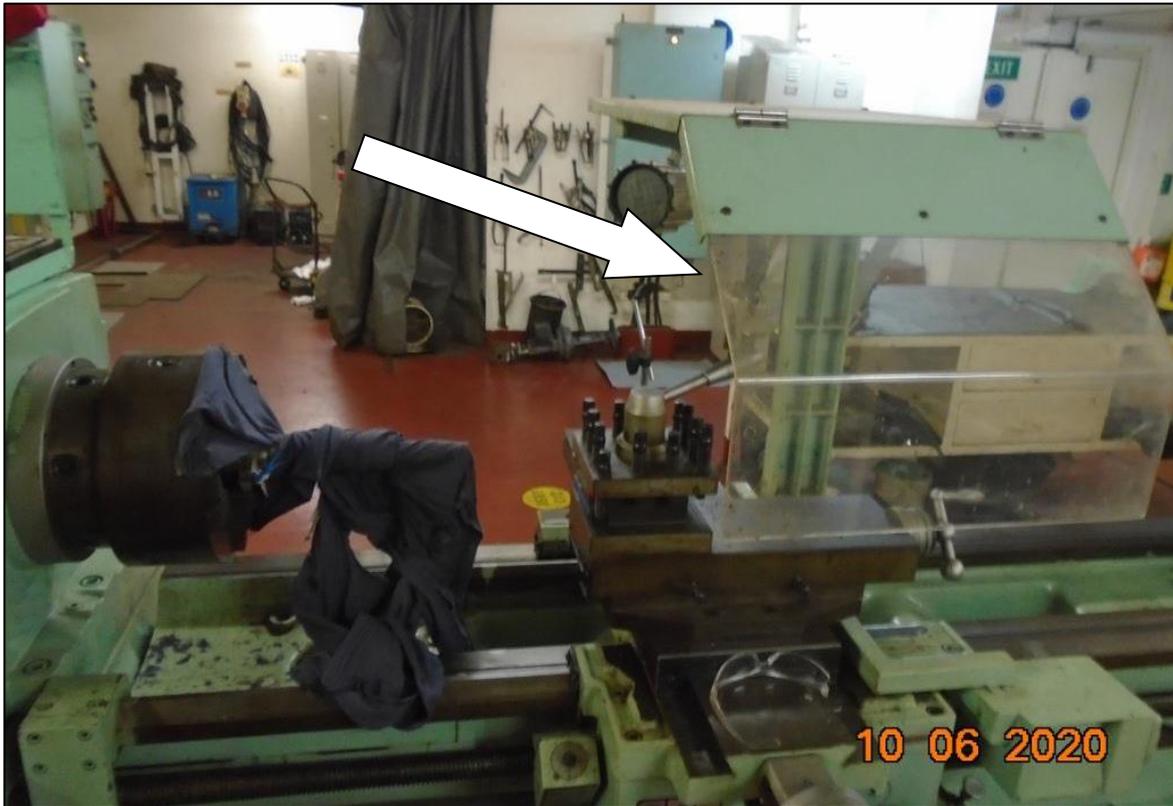
Figure 3: Carriage guard

A guard was fitted to the lathe machine's carriage⁴ (Figure 3).

The safety investigation revealed that the design of the lathe machine fitted on board *Alula* did not provide for a chuck guard. Instead, a carriage guard was fitted on the lathe machine's carriage. The carriage guard was not used since the fitter was using the emery cloth by hand.

In several lathe machine models, a micro-switch fitted to the chuck guard will prevent the lathe machine from starting. Additionally, the guard is permanently fixed to the headstock, therefore serving as a physical barrier between the operator and the hazard (rotating chuck). The carriage guard provided protection over the toolpost area and moved along with the toolpost. Therefore, in almost all instances, there would be times when the rotating chuck would be exposed.

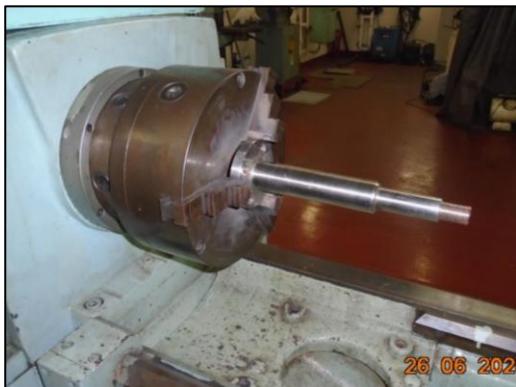
Figure 4: The shaft mounted on the chuck

After the lunch break, on 10 June 2020, the second engineer assigned the fitter to repair an old shaft for the auxiliary boiler feed pump by welding and machine it on the lathe machine. This shaft measured approximately 300 mm in length and 25 mm in diameter (Figure 4). The fitter proceeded to the engine-room workshop to execute this task.

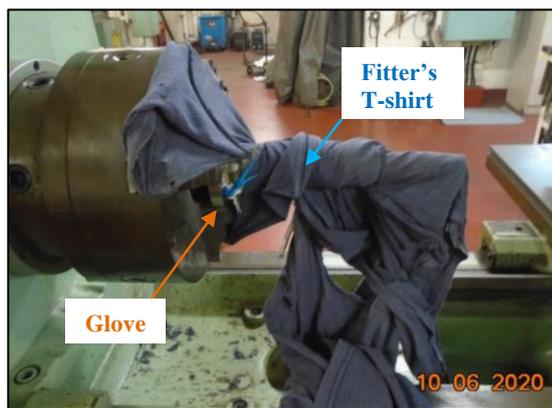
Figure 5: The lathe machine as found after the accident

The chief engineer noticed that rather than a rag, it was the fitter's working gloves, and his T-shirt reeled around the shaft secured to the lathe machine's chuck (Figure 5). Additionally, the fitter's safety goggles were found broken nearby. The chief engineer also observed that the control on the lathe machine's rpm were set on high.

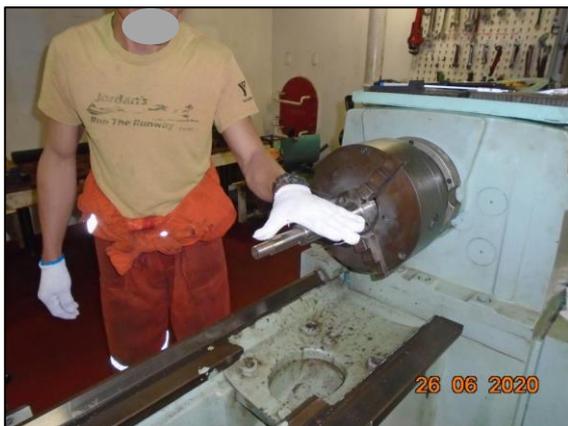
Figure 6: Simulation of fitter's attire prior to accident

In the absence of any witnesses to this occurrence, it is probable that either the fitter's gloves or T-shirt got caught first in the rotating chuck while he was working on the shaft (Figure 6). This dragged the fitter into the hazardous zone, resulting in multiple injuries. It is also probable that once his T-shirt was completely stripped off him by the rotating chuck, the fitter fell backwards and away from the lathe machine.
