MA2021-6

**MARINE ACCIDENT  
INVESTIGATION REPORT**

<b>Accident type</b>	Fatality of a crew member
<b>Date and time</b>	Around 10:45 on September 9, 2019
<b>Location</b>	Kita Wharf, Maizuru Port, Maizuru City, Kyoto Around 208° true bearing 2.2 nautical miles (M) from Toshima Lighthouse, Maizuru Port. (Approximately 35°27.4' N, 135°19.0' E)
<b>Summary of the Accident</b>	While the cargo vessel FIRST AI was mooring, a boatswain died as his head was trapped in a hatch cover panel when performing hatch cover closing duty.
<b>Process and Progress of the Investigation</b>	An investigator-in-charge and a marine accident investigator were appointed to investigate this accident on September 10, 2019. September 10 and 11, 2019 On-site investigation and interviews; November 1, 2019, May 13, 2020, and June 12, 2020 Collection of questionnaires Opinions on the draft report were invited from parties relevant to the cause of the accident. Comments on the draft report were invited from the flag state of FIRST AI.

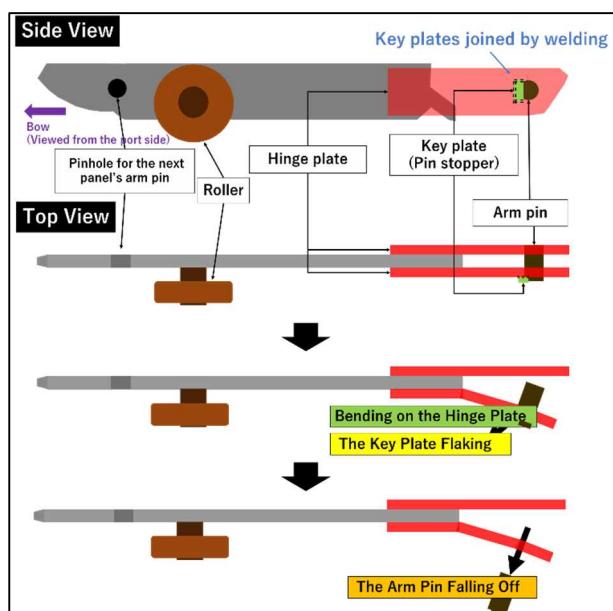
Figure 5 Damage to the Vessel

<p>Male, 34 years old</p> <p>Certificate of Proficiency for Rating Forming Part of Navigational Watch (issued by the Republic of the Union of Myanmar)</p> <p>Date of Issue: November 26, 2016</p> <p>(Valid until November 4, 2021)</p>
Injuries to Persons	Death of one person (boatswain)
Damage to Vessels and Other Facilities	<p>Outward horizontal dent of the hinge plate (hereinafter referred to as "the Hinge Plate") attached with arms for connecting the port side panel between panel No. 11 and No. 10 of the stern side's hatch cover (hereinafter referred to as "the Arm"), flaking of the key plate attached with the Arm (hereinafter referred to as "the Key Plate"), and falling off of the pin attached with the arm (hereinafter referred to as "the Pin")</p> <p>(See Figure 5, Figure 6, Figure 7, Figure 8)</p>

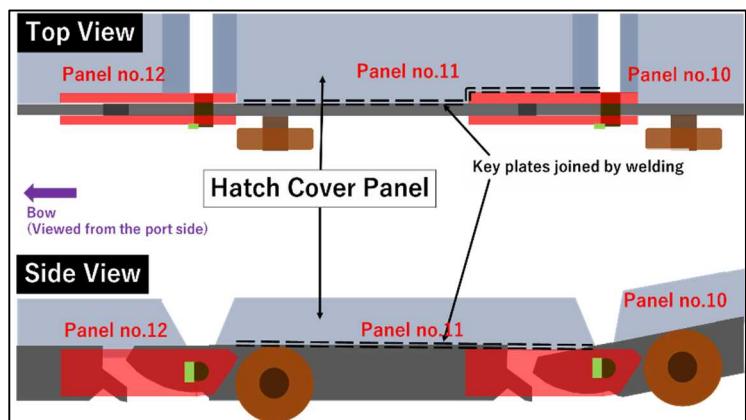
Figure 6 Arm for Connecting Panels

- ① Due to the grease clogging of the pin of the fourth previously-stored arm, the linked part was not folded to 90° during winding, and the Arm was not properly stored. The Arm was then pushed up from the fourth previously-stored arm, causing a bending load on the hinge plate and an outward pulling force on the key plate.
- ② The opening/closing operation exceeded the allowable tilt value of 3°, causing the port and starboard arms to be out of synch and exerting an outward force.

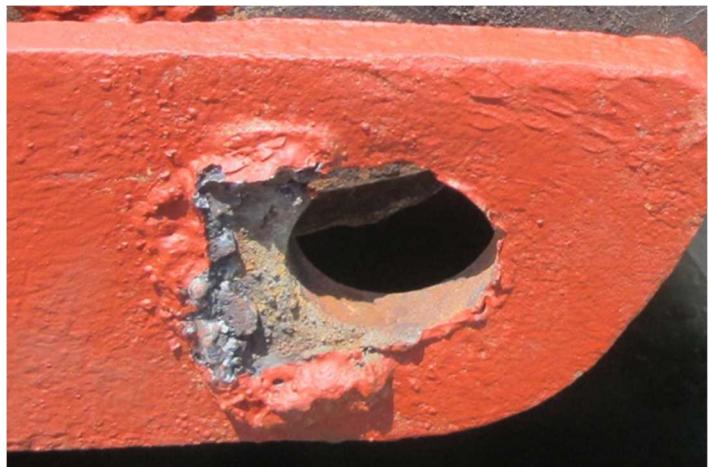
Figure 7 Outline of Connecting Panels Using an Arm

directly.
<b>Probable Causes</b>	<p>It is probable that the accident occurred due to the following situation. As the boatswain received instruction from Officer A, he stopped winding up the drum for the closing of the hatch cover after the Vessel had unloaded the cargo. Afterward, the boatswain passed through the Space, and the Hinge Plate bent outward horizontally, the Key Plate flaked off, and the Arm Pin, which was no longer restrained, fell off, causing panel No. 11 of the hatch cover to fall. As a result, his head was caught between panel No. 11 and panel No. 7, which was already stored in the drum.</p> <p>The reason why the boatswain passed through the Space, although he had been warned not to do so before the accident, could not be clarified.</p> <p>It is probable that the bent of the Hinge Plate occurred because the hatch cover was opened and closed after the temporary repair took place on the Vessel without taking account of the residual stress.</p>

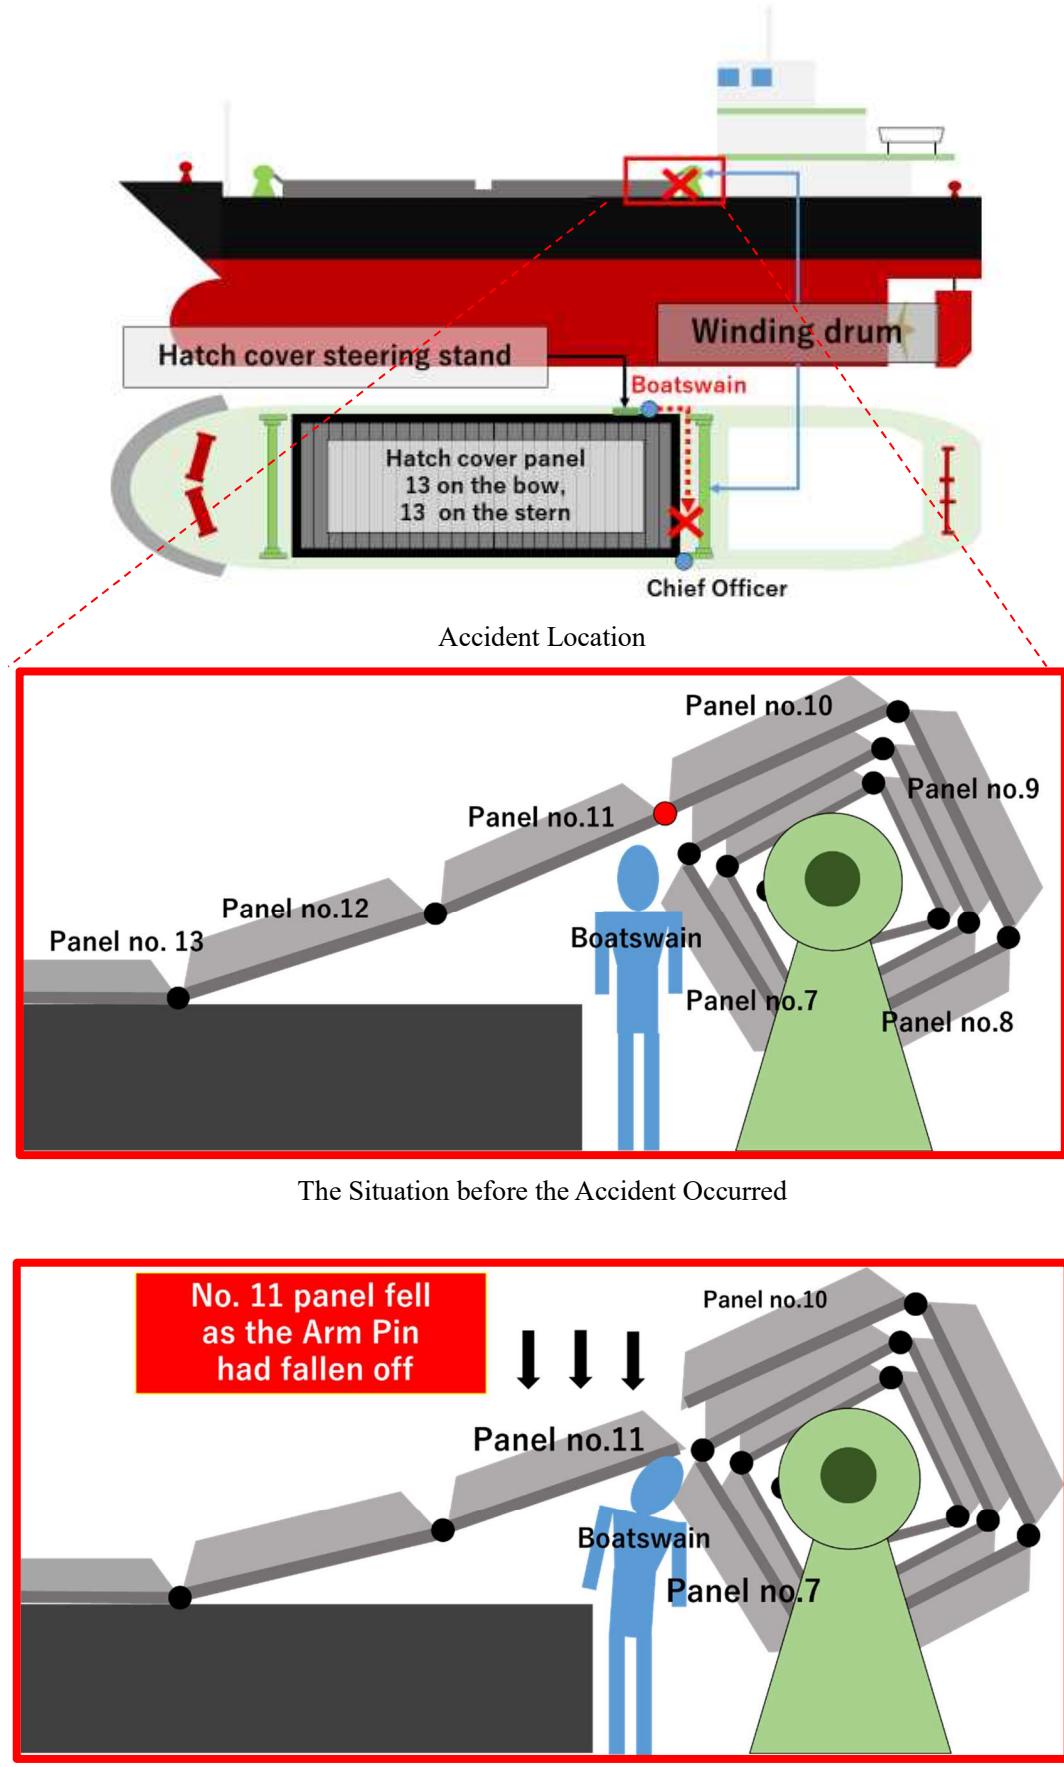
Attached Figure 2 Overview of the Accident Situation

<p>Officer A was checking the condition of the rubber packing after the hatch cover stopped moving. Then, the Arm Pin fell off and hit his right hip, so he turned to where the Arm Pin was inserted. At where the arm pin had fallen off, he noticed that the boatswain's head was caught between panel No. 11 (about 2.5 tons), which had fallen, and panel No. 7 which is already stored in the drum (See Attached Figure 2). He called out loudly for other crew members to come, and asked the stevedore who came to the scene to call an ambulance.</p> <p>The helmsman was in his room when he heard Officer A shouting and rushed to the scene of the accident. He confirmed that the head of the boatswain was caught between two hatch cover panels, reported the accident to the second officer in the chart room, and called the chief cook and the ordinary seaman.</p> <p>The second officer reported that the boatswain was injured to the master and immediately went to the scene of the accident.</p> <p>The helmsman and the chief cook transported the boatswain to the nearby corridor of the living quarter.</p> <p>As the boatswain was in cardiac arrest, he received chest compressions and artificial respiration from the rescue squad that arrived near the scene at around 11:02.</p> <p>At around 11:08, the rescue squad called for a medical helicopter to be dispatched.</p> <p>The boatswain was transported to a hospital in Toyooka City, Hyogo, at around 12:24 by a medical helicopter that arrived near the scene of the accident at around 11:31.</p> <p>(See Attached Figure 1 Overview of the Accident Location, Attached Figure 2 Overview of the Accident Situation)</p>

<b>Safety Actions</b>	<p>It is probable that it is useful for the following measures to be implemented to prevent the recurrence of similar accidents.</p> <ul style="list-style-type: none"> <li>▪ Company A should make the crew aware of the danger of being caught in the hatch cover, and instruct them not to pass through the Space except for the situations of absolutely necessary repairs and inspections. Also, if working from under the panel is unavoidable, the crew should be instructed to take measures to prevent falling before starting their work.</li> <li>▪ If the hatch cover is damaged, Company A should carry out appropriate repairs before opening and closing it.</li> </ul>
<b>Safety Recommendations</b>	<p>In view of the results of this accident investigation, the Japan Transport Safety Board recommends that JANGHO SHIPPING CO., LTD., which is the management company of FIRST AI, takes the following measures for the purpose of preventing the reoccurrence of a similar accident and reducing damage.</p> <ol style="list-style-type: none"> <li>1. JANGHO SHIPPING CO., LTD. should make the crew of ships under their management aware of the danger of being caught in the hatch cover and instruct them not to pass through the space between the winding drum and the hatch coaming unless it is absolutely necessary. Furthermore, when it is unavoidable to work under the panel, the crew should be instructed to take measures to prevent falling before starting the work.</li> </ol>
