## MONTHLY SAFETY SCENARIO

**JULY 2021**

## Tide caught pilot by surprise

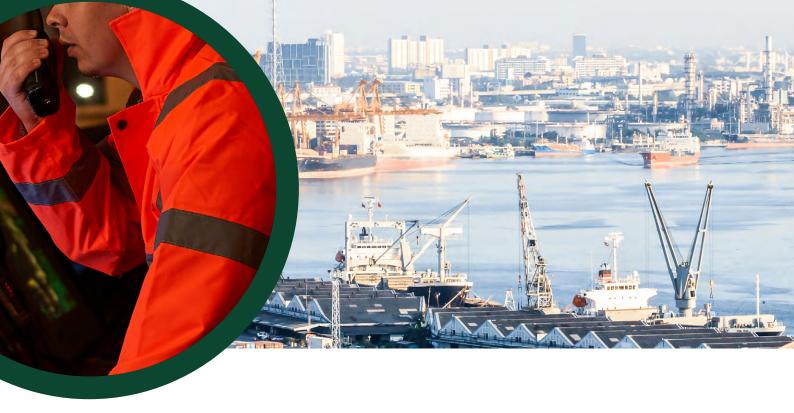
The vessel was now heading for another vessel that was berthed at

the terminal on the south bank. The strong current surprised the pilot and he froze doing nothing for a minute.

At this point the Master feared that the risk of collision was imminent, relieved the pilot and ordered full astern to reduce the speed and also take advantage of the transverse thrust effect of the right hand propeller to swing the bow further to starboard. At the same time port anchor was dropped but it was too late. As a result of these actions the vessel's bow cleared the berthed vessel by around 30 metres but the vessel instead made heavy contact with the berth at a speed of about 4 knots.
