SAFETY INVESTIGATION REPORT

REPORT NO.: 16/2021

MT KEY FIGHTER **Grounding** **in position 67° 29.15' N 012° 04.02' E** **01 July 2020**

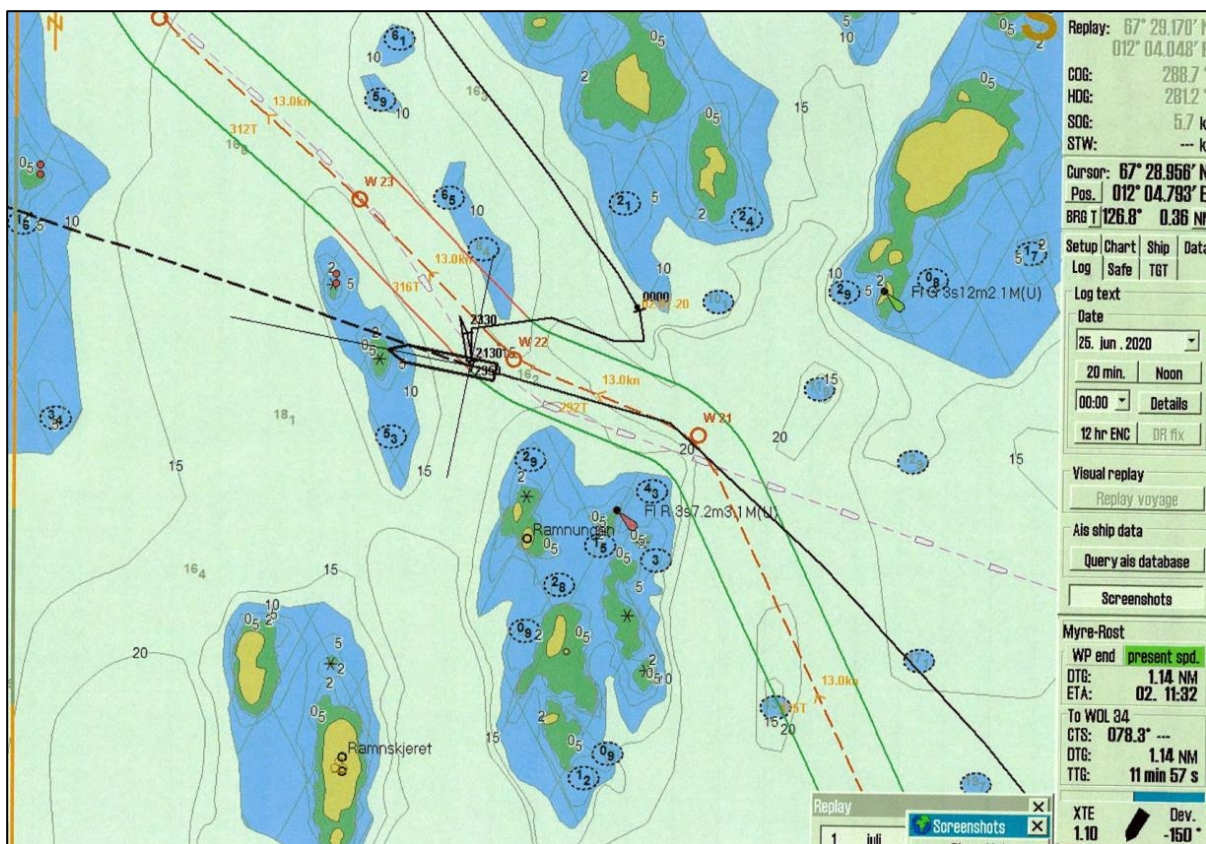
Although he pushed the joystick to starboard, the master sensed poor rudder response and he instantly ordered the engine full astern and bow thruster to starboard. A few seconds later at 2130, *Key Fighter* struck a rock and ran grounded in position 67° 29.15' N 012° 04.02' E (Figure 3).

Figure 3: ECDIS Image showing vessel's track and position of grounding

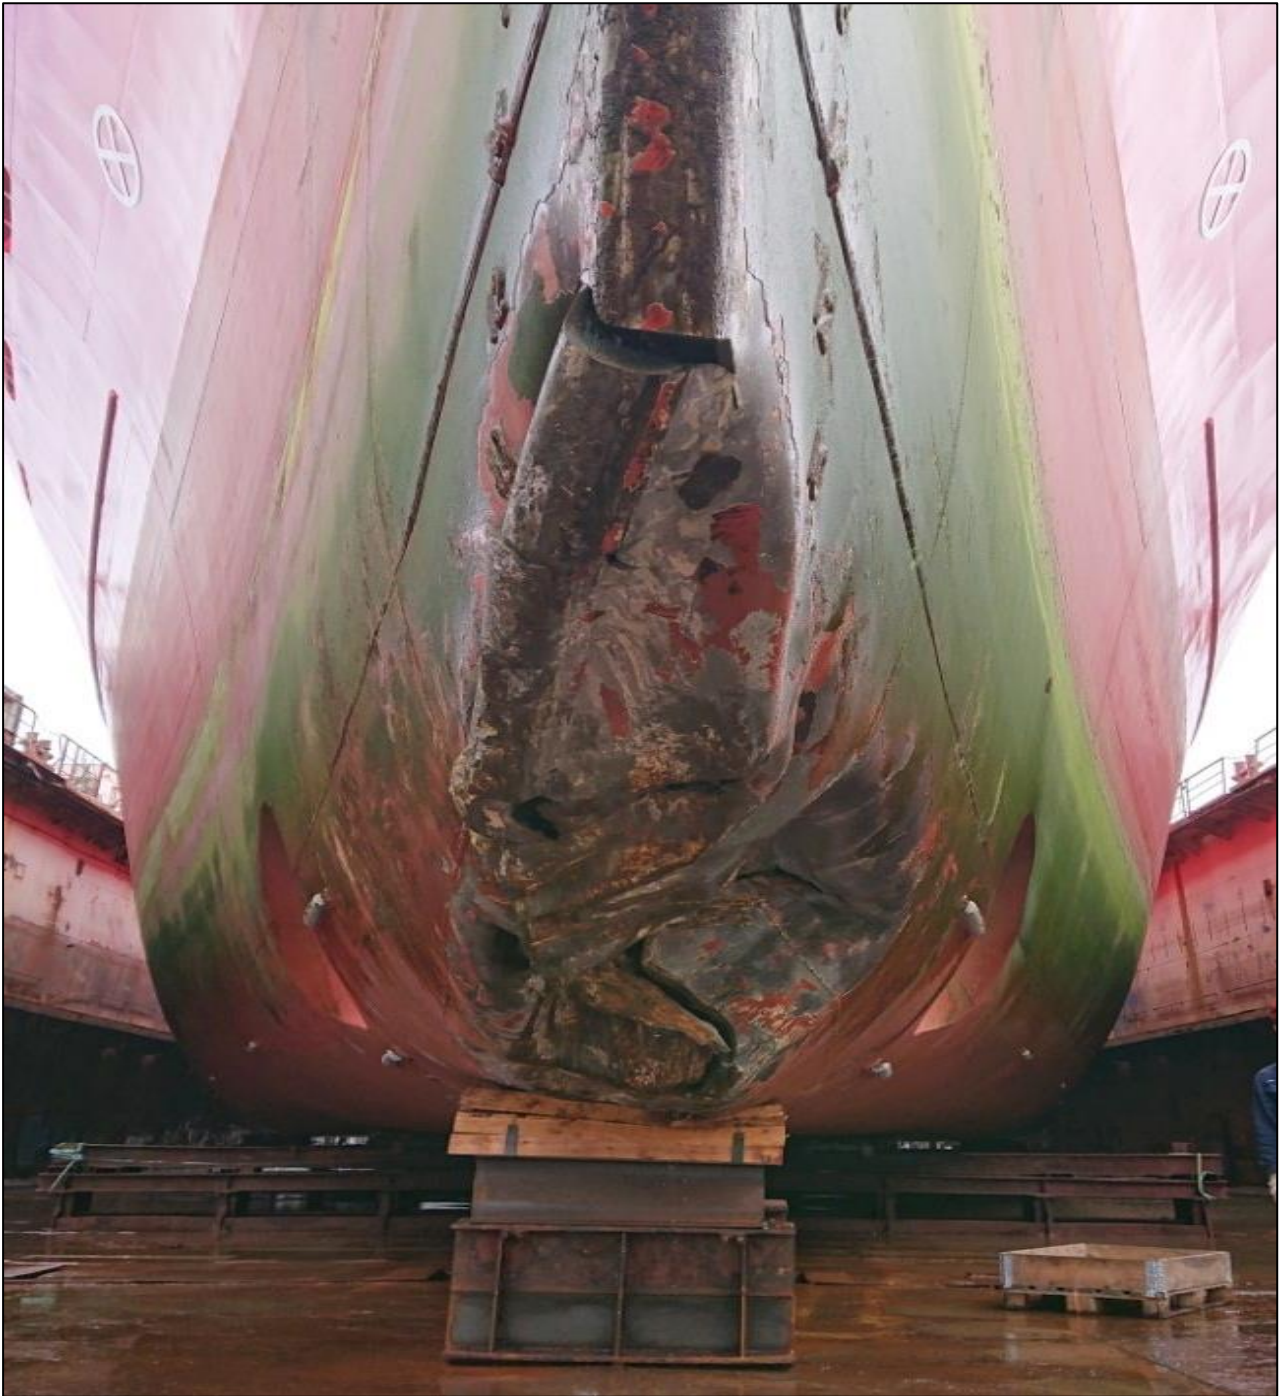
No injuries and pollution were reported. However, the vessel sustained extensive material damage and ruptured her hull.

The vessel sustained structural damage (Figure 4), but neither pollution nor injuries were reported.

Figure 4: Structural damage to the vessel's stem and hull

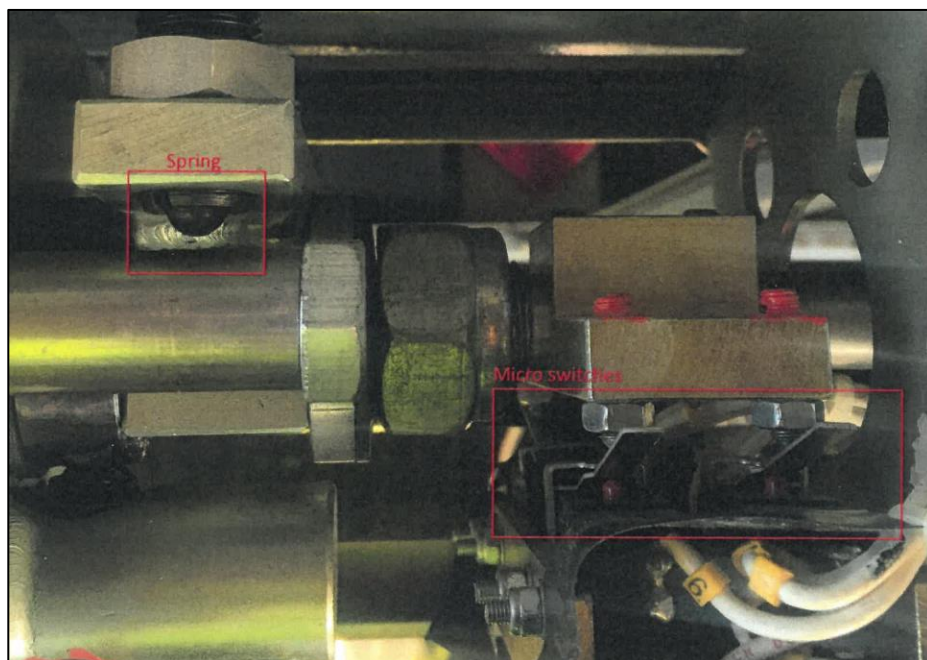
On 03 July, following the grounding, a service technician inspected the steering control system. The technician reported that the spring to prevent activation of micro switches in the wheel assembly unit, on starboard side was defective (Figure 5), "resulting in activation of micro switches on SB side by accident or by itself as there is nothing to stop it." The technician explained that when activated, the vessel would turn to starboard and at the same time, disabling the joystick, autopilot and one steering gear pump.

Figure 5: Spring and micro switches on wheel assembly unit

He further noted that the design of the steering gear system was such that the activation of the steering wheel would disable the autopilot and joystick function. In Esbjerg Shipyard, the steering system was further examined by service engineers, the defective spring was replaced. Tests on the rudder movement indicated that they were within the prescribed limits.

1. The grounding was caused by the vessel's deviation from the planned route because of loss of directional control;
2. The spring for preventing activation of microswitches on starboard side in the steering wheel unit was found to be defective;

- the steering gear system, including electronics and hydraulics were inspected by service engineers and the worn-out parts were replaced;
