Report 2021/000514

## Report on the investigation

into a fire

on board **TSHD UILENSPIEGEL**

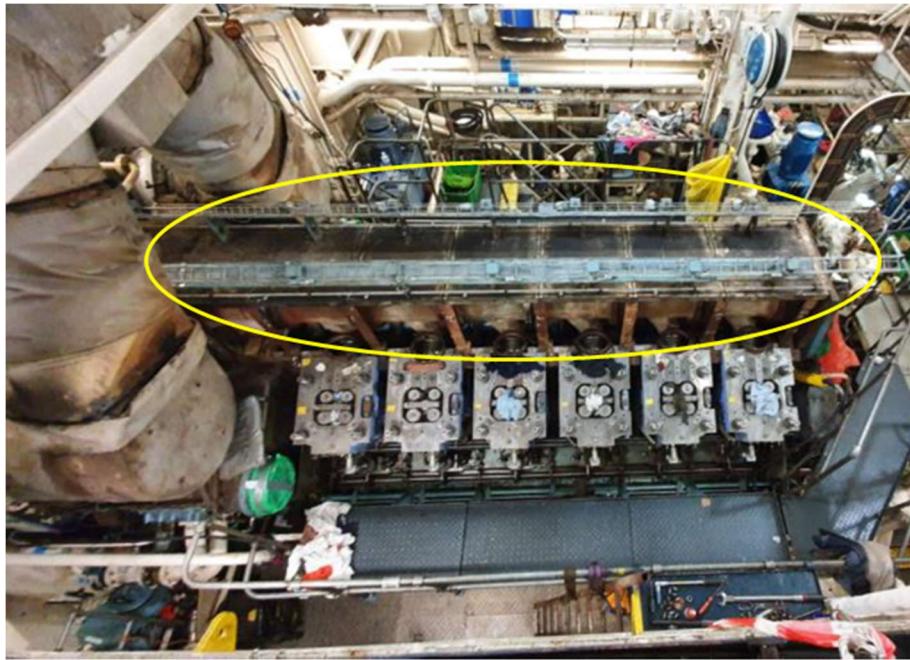
Figure 2 – Exhaust of PS main engine

At 15:15 hours, the PS main engine started smoking and very shortly thereafter, flames were observed at the exhaust of PS main engine in the engine room, as indicated in Figure 2.

*This picture was taken when the engine was not completely assembled yet. The structure in the middle, marked with a yellow circle, is the exhaust line covered with insulation panels.*

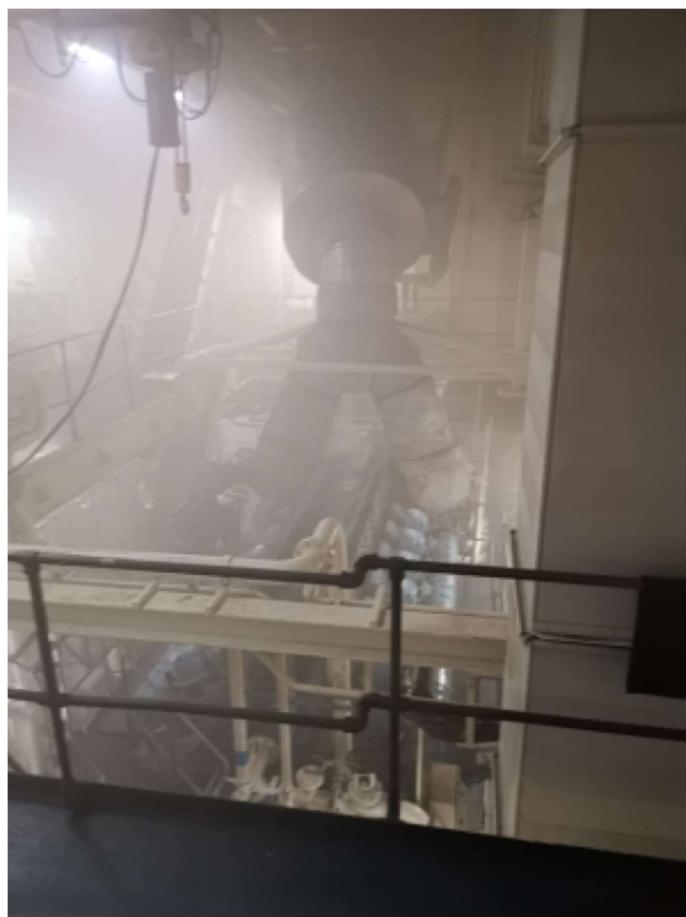
Smoke was observed inside the engine room, but no flames were visible, as shown in Figure 3.

*Figure 3 - Smoke inside the engine room*

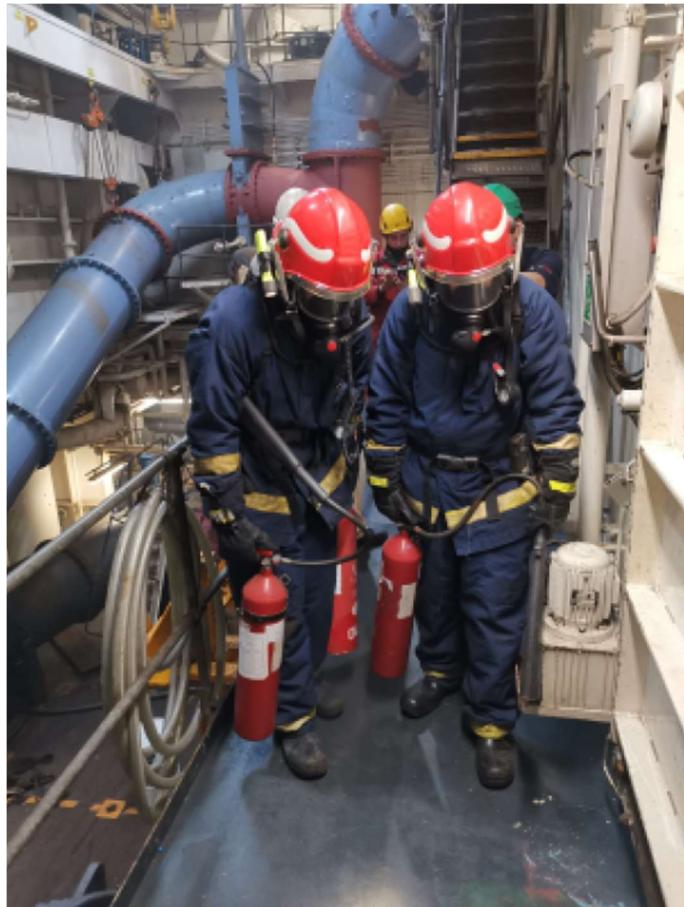
After leaving the engine room again and waiting for another 20 minutes, the fire team entered the engine room with 3 CO<sub>2</sub> fire extinguishers to cool down the exhaust line of the PS main engine, as shown in Figure 4<sup>1</sup>.

*Figure 4 - Shipboard fire team equipped with CO<sub>2</sub> fire extinguishers*

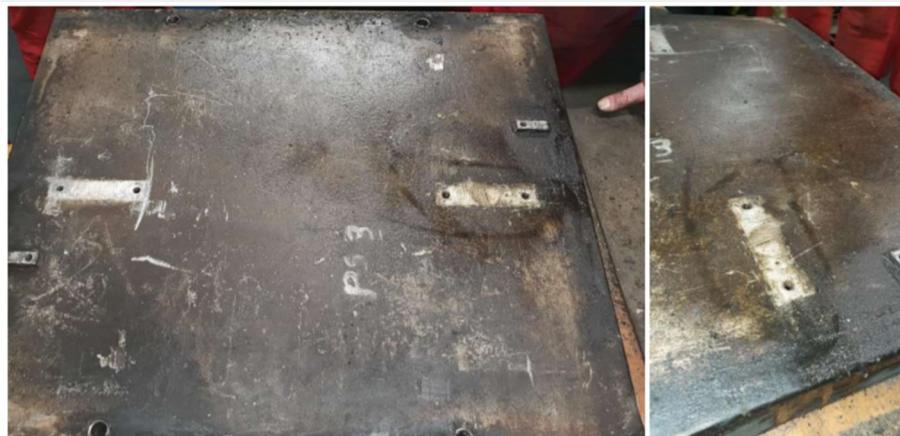
After the fire, it was observed that insulation panel PS3 was covered with an oily substance, especially around the bolt holes. This is shown in Figure 5.

Figure 5 - Oily substance on top of insulation panel PS3

| <b>Incident Barrier Failed</b> | <b>Performance</b> | <b>Barrier Challenge</b> | <i>Remarks regarding performance</i> |
|---|---|---|---|
| Condition of disassembled parts | BFA Primary Causes | Work preparation | The insulation of PS main engine got contaminated with oil when maintenance on the thermal oil line above the stored insulation was carried out. |

The fire was caused because insulation panels contaminated with oil were installed during the re-assembly of the main engine.

- The inspection of the condition of the exhaust insulation before reinstallation had been added to the company's quality card for tasks during the overhaul of a main engine.

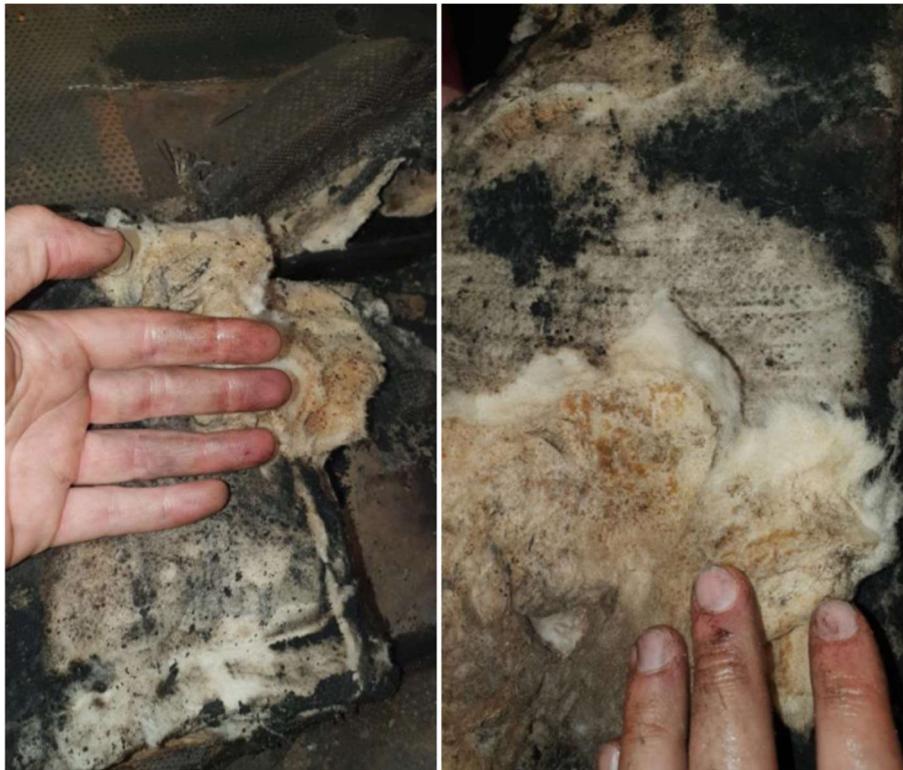
The insulation felt greasy, as indicated in Figure 6.

A small test was executed by the crew to test the flammability of the greasy insulation. When it was exposed directly to a flame, the insulation caught fire immediately and kept on burning.

*Figure 6 - The insulation felt greasy after the fire*

To test the flammability of the greasy insulation, the crew exposed a part of it directly to a flame. It was observed that the insulation caught fire immediately and kept on burning.
