MONTHLY SAFETY SCENARIO

SEPTEMBER 2021

Broken davit wire on rescue boat

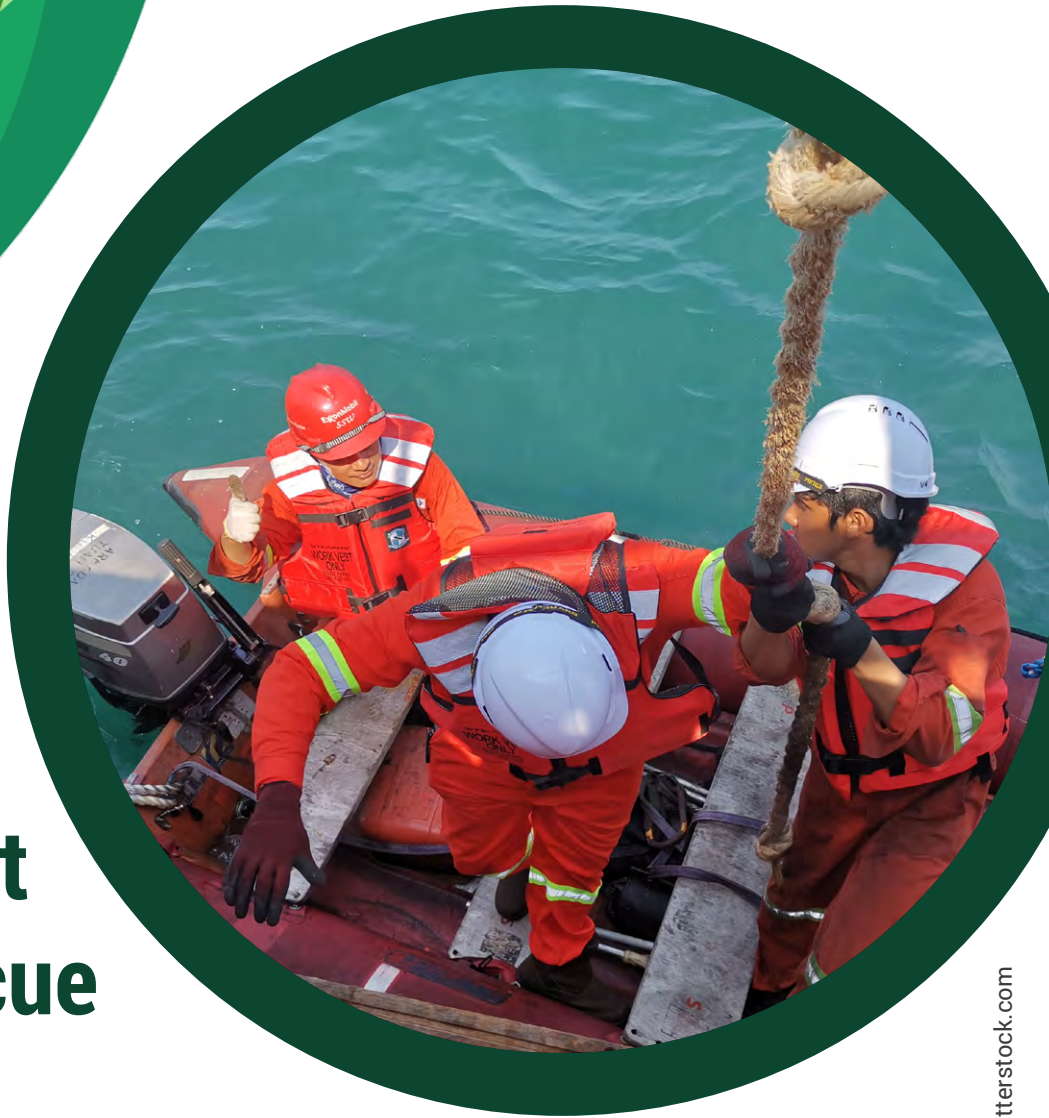
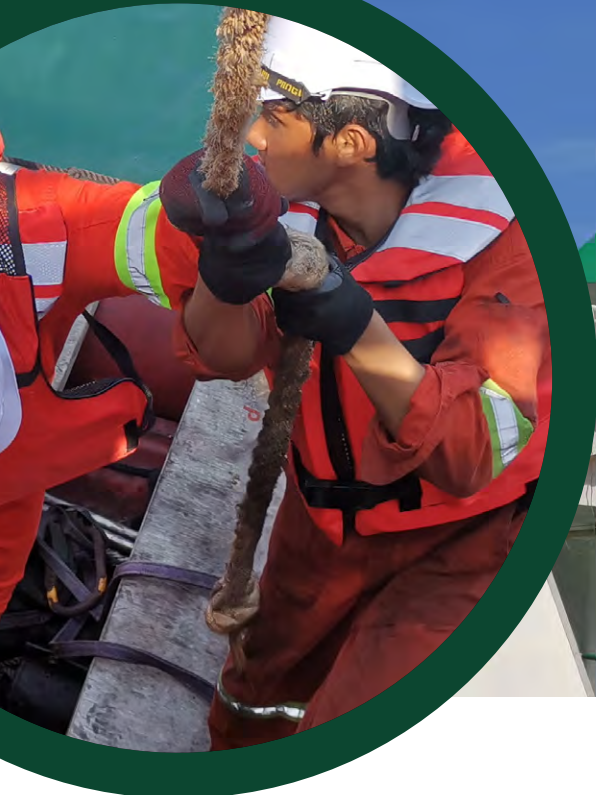
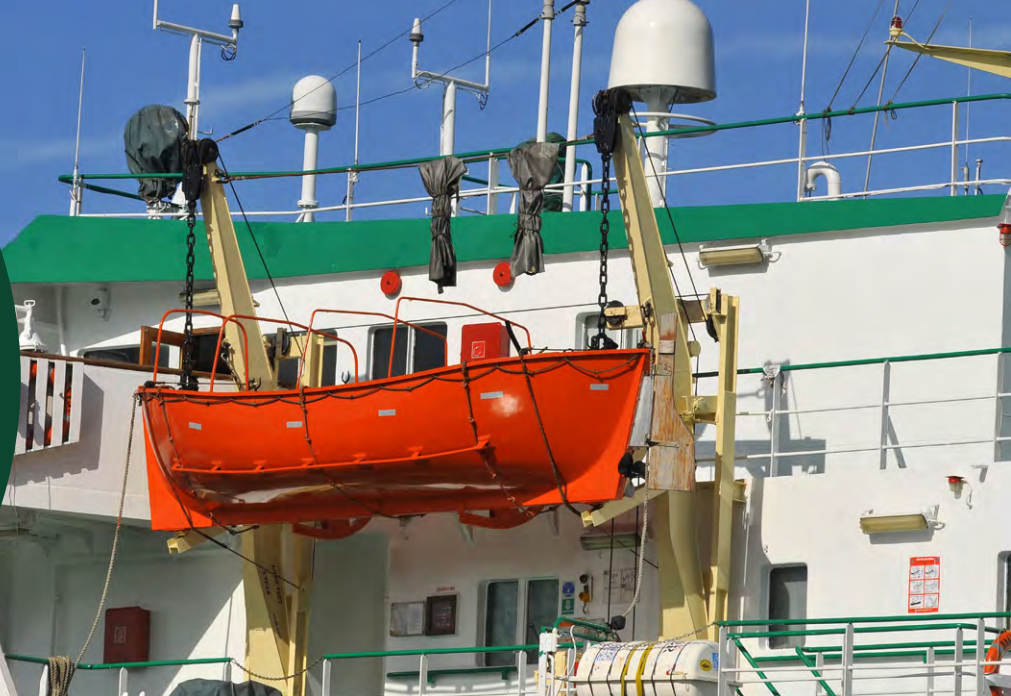
The bosun continued to hoist the boat at slow speed to the stowed position and expected that the proximity switch would shut down the motor before the davit arm made contact with the structure. Unfortunately the proximity switch

was not operational and so this did not happen and the motor applied even more power.

This sudden increase in power caused the wire to break and the boat to fall more than 20 metres into the water, taking the crew members with it.

1. The Chief Officer was unaware that the davit winch motor was too strong for the replacement davit wire.
2. While in dry dock an electrician had replaced the fuse in the circuit board of the davit winch motor. He had replaced the original fuse with a much higher amperage fuse.
3. It was also the case that the electronic proximity switch was not working. When the rescue boat had been washed down with the high-pressure hose, moisture had entered the system through the cover of the proximity switch, causing a short circuit.

The proximity switch is intended to cut power to the winch motor when the boat is close to being in the stowed position. This is an emergency device to ensure that the winch motor does not put too much stress on the davit wire. It is essential for preventing possible catastrophic failure. The davit had only one proximity switch so there was no back-up.
