# ACCIDENT REPORT

REPORT NO 12/2021

SEPTEMBER 2021

## Fatal crush accident while a gantry crane was moving a hatch cover on board the general cargo vessel *Cimbris*, at Antwerp, Belgium, on 14 July 2020

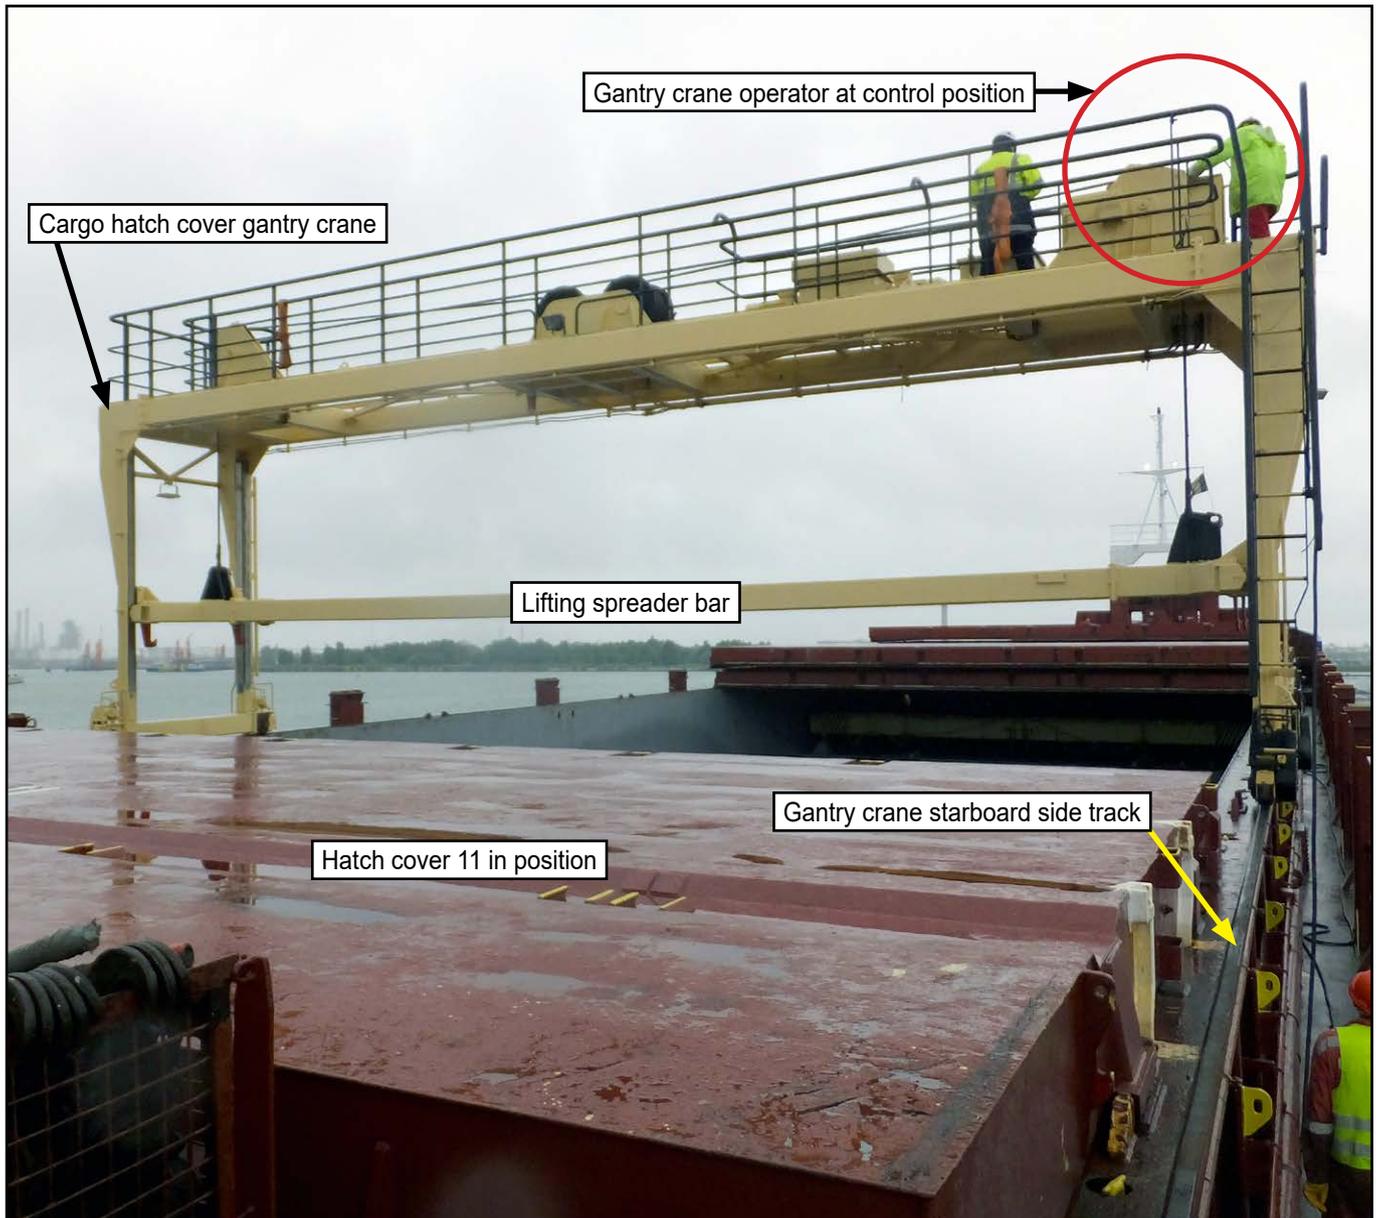
**Figure 1:** *Cimbris*' hatch cover gantry crane (photograph taken from the vessel's starboard side, looking forward)

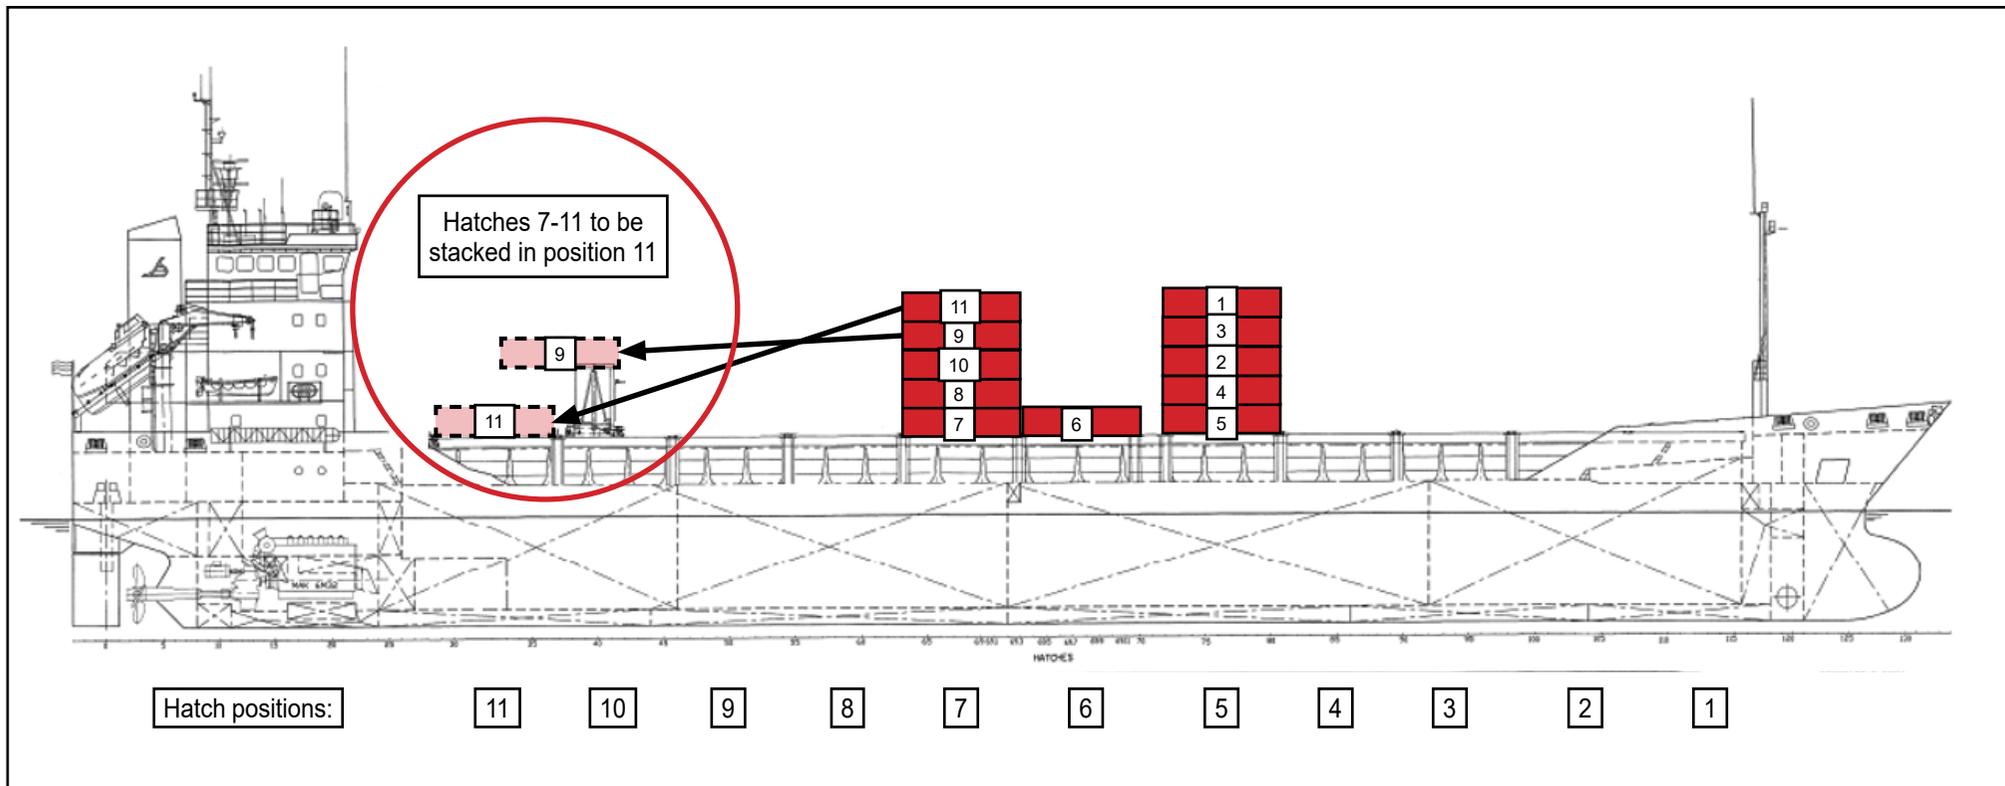
**Figure 2:** Hatch configuration before and at the time of the accident

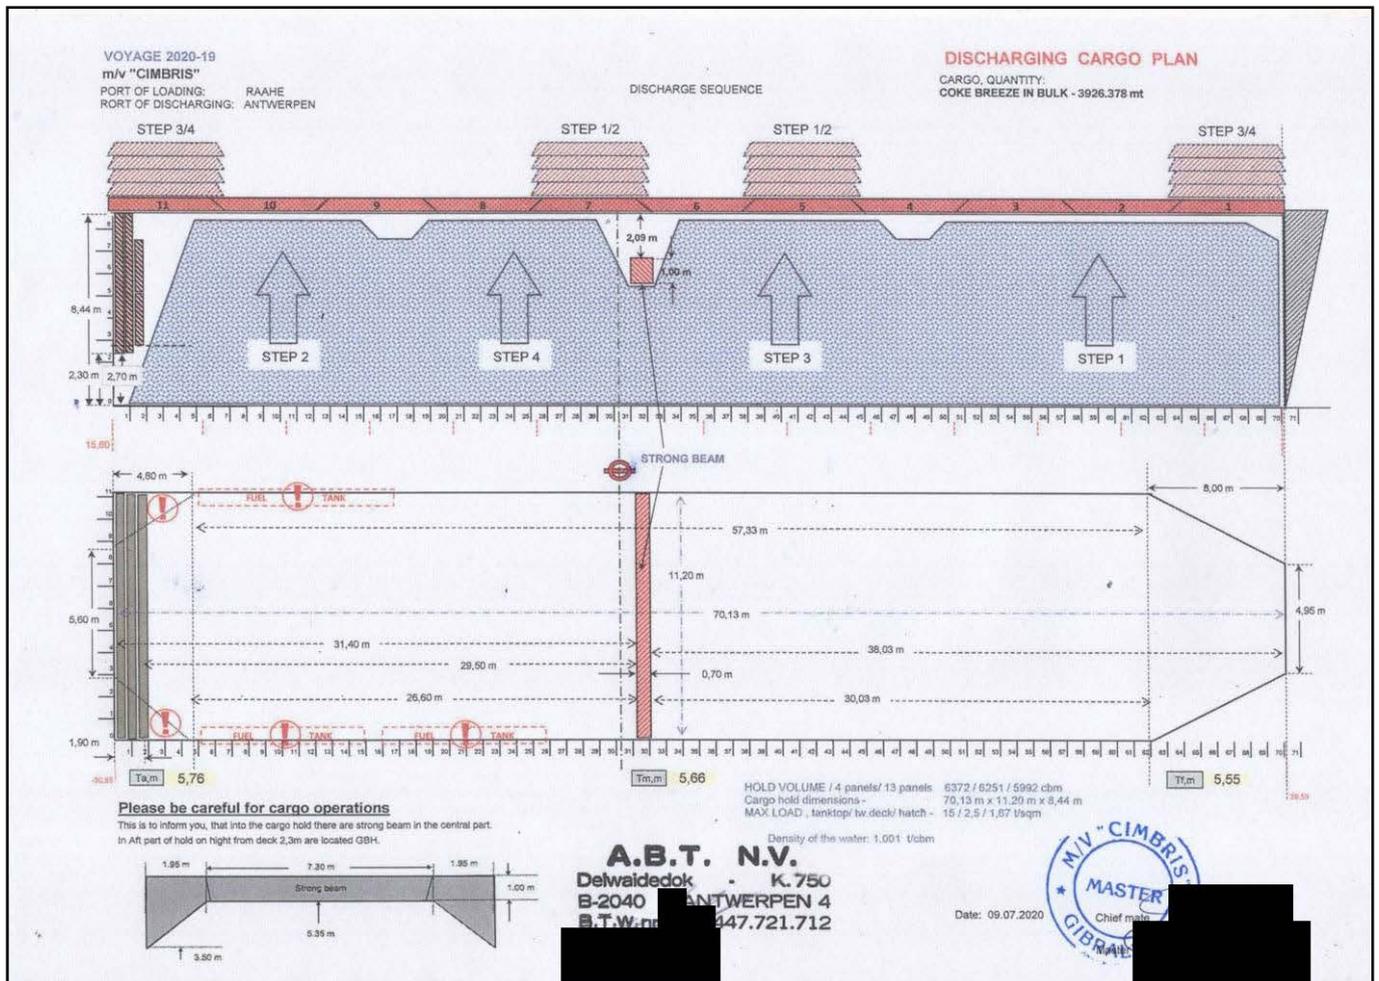
Figure 3: Cimbris' cargo discharge plan

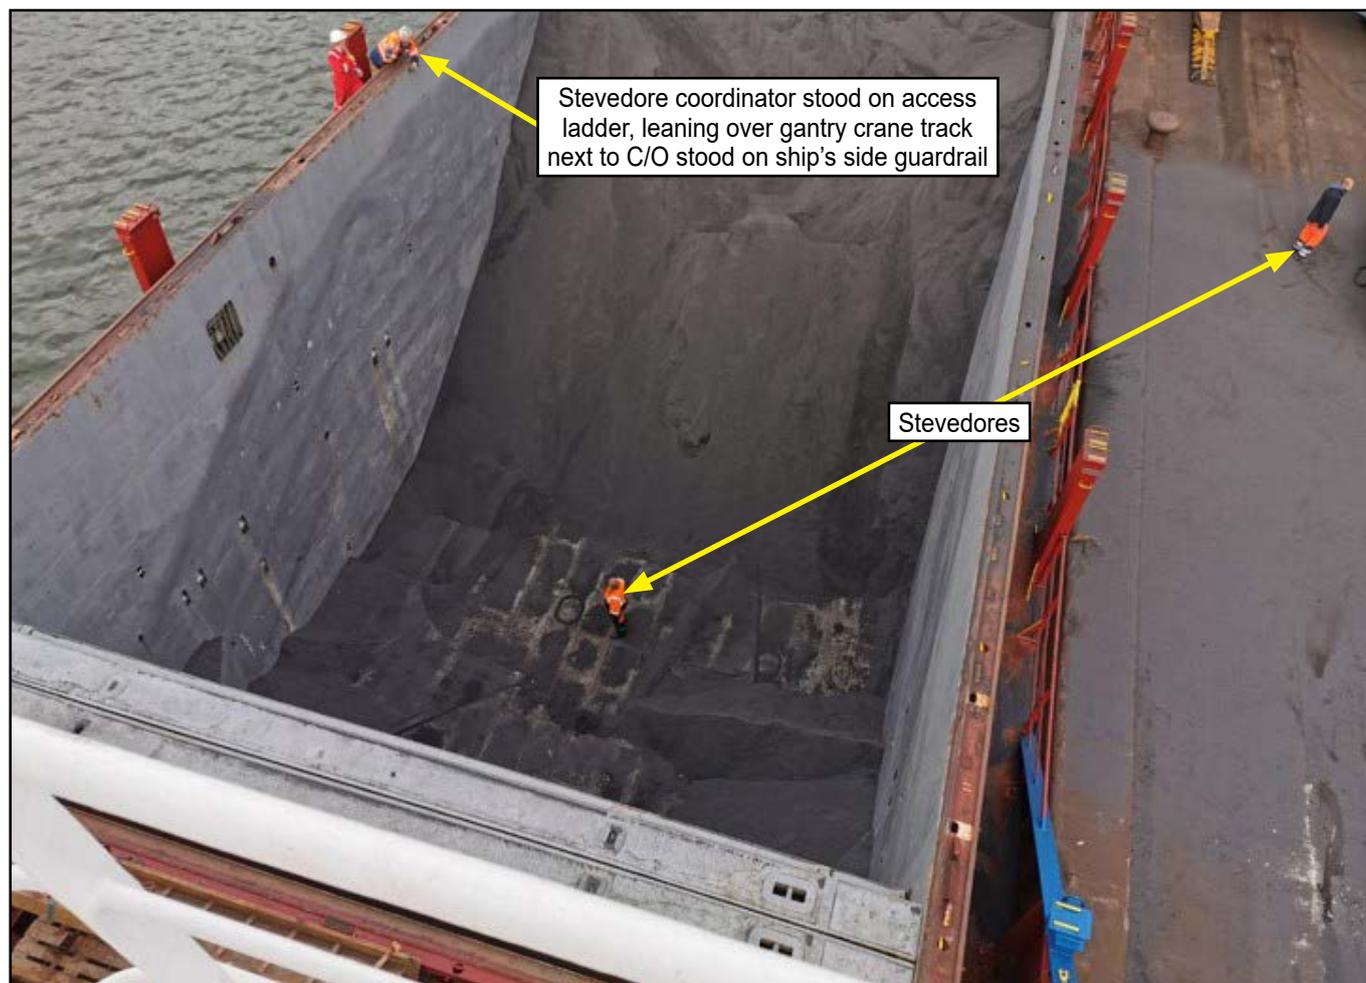
**Figure 4:** Photograph taken by ship's crew prior to front-end loader being lowered into aft end of cargo hold

Exactly when and why the stevedore coordinator placed himself in the path of the moving crane is unclear. However, it is most likely that his intention was to lean over the hatch coaming and communicate with, or assess the progress made by, the stevedores working in the hold. The port workers could communicate with each other using their handheld radios; however, it was standard practice for the stevedore coordinators to climb onto the hatch coaming to observe and shout down to the team working in the holds below (**Figures 4 and 8**).

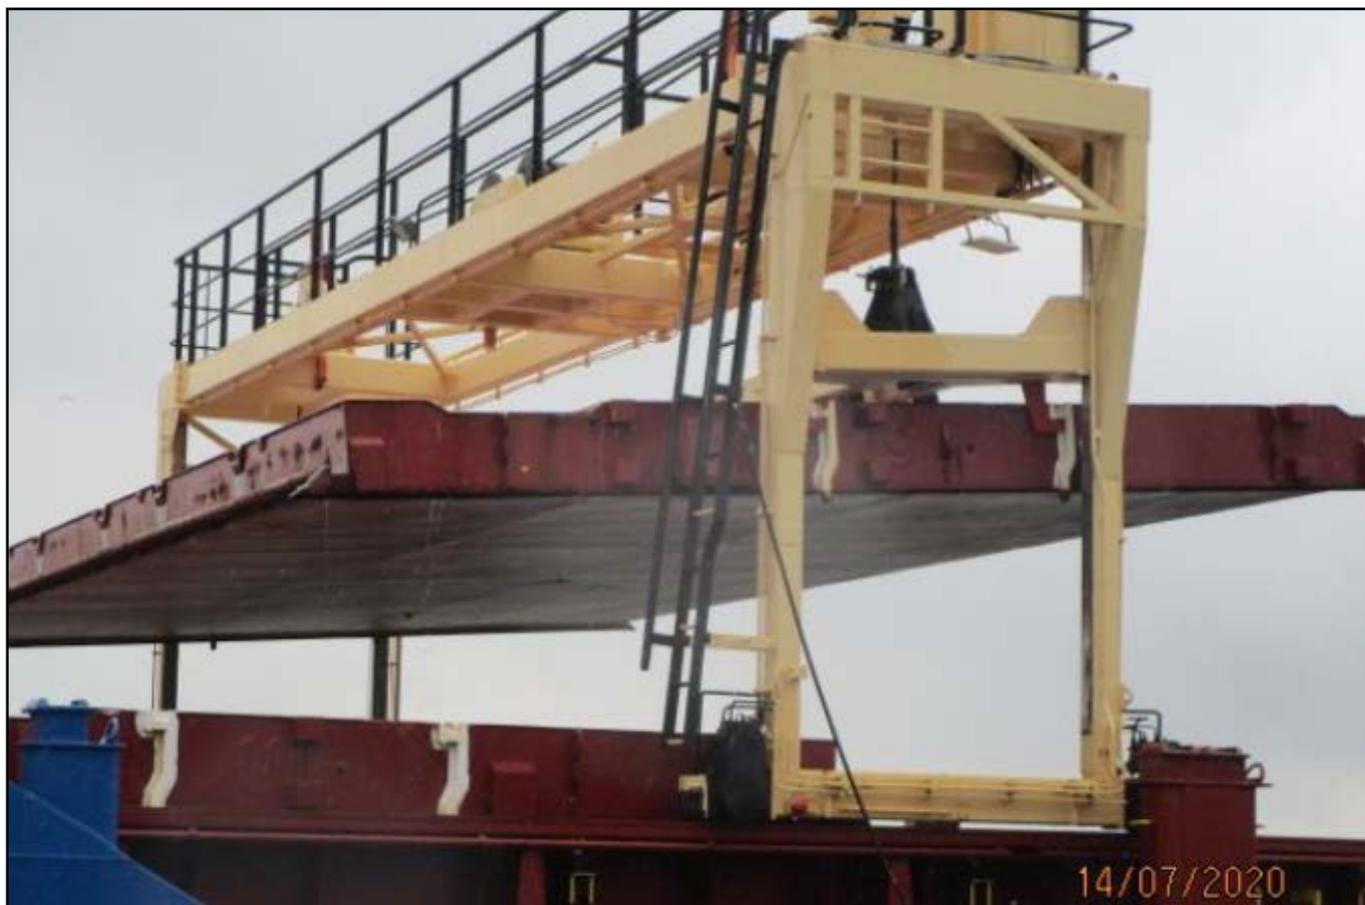
At about 0900, as the C/O drove the gantry crane over hatch cover position 10, the crane suddenly stopped (**Figure 5**). The C/O did not know why the crane had stopped, but the stevedore foreman, who saw the stevedore coordinator's head appear above hatch cover 11 on the port side, immediately realised that there had been an accident and shouted up to the C/O. The C/O climbed down from the crane and ran with the foreman to the port aft walkway, where they found the stevedore coordinator wedged between the aft leg of the gantry crane and hatch cover 11, a gap of approximately 130mm (**Figure 6**).

**Figure 5:** Gantry crane (in accident position) with hatch cover 9 suspended

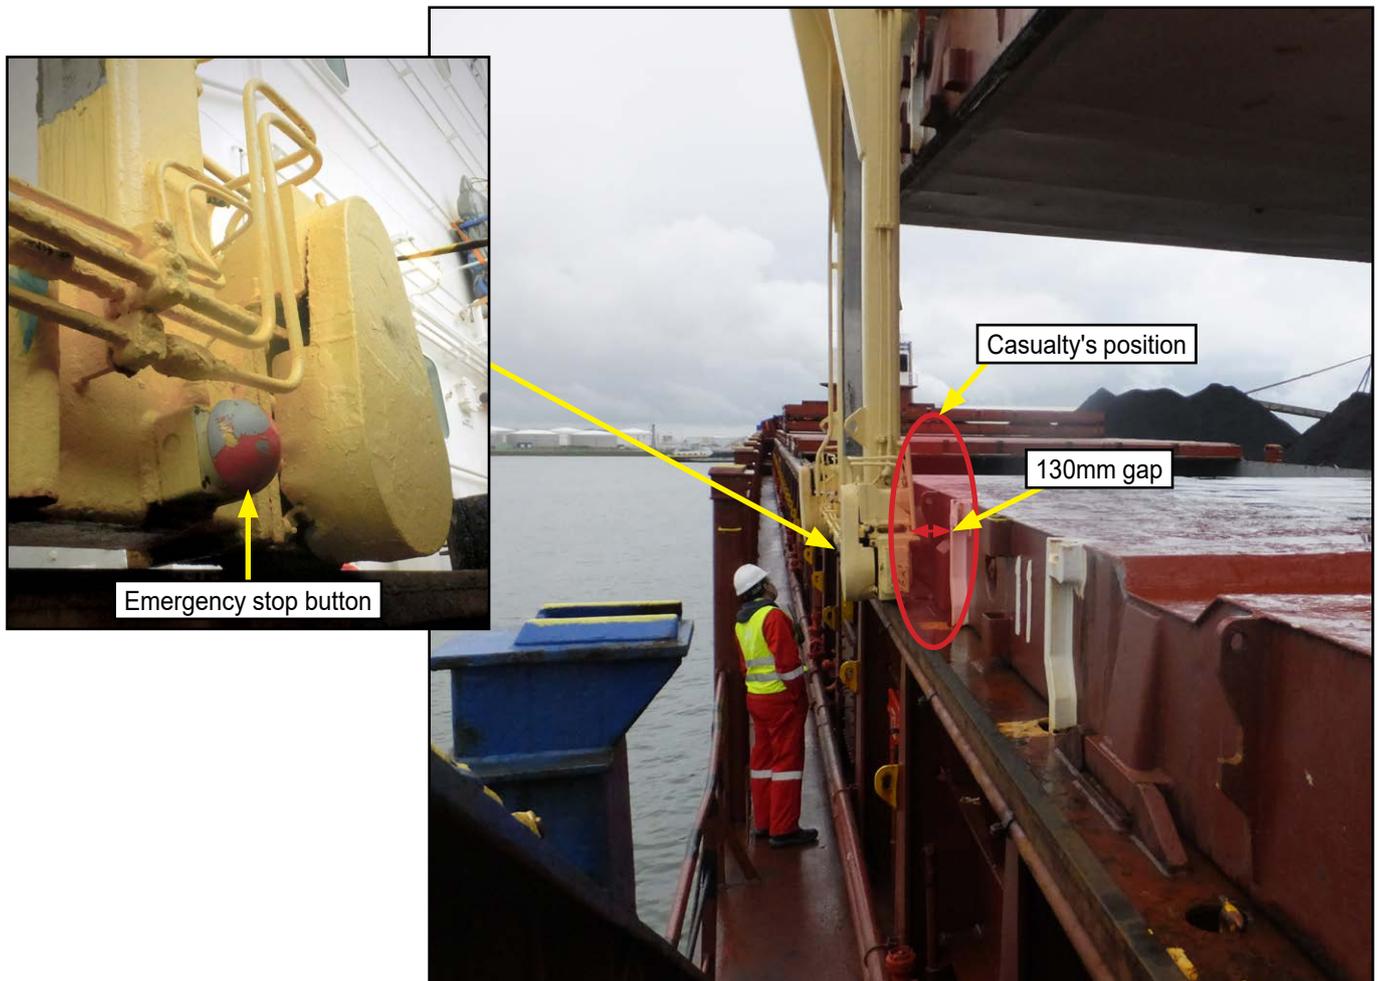
The gantry crane was inspected and its emergency stops, movement warning bell and flashing light were tested and found to be operating correctly. The warning bell was loud and, although it was not possible to replicate the sound of the front-end loader engine in the hold, it was considered unlikely that the bell would have been drowned out by the ambient noise at the time of the accident. The gantry crane flashing light was clearly visible, even in daylight, but the suspended hatch cover obscured it from the position the stevedore coordinator was found as the crane and suspended hatch cover approached. When in motion, the crane caused significant vibration, which could be felt when leaning over the hatch coaming.

**Figure 6:** View of location where stevedore coordinator was discovered with inset showing position of emergency stop button

When the C/O moved the first hatch cover aft (hatch cover 11), the stevedore coordinator was working at the forward end of the cargo hold. At about the time the C/O was preparing to move the second hatch cover, the stevedore coordinator walked aft to check on the team working in the aft part of the hold. At some point before the accident, the stevedore coordinator must have climbed up the side of the hatch coaming and positioned himself between the moving gantry crane and hatch cover 11. Once trapped, he was unable to alert the C/O or stop the crane. This was probably because he had little time to react and was unable to reach the emergency stop positioned on the outer side of the crane structure (**Figure 6**).

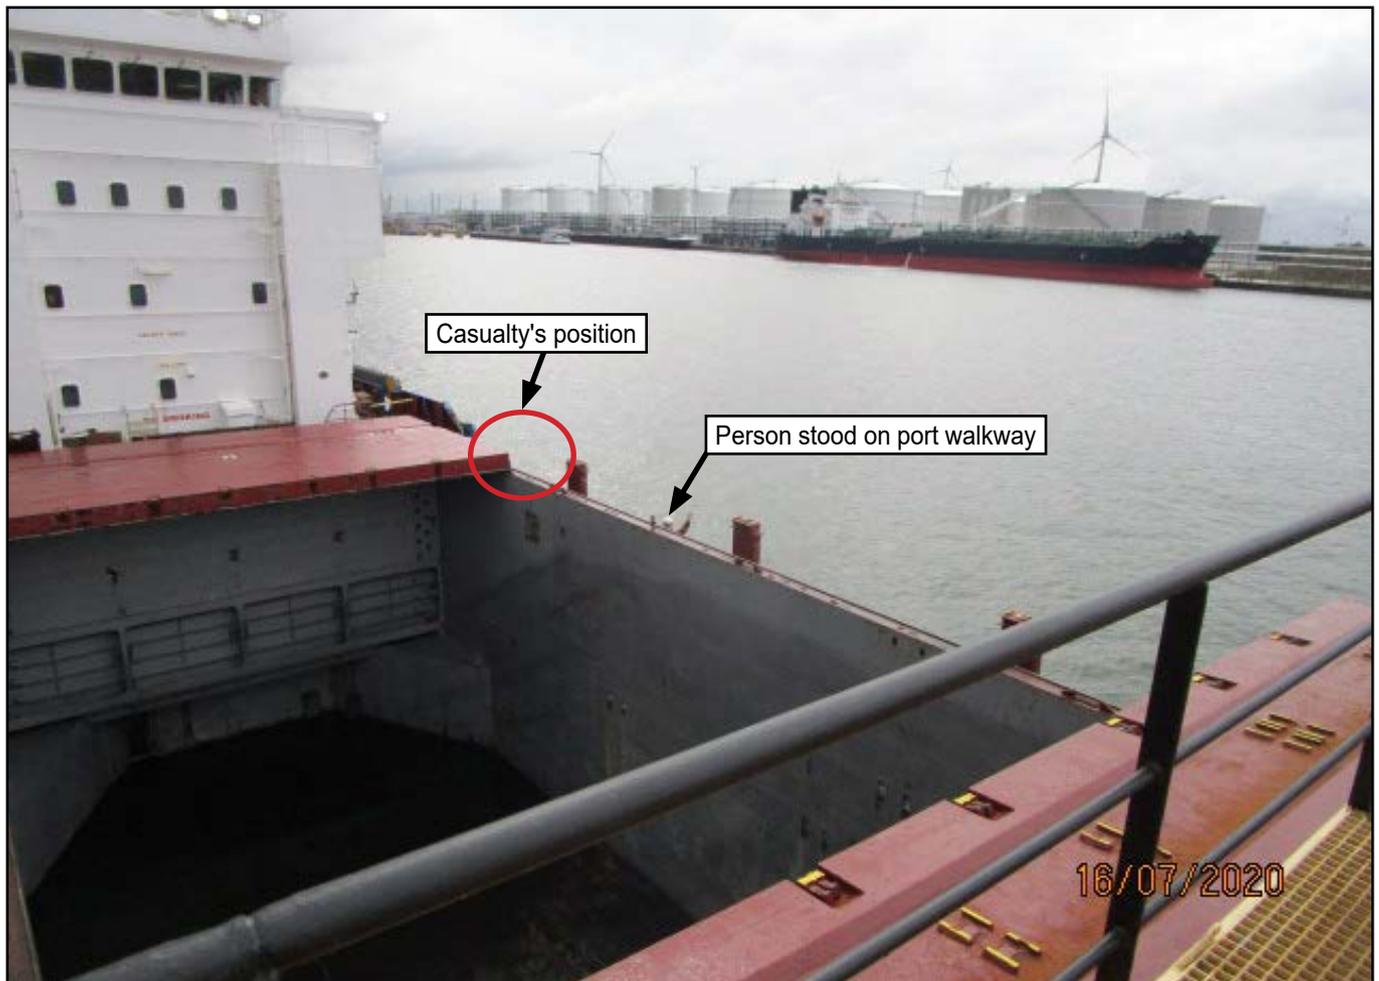
**Figure 7:** View from gantry crane control position toward location where stevedore coordinator was discovered

While it might have been difficult to spot a person standing on or walking along the port walkway (**Figure 7**) from the gantry crane control position, the stevedore coordinator would have been clearly visible had he climbed on to or leant over the top of the hatch coaming. This was particularly so given that the stevedore was wearing high-visibility clothing. It is therefore unlikely that the stevedore coordinator was on the hatch coaming before the C/O started repositioning the second hatch cover.

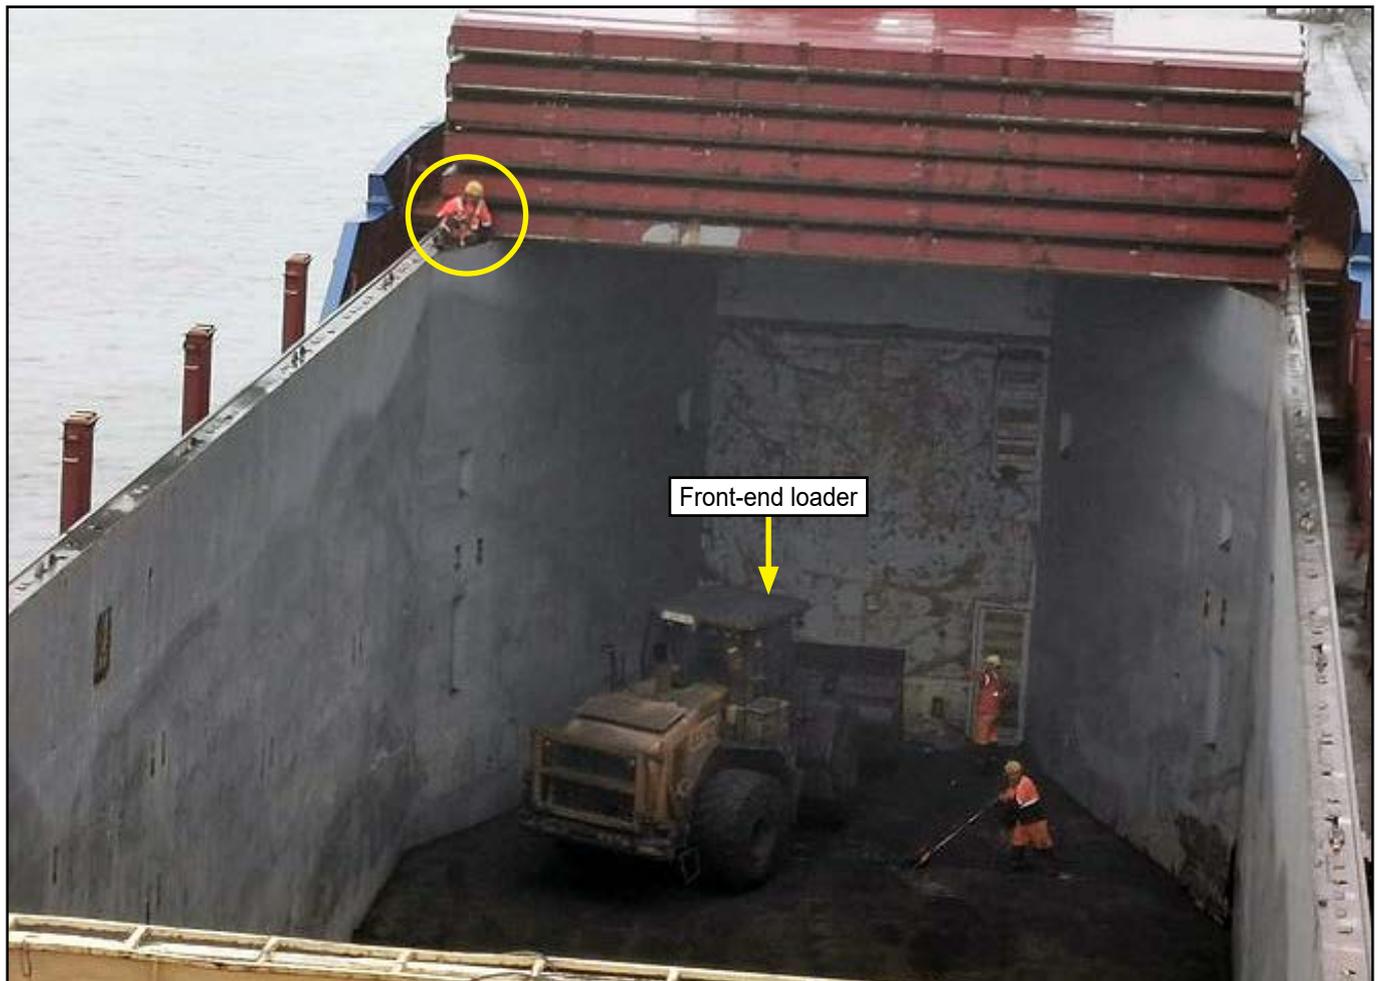
During *Cimbris'* visit to Antwerp, the vessel's crew witnessed the port stevedores carrying out several unsafe acts. On the day of the accident, these included the failure to wear hard hats (**Figure 4**) and climbing over the coaming and sliding down the cargo to access the holds. The day after the accident, the replacement stevedore coordinator was observed sitting on the hatch coaming with no form of fall restraint (**Figure 8**).

**Figure 8:** Photograph taken by ship's crew after the cargo operations resumed, showing stevedores working in the forward end of the cargo hold with a stevedore coordinator sat on top of the cargo hatch coaming
