Collision between *Accolade II* and *Sandgroper*

Off Port Adelaide, South Australia, on 29 February 2020

ATSB Transport Safety Report

MO-2020-001

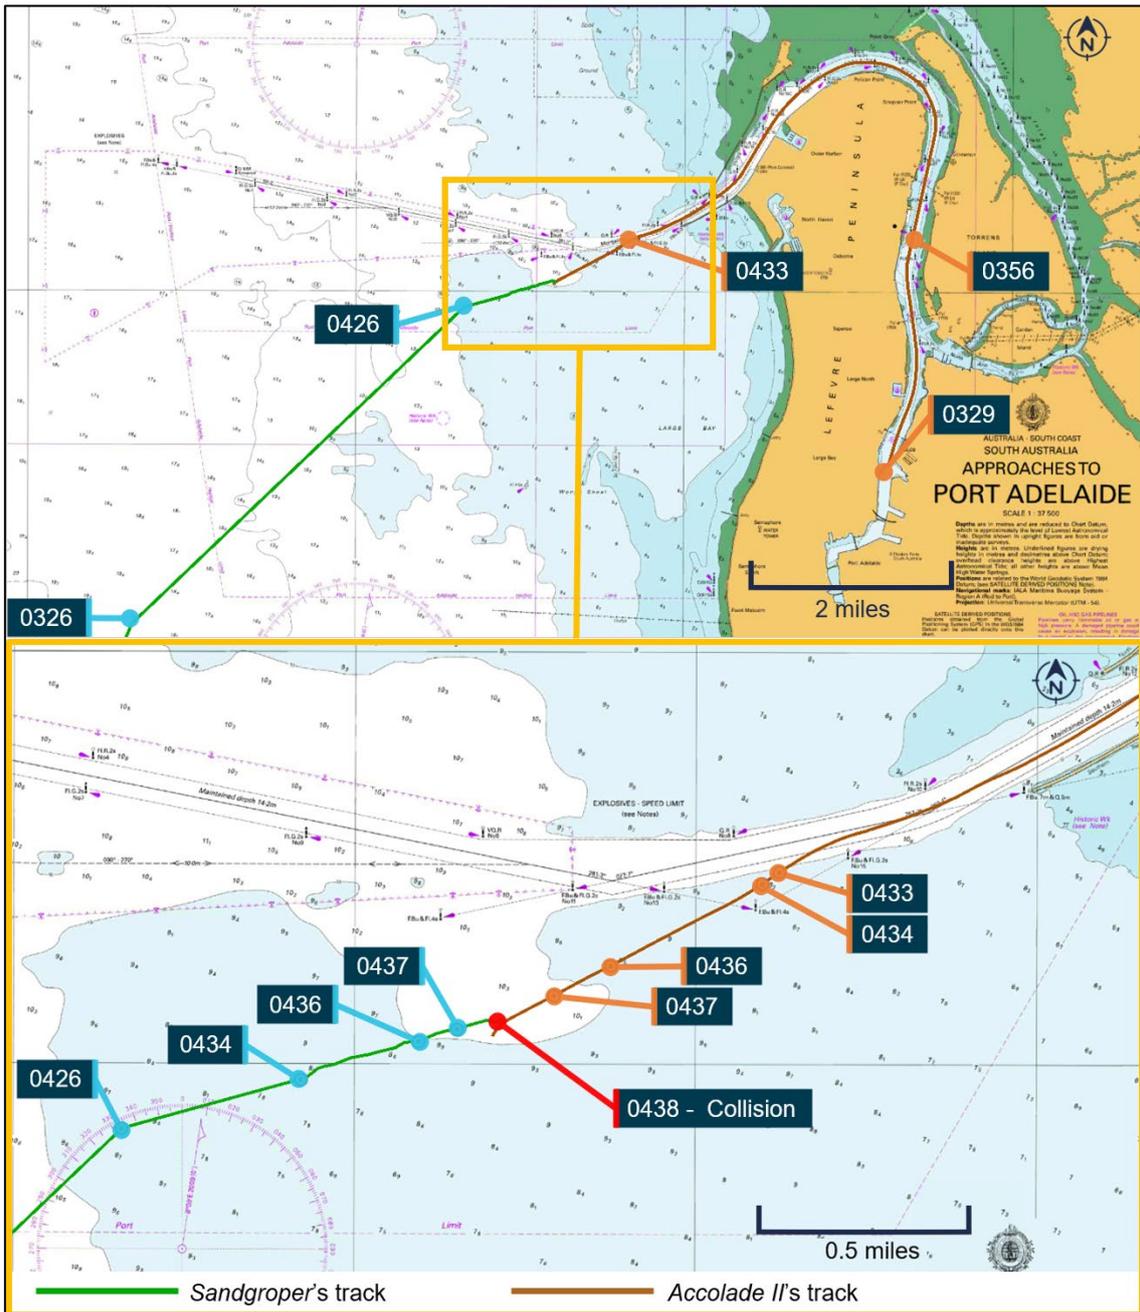
Figure 3: Sections of charts Aus 130 and Aus 138 showing sequence of the collision

Meanwhile, on board *Sandgroper*, the skipper unexpectedly saw *Accolade II*'s green sidelight at very close range. The skipper quickly put the vessel's propulsion full astern, but this had little effect. Shortly after 0438, *Sandgroper* collided with *Accolade II*'s starboard side, just forward of midships (Figure 3).

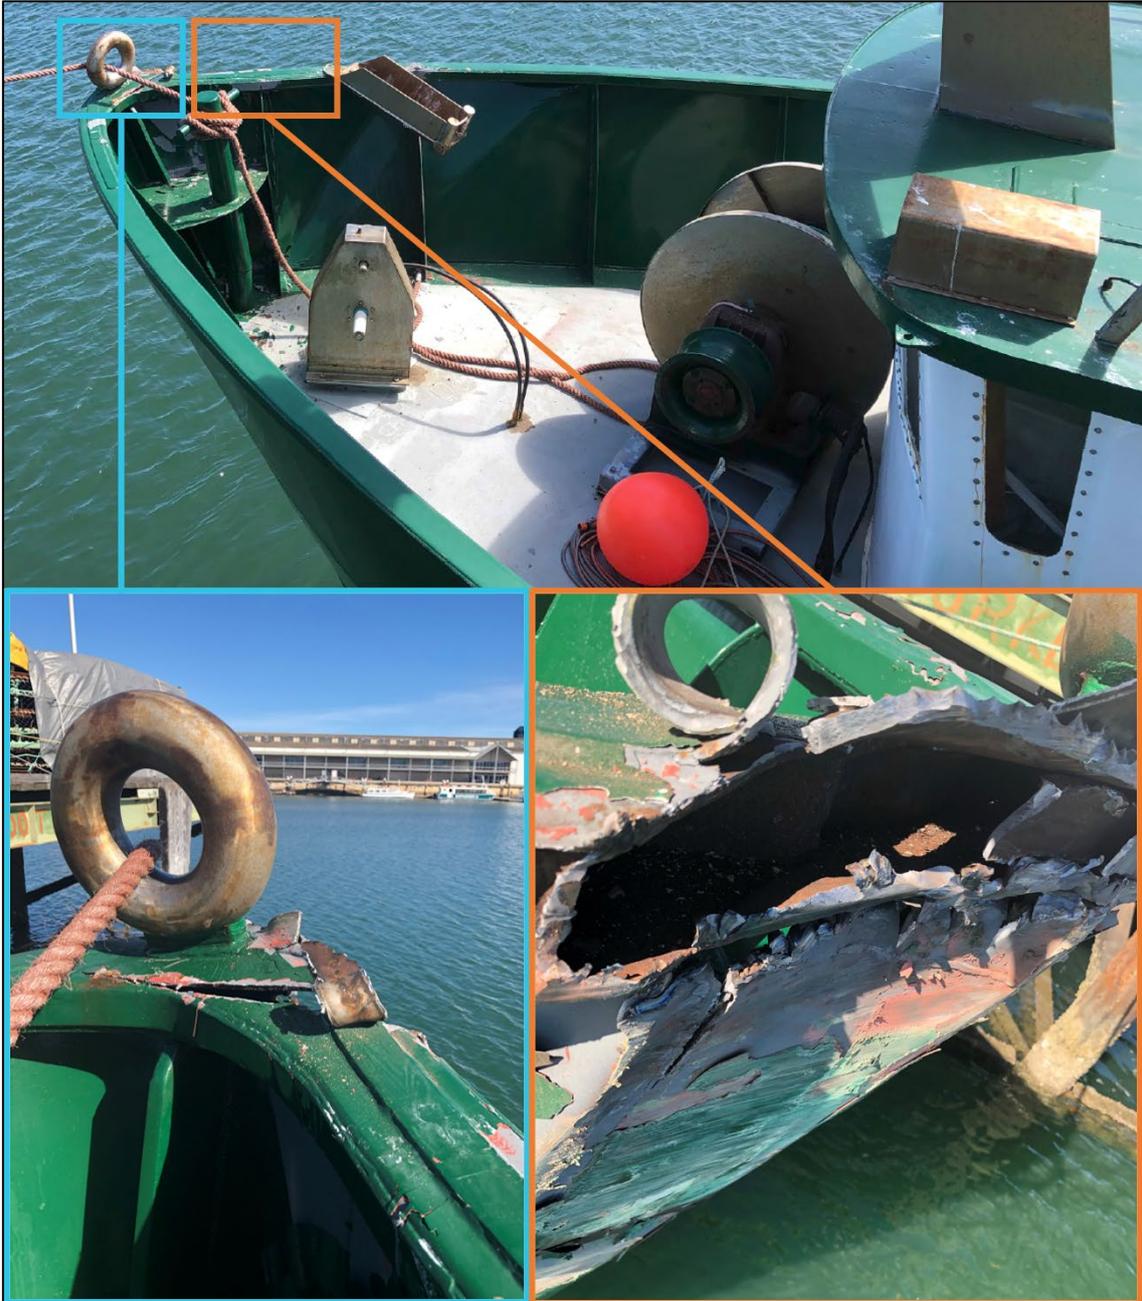
Figure 4: Damage to *Sandgroper*

Sandgroper sustained significant structural damage to the starboard bow (Figure 4) with some minor damage to the vessel's port side as well. Additionally, *Sandgroper's* anchor was lost from the vessel's bow and was found lodged in *Accolade II's* deck railings.

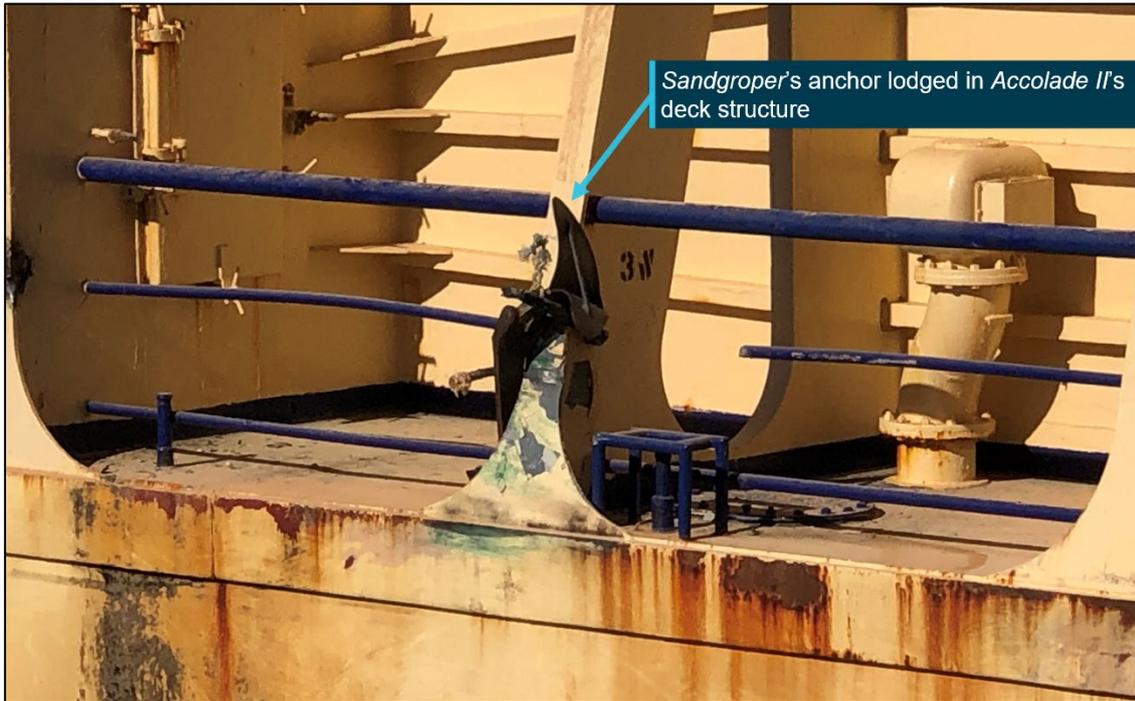
Figure 5: Damage to *Accolade II*

Accolade II sustained relatively minor damage to deck structures and railings on the ship's starboard side as a result of the collision (Figure 5).

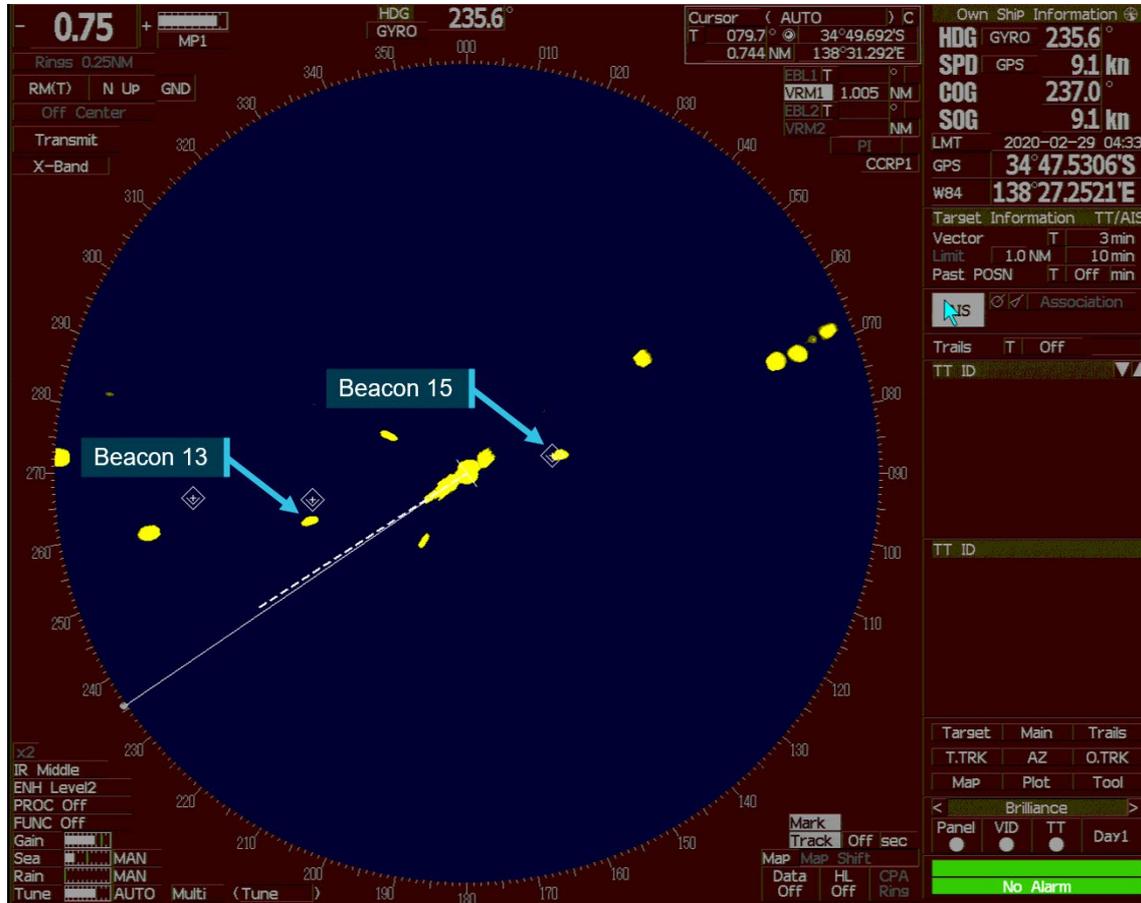
Figure 6: Set-up of *Accolade II*'s radar as it exited the channel at 0433

During the bridge pre-departure checks, the cursor was moved to the right of the display, over the AIS information menu item (Figure 6). The cursor's position and other radar settings remained unchanged for *Accolade II*'s passage through Port Adelaide River and channel.

The radar image at 0433 shows *Accolade II* departing the channel with the radar settings unchanged from the ship's departure. Note that the radar display was centred on a 0.75 mile range scale and that *Sandgroper*'s radar echo was not visible with these settings.

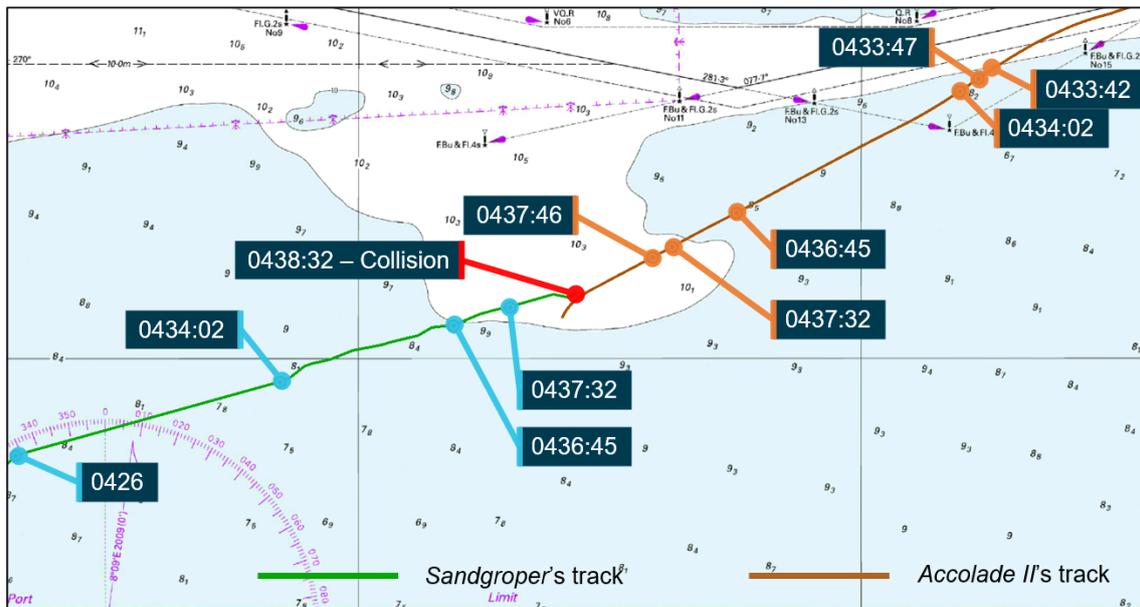
Figure 7: Section of chart Aus 138 showing events leading up to collision

0437:46	<ul style="list-style-type: none"> Master ordered the chief mate to 'go more south...'
0438:02	<ul style="list-style-type: none"> Ship's heading began to alter to port (Figure 9)
0438:32	<ul style="list-style-type: none"> <i>Sandgroper</i> collided with <i>Accolade II</i>.

Note that *Sandgroper*'s actual track between 0426 and 0434:02 is an approximate track as there was no positional data available for the vessel between these times

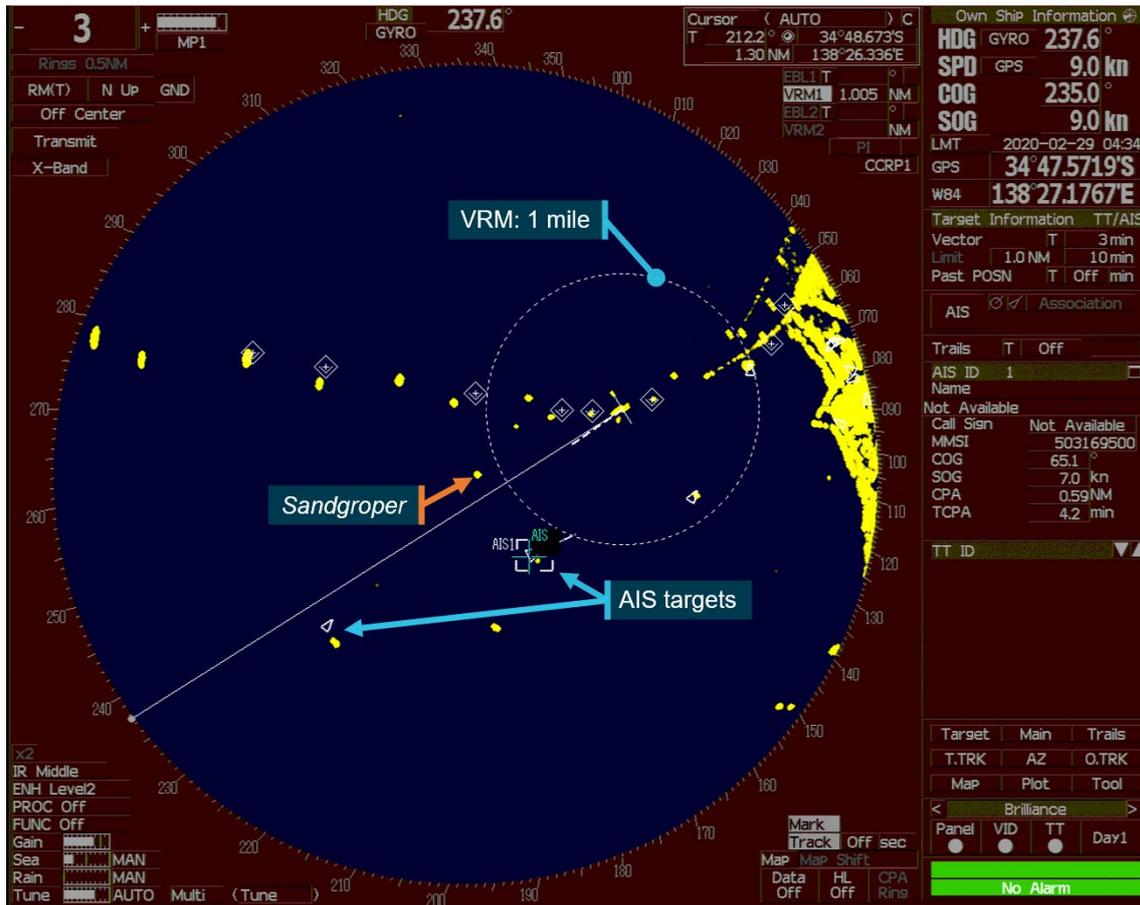
Figure 8: *Sandgroper's* first appearance on *Accolade II's* radar at 0434:02

The radar image at 0434:02 shows that as soon as the range scale was increased from 0.75 miles to 3 miles and the 'Off Center' view was selected, *Sandgroper's* radar echo immediately became visible on the radar display.
 Source: *Accolade II's* VDR, annotated by the ATSB

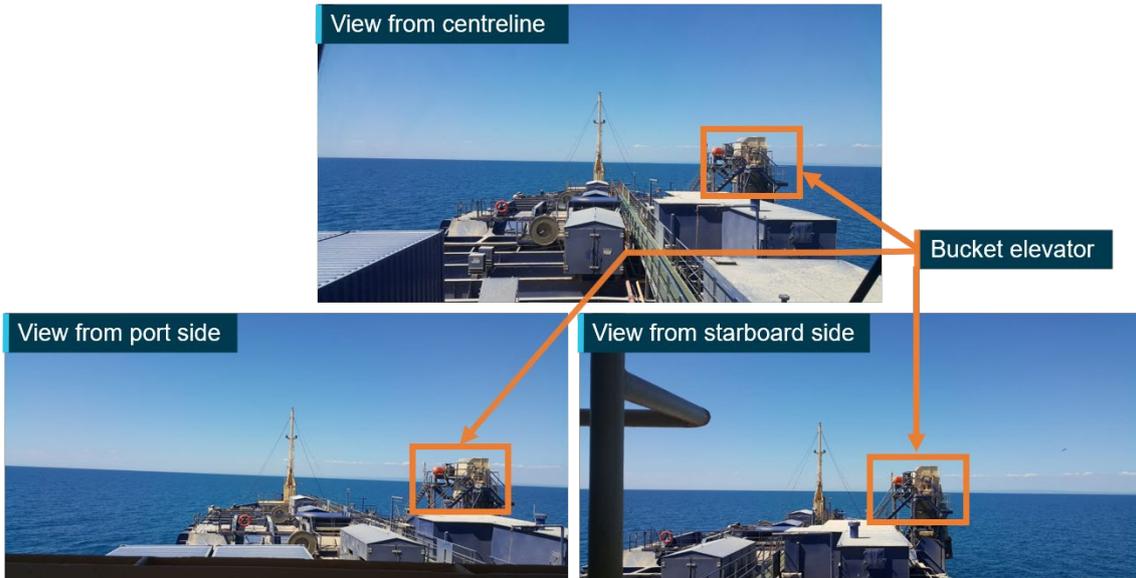
Figure 10: Views from different positions on *Accolade II*'s bridge

The visual blind sector created by the bucket elevator was estimated to be about 5-7°. An ATSB analysis of the blind sector assessed that it probably covered an arc of about 3° when viewed from the bridge. Observers at different locations on the bridge would experience a blind sector across a different arc of relative bearings on the starboard bow. Figure 11 shows the arcs of blind sectors for an observer standing on the port side, centreline, and starboard side.

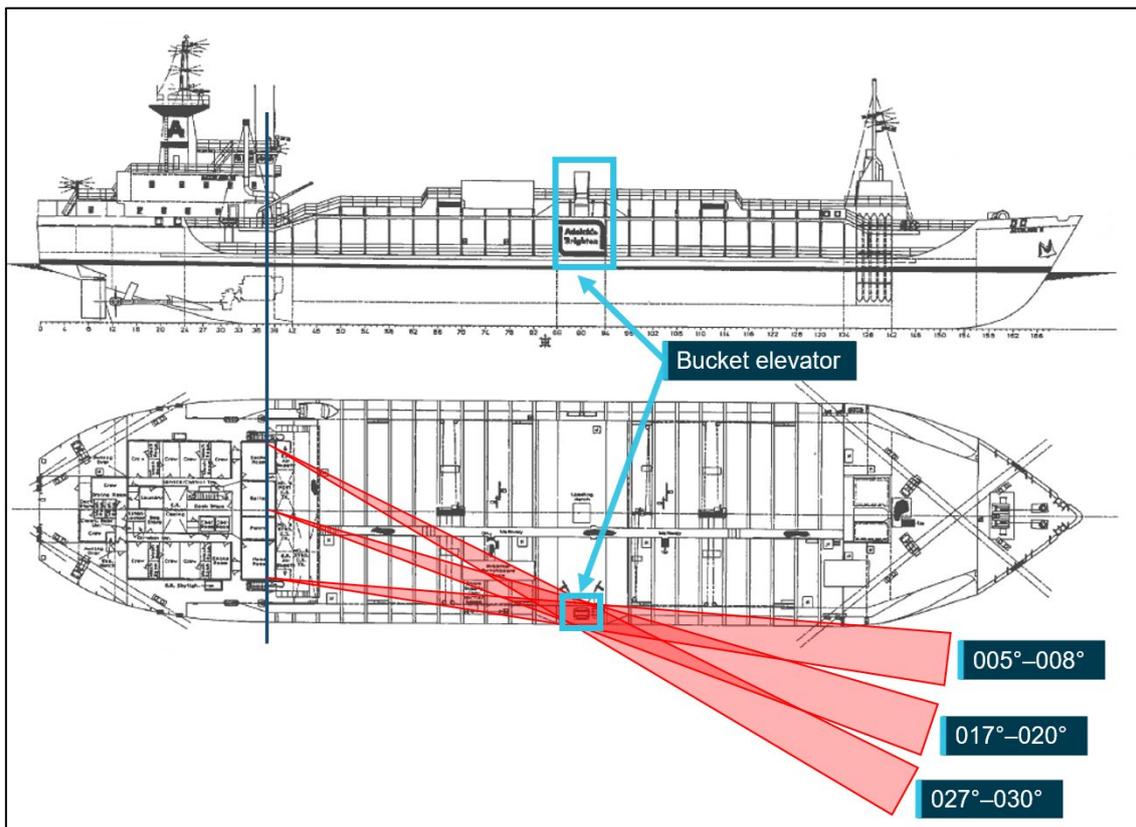
Figure 11: Bucket elevator visual blind sectors

The bucket elevator had been documented in several of the ship's annual navigational audits as a known visual obstruction. As such, the blind sector created by the elevator was a known factor that the ship's crew were aware of and one they routinely allowed for.
