National Transportation Safety Board

Marine Accident Brief

Contact of Bulk Carrier *GH Storm Cat's* Crane with Zen-Noh Grain Facility

Accident type	Contact	No. DCA21FM006
Vessel name	<i>GH Storm Cat</i>	
Location	Zen-Noh Grain Facility, Lower Mississippi River, mile 163.8, Convent, Louisiana 30°3.87' N, 90°52.59' W	
Date	November 11, 2020	
Time	0910 central standard time (coordinated universal time – 6 hours)	
Injuries	None	
Property damage	\$481,006 est.	
Environmental damage	None	
Weather	Visibility 10 miles, clear, winds from north at 5 knots, air temperature 79°F ¹	
Waterway information	The Mississippi River at the Zen-Noh facility is one-third of a mile wide.

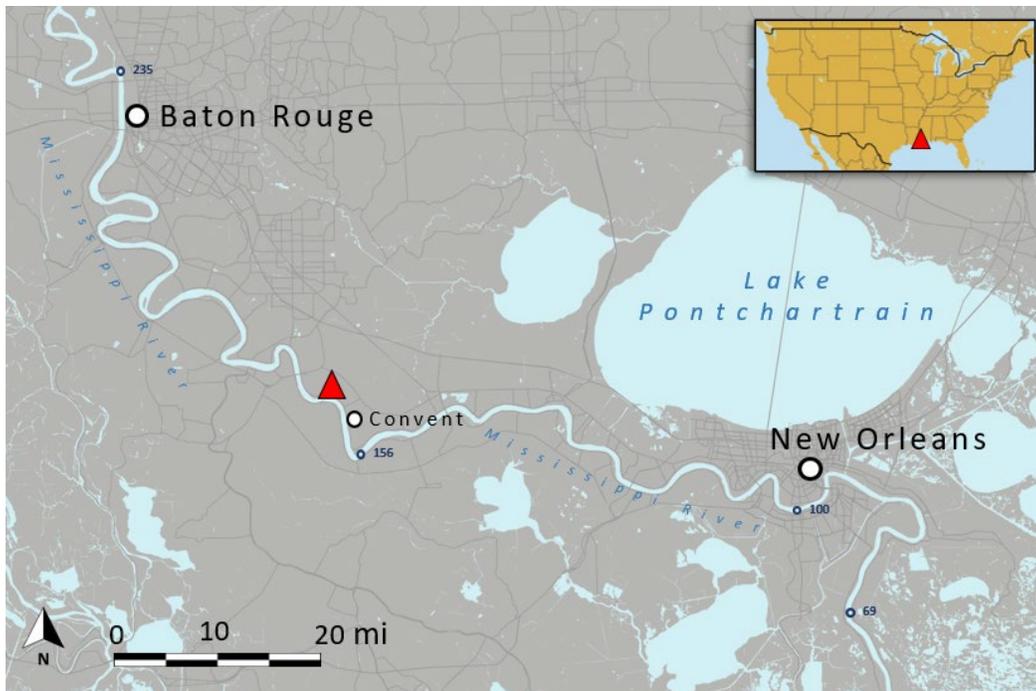
Area of accident where the *GH Storm Cat's* crane contacted the Zen-Noh shoreside conveyor runway, as indicated by the red triangle. (Background source: Google Maps)

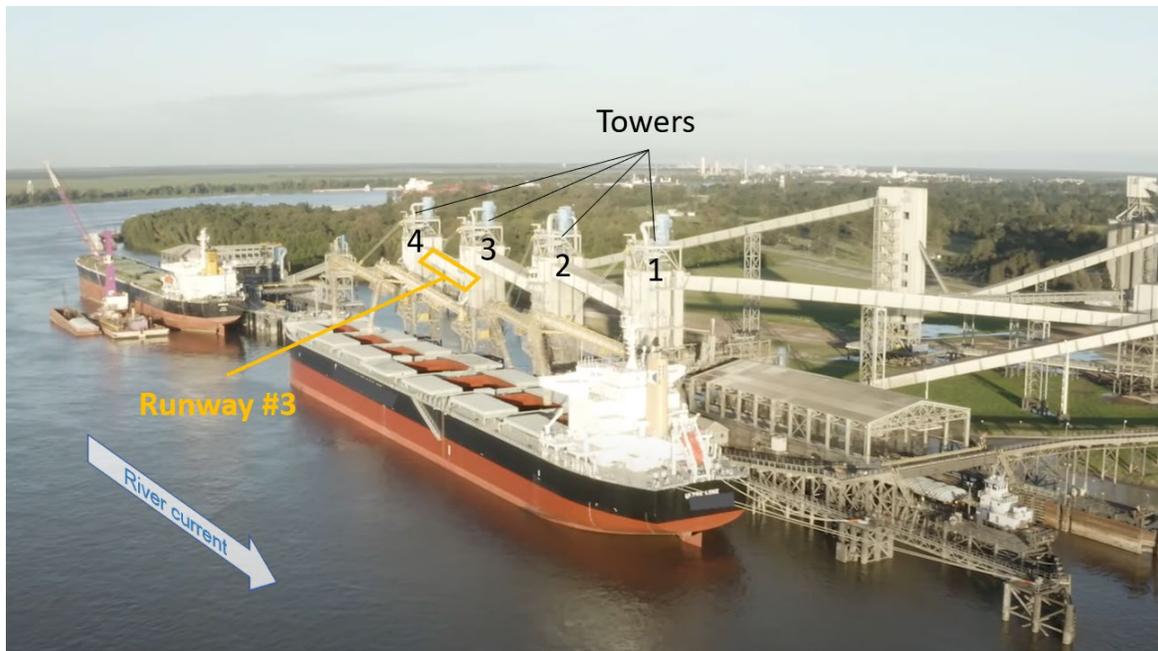
The ZGC shoreside facility before the accident. An unknown vessel, similar to the *GH Storm Cat*, is pictured. Runway no. 3 is highlighted with an orange rectangle. (Background source: ZGC)

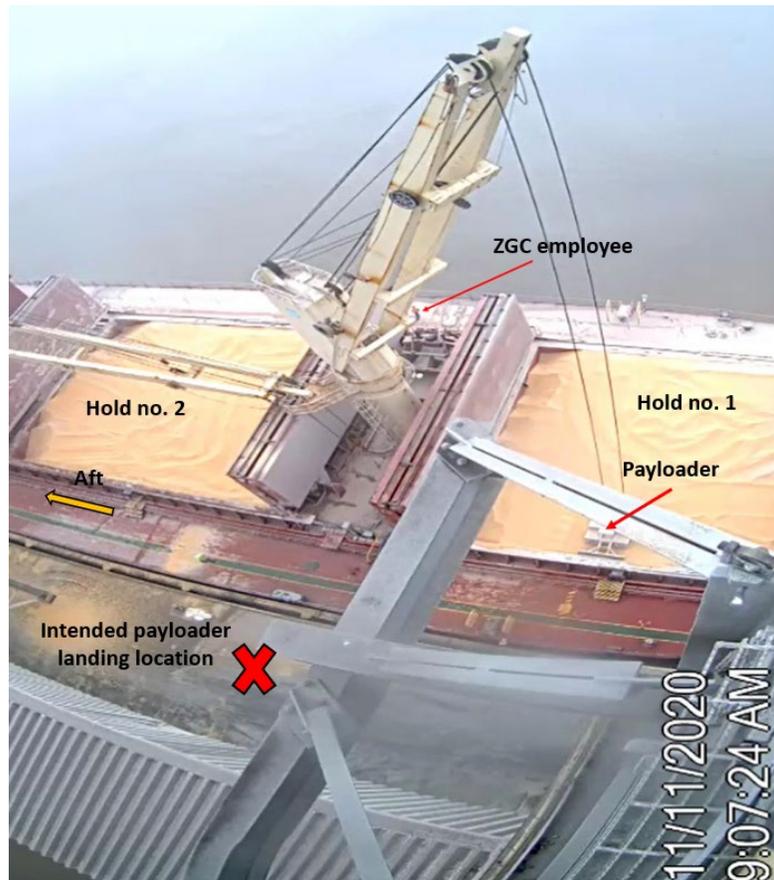
About a minute later, without the assistance of a signalman or spotter, the crane operator hoisted the payloader with the no. 1 crane clear of the no. 1 cargo hold hatch coaming and then slewed the crane to starboard.² After positioning the crane boom perpendicular to the vessel and suspending the payloader above the pier, the crane operator began lowering the boom of the crane to position the payloader to be landed on the pier.

Video footage still image of the *GH Storm Cat's* crane during the initial sequence of the accident lift (lifting the payloader out of ship's no. 1 cargo hold). (Background source: ZGC)

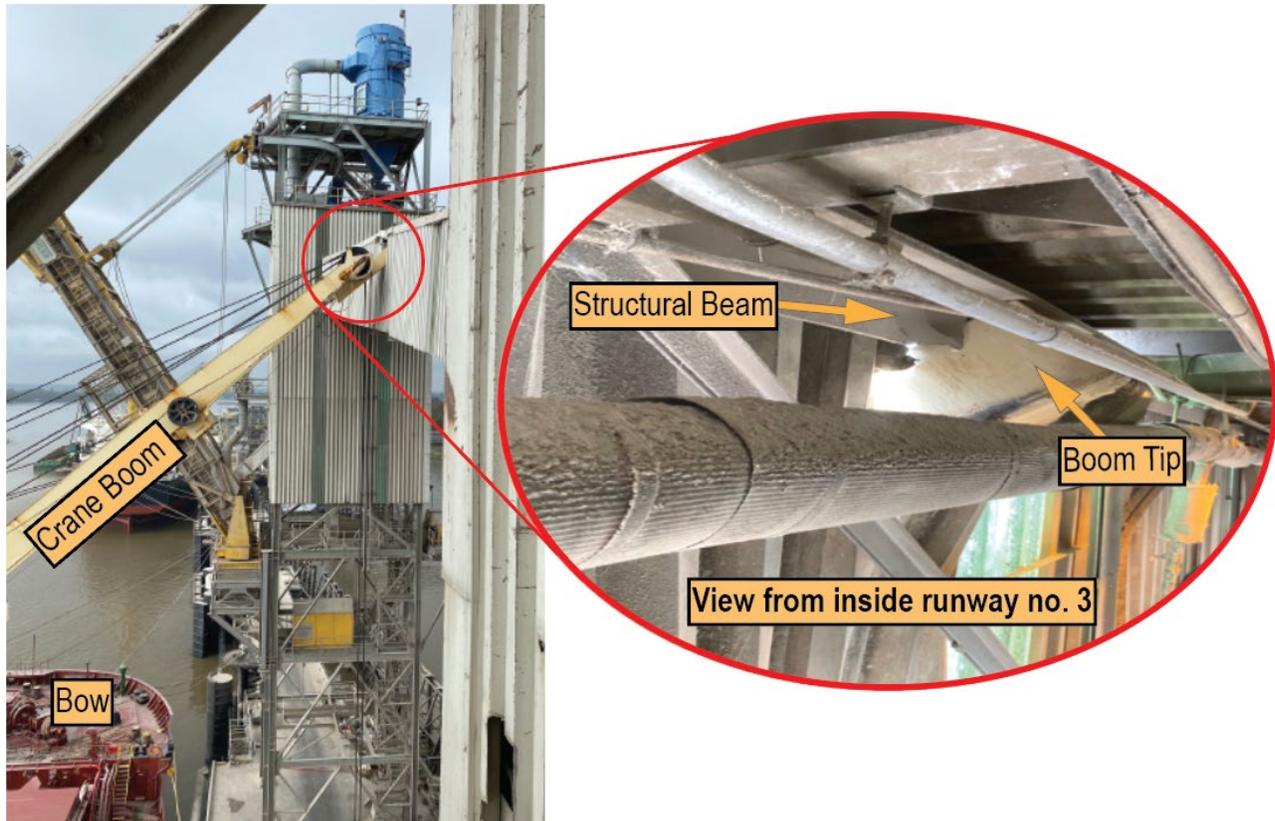
At 0909:30, as the crane operator continued to lower the crane boom, still without the aid of a signalman or spotter on the vessel or pier, the boom tip contacted and penetrated the shoreside facility's no. 3 runway between towers no. 3 and no. 4.

Point of contact of *GH Storm Cat's* crane boom and ZGC runway. (Source: ZGC)

There were no injuries reported, and the vessel's crane was undamaged. The top structural beam of the runway suffered localized deformation where the boom tip made contact. In addition, angle bracing near the area of impact was damaged. The corrugated tin sheets that enclosed the runway below the point of impact were also damaged. ZGC estimated the total cost to repair the damage was \$481,006. The facility returned to operation at a reduced loading rate on November 15 and increased to their normal loading rate two days later on November 17, 2020.

The National Transportation Safety Board determines that the probable cause of the *GH Storm Cat*'s crane contact with the Zen-Noh grain facility runway was the absence of a dedicated signalman, which led to the ship's crane operator's misjudgment of the location of the crane boom while lowering the payload to the pier.

All ships' crane lifts—no matter how routine—should be adequately planned and risk-assessed. All personnel involved in the lifting operation should be clearly identified and their duties understood before the start of the lift.
