National Transportation Safety Board

Marine Accident Brief

Engine Room Fire aboard Fishing Vessel *Master Dylan*

Accident type	Fire/Explosion	No. DCA21FM009
Vessel name	<i>Master Dylan</i>	
Location	Gulf of Mexico, about 32 miles west-southwest of Port Fourchon, Louisiana ¹ 28°55.7' N, 090°48.0' W	
Date	December 1, 2020	
Time	0745 central daylight time (coordinated universal time – 6 hours)	
Injuries	None	
Property damage	\$300,000 est.	
Environmental damage	None reported	
Weather	Visibility 10 miles, clear skies, winds east at 8 knots, seas east 1 foot, air temperature 52°F, water temperature 71°F, sunrise 0647	
Waterway information	Gulf of Mexico

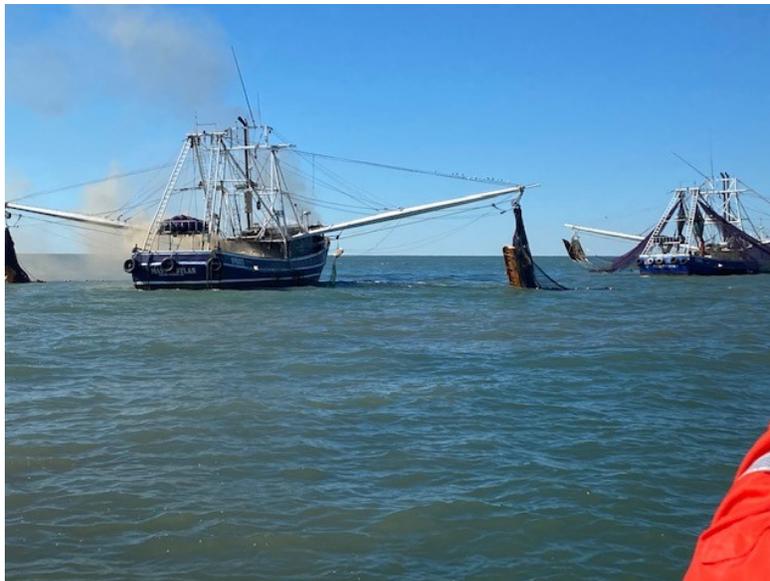
At 1240, about an hour after beginning the tow, the *Master Dylan* grounded on a sandbar that the towing vessel had passed over. Shortly after the grounding, the fire re-flashed. No further firefighting efforts were made. The Coast Guard small boat arrived on scene at 1304 and monitored the situation. The *FMS Courage* departed shortly after the arrival of the Coast Guard small boat.

Photo taken from the Coast Guard small boat showing the *Master Dylan* aground after being towed by the *Master Dustin II*. (Source: Coast Guard)

Investigators also assessed the cause of the vessel sinking, which occurred about 27 hours after the fire began. Because there were no further firefighting efforts after 1140 on the accident day, additional flooding must have occurred after the *Master Dylan* grounded and the fire re-flashed. The destruction of the hoses in the engine room connected to through-hull fittings, due to the long-term exposure to the heat of the fire, most likely resulted in the sinking of the vessel. As the hoses failed, water would have entered the hull, causing the vessel lose stability, roll, and sink.
