Issued November 1, 2021

MAB-21/22

Contact of *Trent Joseph* Tow with Barataria Bridge

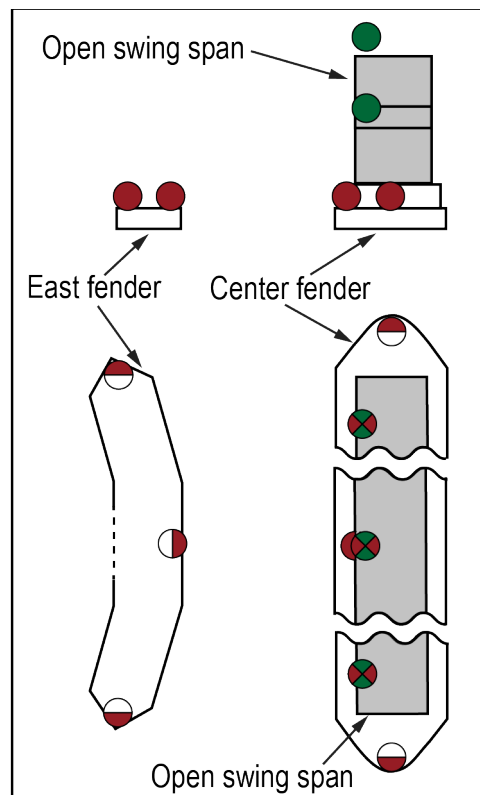
Each of the fenders had red lighting marking the ends and middle. According to the bridge tender, at the time of the accident, the red lights on the east fender had been removed to be repaired. No temporary lighting was fitted to replace the lights that had been removed. On the northern side of the swing span of the bridge (east-facing when open) were three navigation lights (each light showed alternating red and green colors) marking each end and the top center of the swing span. For an approaching vessel, when the bridge was in the closed position, the swing span's lights would show red, and

in the open position, the lights would show green and be in line.³ According to the bridge tender, all of the lights except for the lighting on the east fender (three red lights) were working on the night of the accident.

Figure 5. Simple representation of fendering and swing span lighting; profile (top) and plan (bottom) views. (Background source: Coast Guard)

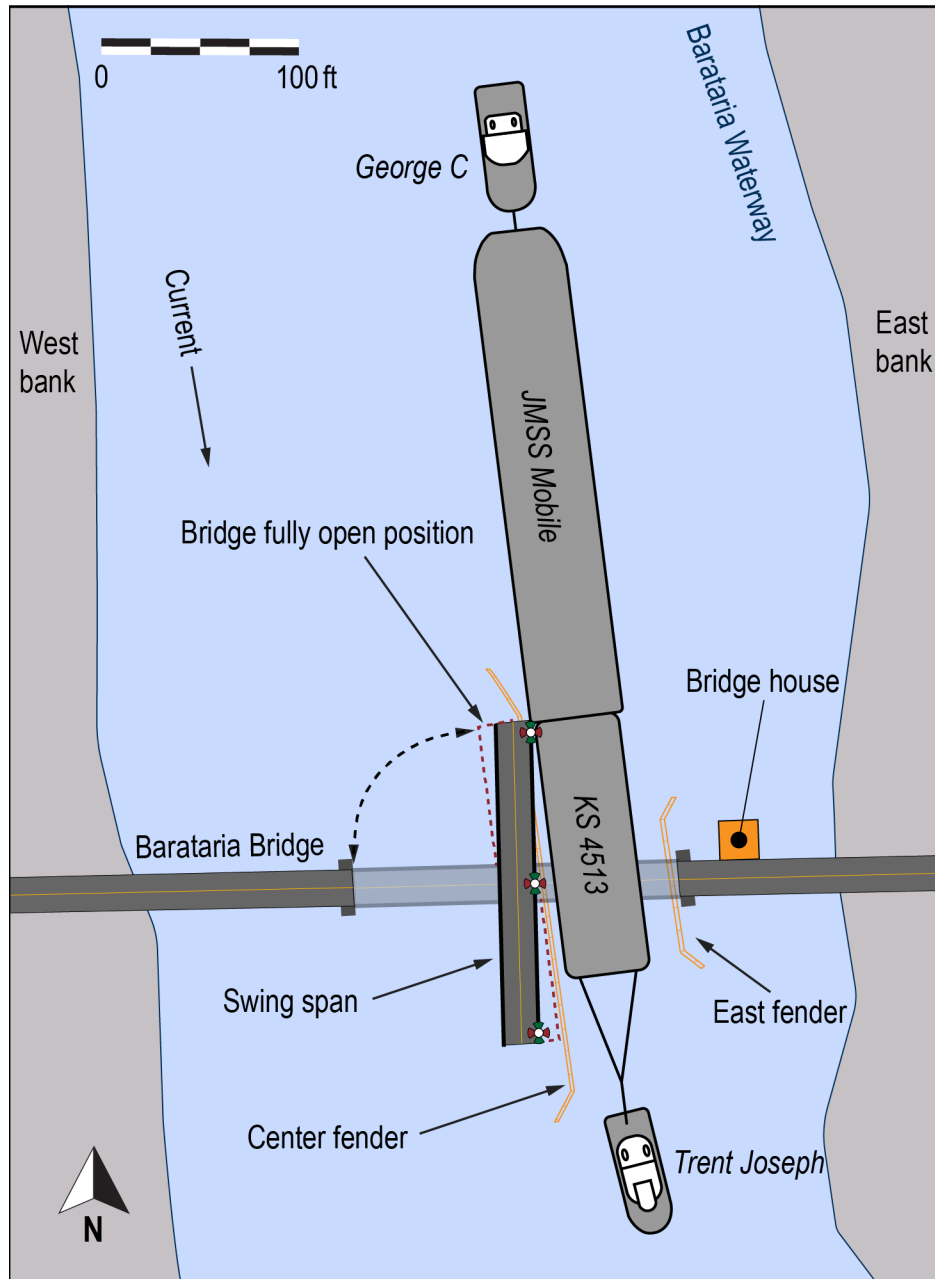
At 2122, at a speed over ground about 2 mph, the starboard forward side (port aft quarter) of the trailing barge, *JMSS Mobile*, struck the northeast-facing corner of the swing span and dislodged it from its mounting and supports. The captain of the *George C* stated that he saw the barge strike the swing span, but it did not hit the fender. According to the bridge tender, the *Trent Joseph* was completely clear of the bridge at the time the aft barge struck the swing span.

Figure 6. Estimated position of the *Trent Joseph* tow as it passed through the Barataria Bridge and approximation of the contact of barge *JMSS Mobile* with the northeast corner of the swing span. (Navigation lights not to scale.)

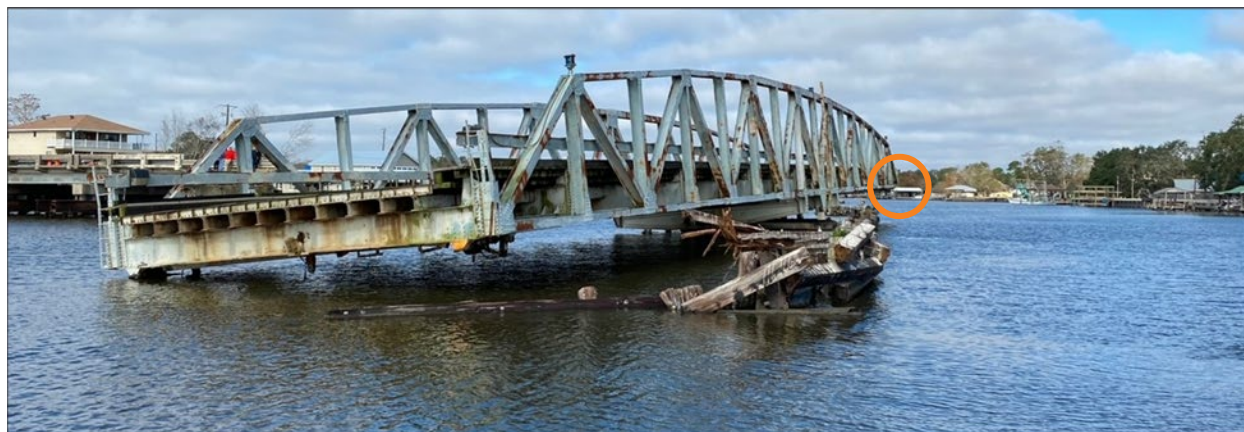
The Barataria Bridge sustained major damage, with a shear in the north end floor beam and damage to the center bearing, guide wheels, supports, drive system gears, and mounting. There was also damage to the electrical cabling for the bridge and to the center pier concrete.

Figure 7. Postaccident damage to Barataria Bridge looking north. The corner of the swing span that the barge contacted is circled. (Source: anonymous)

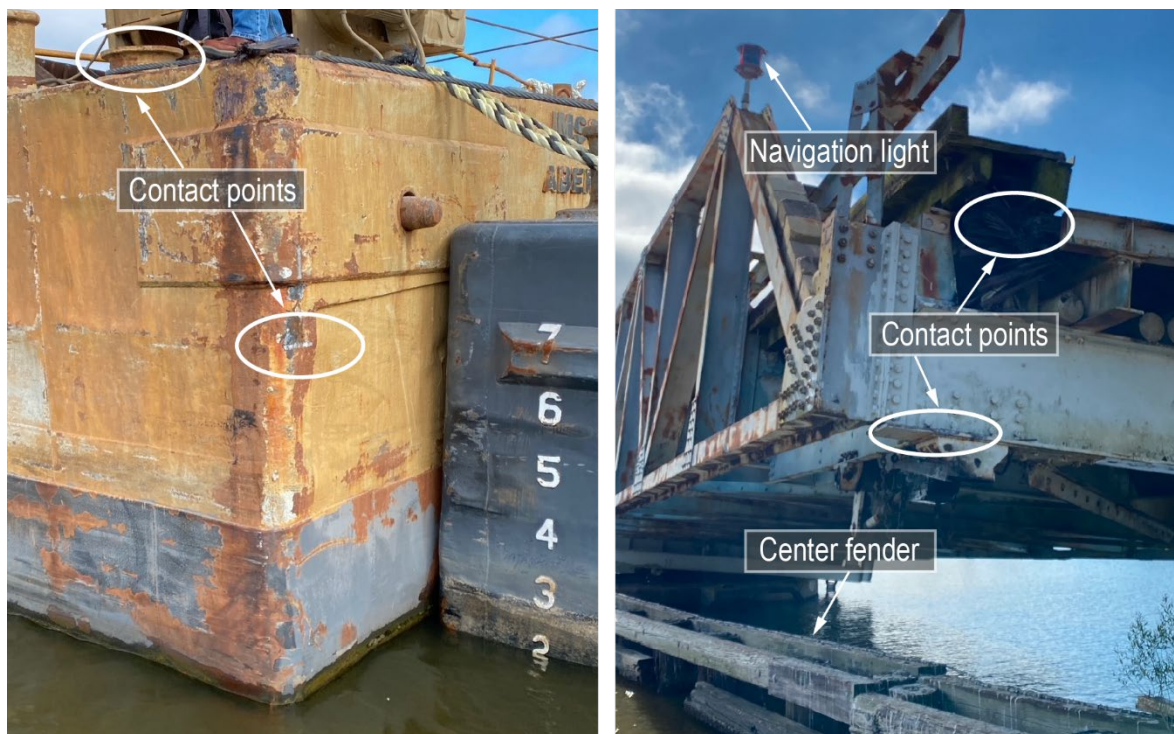
There was no damage to the *Trent Joseph*, *George C*, or the forward barge, *KS 4513*, or any deck equipment and cargo. The aft barge, *JMSS Mobile*, sustained paint scrapes and gouges about 6 feet above the waterline on the aft port corner with no indentations or fractures found. Repairs were not required.

Surveyor photographs and a postaccident barge damage survey report showed that the points of impact were between the port corner and a deck button of the *JMSS Mobile* and the swing span (the northeast corner when the bridge was open), including the span's steel center floor beam and road surface deck timbers. There were no signs of contact with the fendering system on the hull of the barge, and, according to the survey report, neither the center nor the east fender walls displayed any signs of new contact. A Louisiana DOTD postaccident examination report did not provide any findings regarding factors that would have allowed the bridge to extend past the fendering prior to it being struck.

Figure 8. Postaccident damage to the corner of barge *JMSS Mobile*, with damage markings and scrapes about 6 feet above the waterline (left), and to the northeast corner of the Barataria Bridge, with points of contact with the barge *JMSS Mobile* indicated (right). (Source: anonymous)
