Marine Safety Investigation Report

into a fatal fall onboard Star Planet
04 June 2021

The Bahamas
Maritime Authority

Date of Issue: 20 December 2021
Bahamas Maritime Authority
120 Old Broad Street
LONDON
EC2N 1AR
United Kingdom

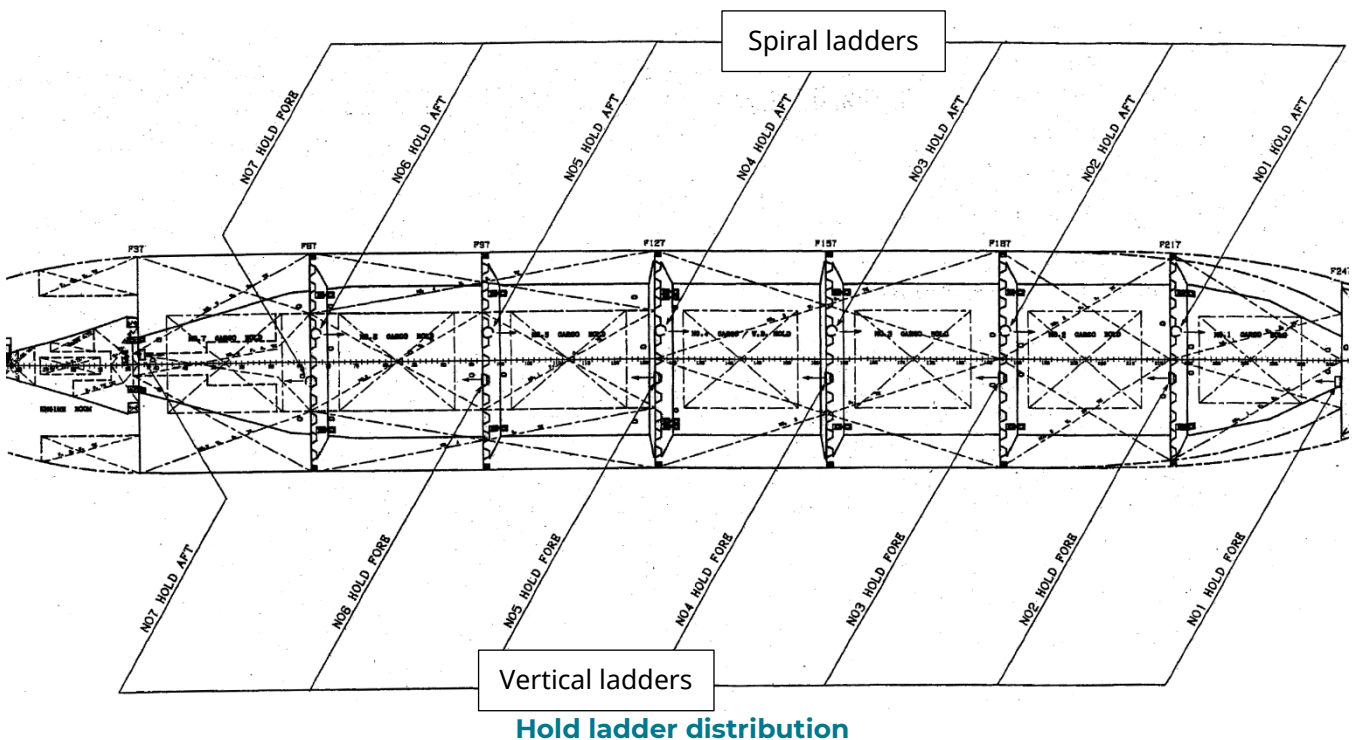
The holds were fitted with a vertical ladder and a spiral ladder, located on the centreline, at opposite ends of each hold. With the holds’ hatches open, the survey was completed entering down the forward ladder and leaving via the aft ladder. Distribution of the ladders meant that both types were used to descend and ascend.

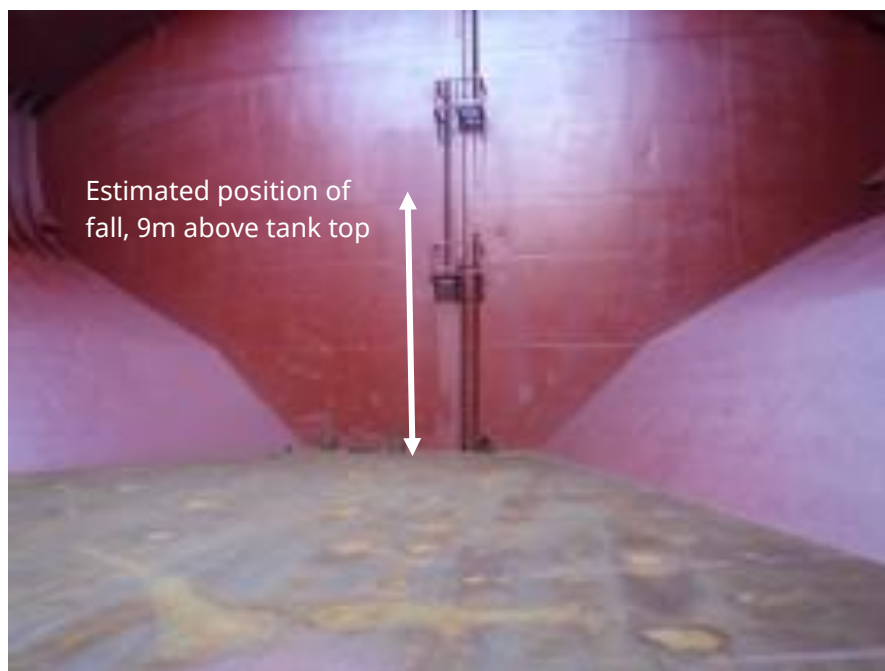
Hold 7: vertical (aft) ladder

On 4 June 2021, the vessel was rolling with an amplitude of around five degrees – too much to open the chain-driven hatches. At 13:45 the chief officer was seen entering hold 7 via the forward (spiral) ladder. Five minutes later, he was found by a member of the crew on the tank top, conscious but clearly injured, in the vicinity of the aft (vertical) ladder. Evidence suggests he had fallen approximately 9m.

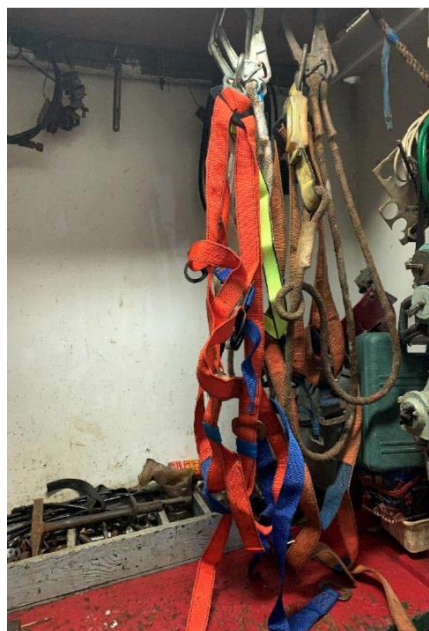
The vessel carried two full-body harnesses and two twin-leg lanyards fitted with scaffold hooks. There was no record of training in their use.

Harnesses and hooks, kept in the deck workshop

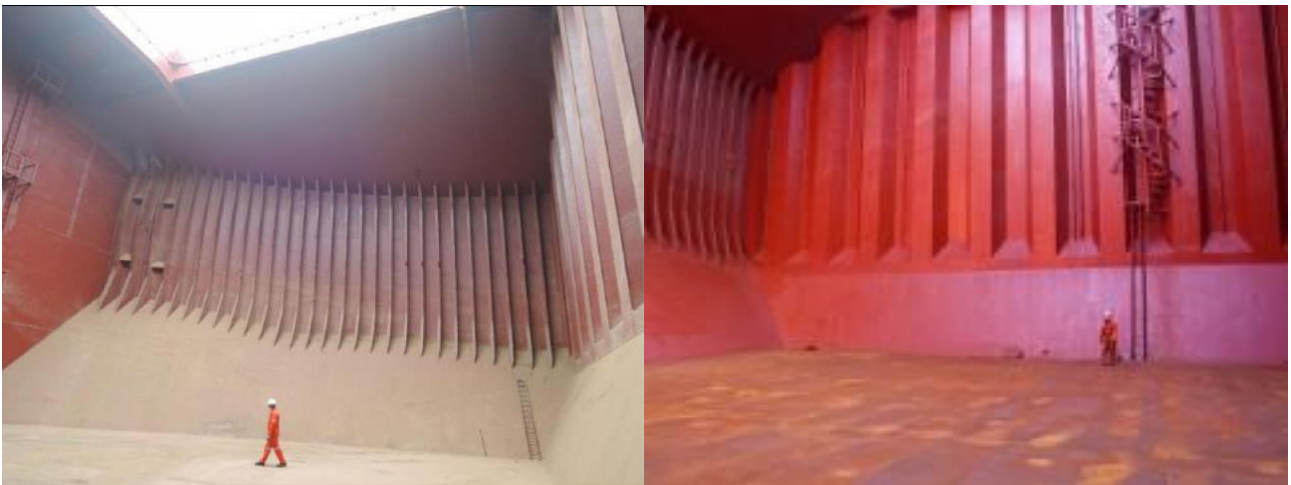
Star Planet's initial hold survey, conducted at Tianjin, was completed whilst cargo was still being discharged, meaning access to the holds was limited, but empty holds were accessed where possible. In Kwinana, every hold was inspected, including every ladder. During these surveys, neither the surveyor nor the chief officer, who was accompanying, wore a harness.

Surveyors' photographs taken during Tianjin and Kwinana surveys

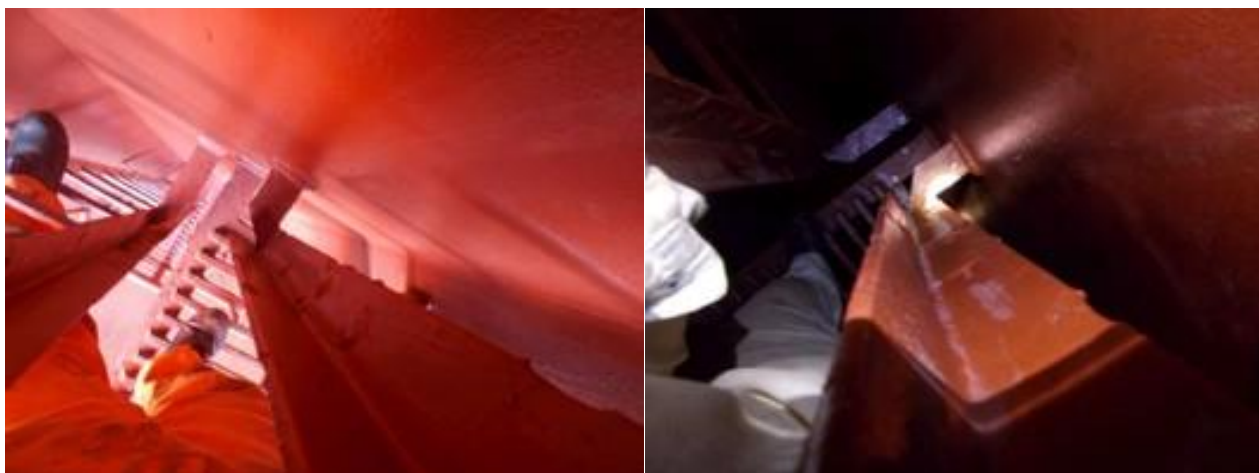
Progress updates sent by the vessel to cargo surveyors⁴ in the days leading up to the casualty included photographs detailing the vertical ladders in holds 1-3. These photos indicate that inspections were conducted regardless of whether the holds' hatches were open or shut and that a full body harness was likely not used when inspecting the vertical ladders as indicated in the pictures shown below.

Progress updates on vertical ladder cleaning - no harness thigh strap visible

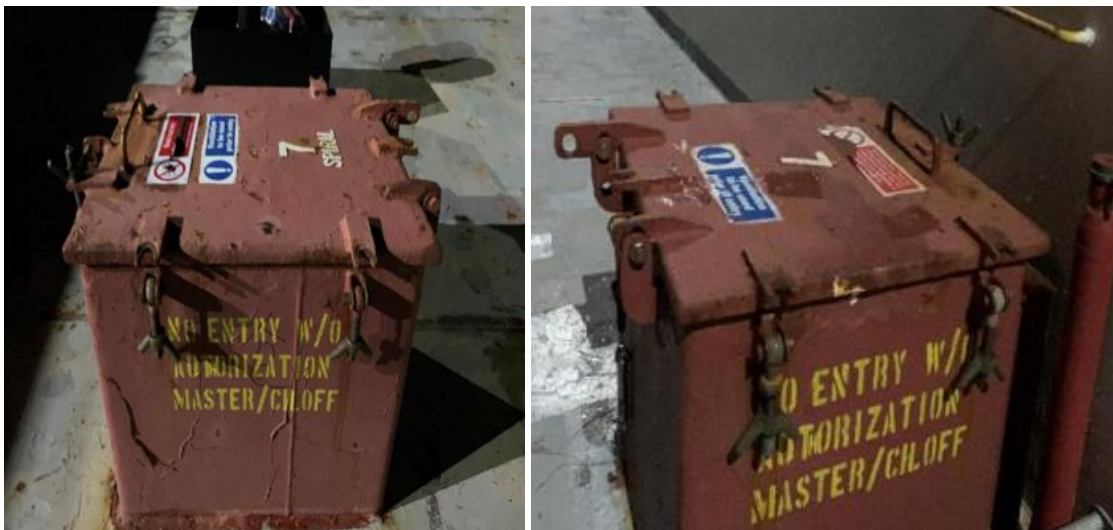
Hold 7 booby hatches

Booby hatches for the vertical and spiral ladders were similarly marked “no entry without authorisation of master / chief officer” (or words to that effect), as well as the need to ventilate before entry. Hatches to the spiral ladders could be identified as such but there was nothing to indicate that vertical ladders should be used for emergency escape only. Similarly, there was nothing to indicate restrictions on use of the vertical ladders in the holds.

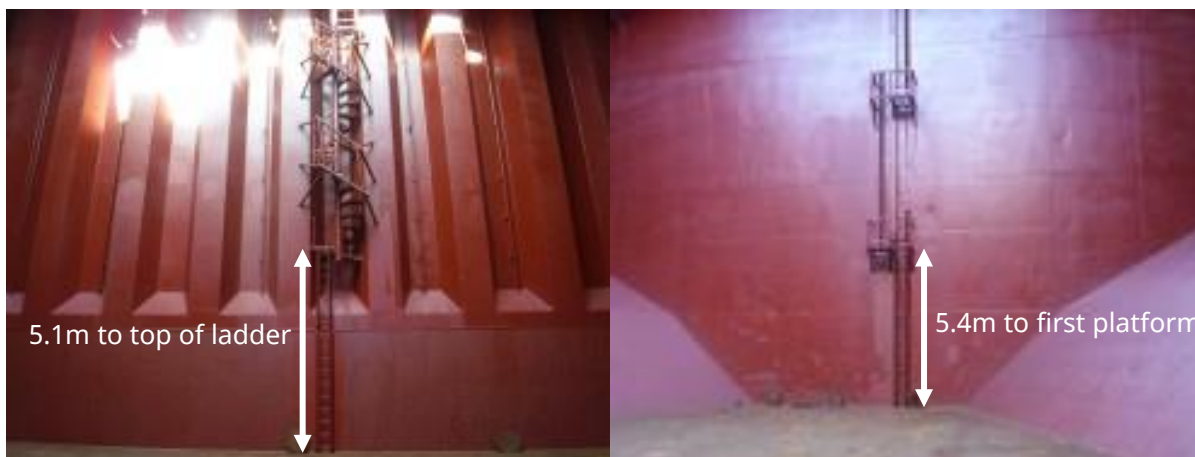
Spiral and vertical ladders in hold 7

The design of the spiral ladders incorporates an unprotected vertical⁷ ladder as the lowermost section. This extends to a height of over five metres above the tank top.

The holds were not fitted with any means of lighting and, at the time of the fall, the only potential source of light was the portable torch carried⁸ by the chief officer. Carriage and use of the torch may have increased the difficulty of climbing a vertical ladder.

- Review its risk assessment process to ensure that all generic risks of falling are identified, assessed and mitigated. This should include, but not be limited to, implementation of fall protection measures for access to cargo holds where ladder design increases a risk of falling from height.
- Consider adding task-based risk assessments to its safety management system.
- Ensure adequate provision of fall protection equipment and training in its use.
- Work with crews to ensure fall hazards can be clearly identified and the potential outcomes of a fall are understood.
