Investigation Report 23/20

Less Serious Marine Casualty

**Cargo-related accident
(loss of two mobile cranes)
on the
JUMBO VISION
at berth in the port of Rostock
on 31 January 2020**

21 December 2021

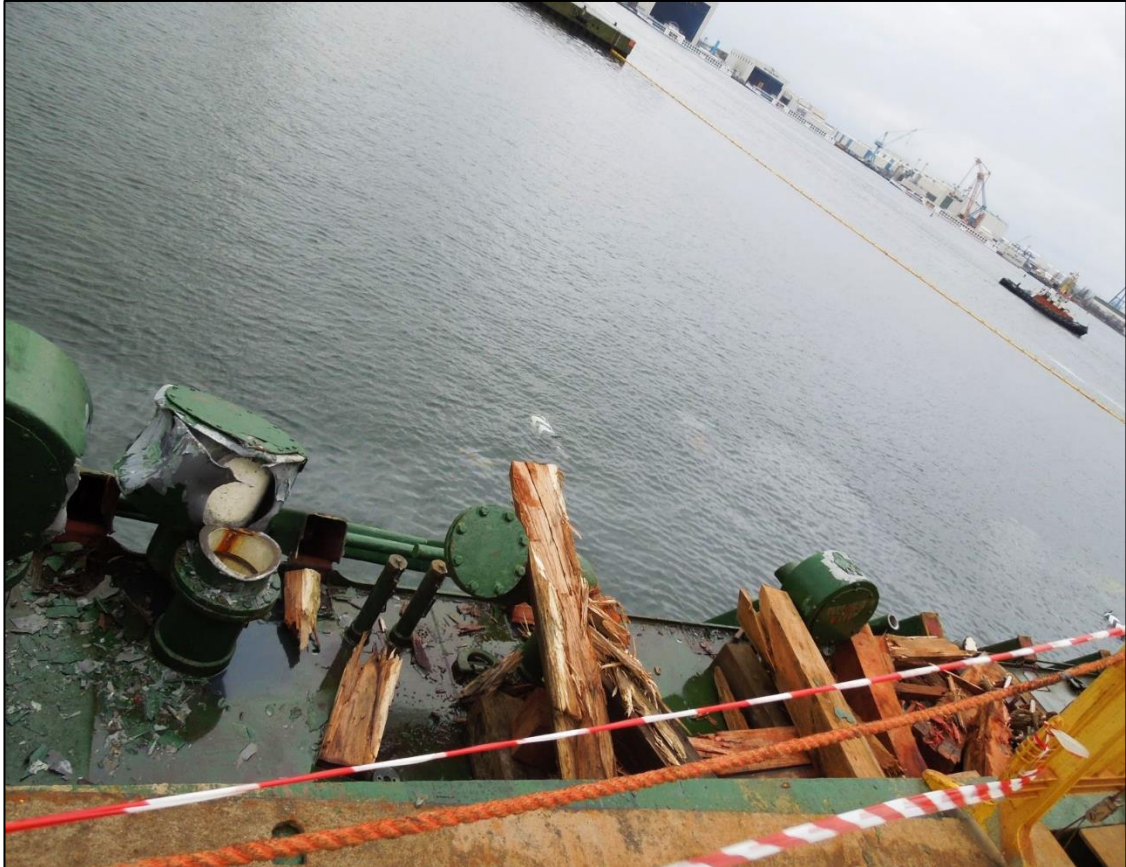
Figure 13: Damage to port-side deck passageway caused by crane 2 (sounding pipes, vent heads, overflows, wooden blocks, missing railing)

Various repairs were carried out on the JUMBO VISION's damaged port side (see Figure 12 and Figure 13). For this, the ship was rotated and made fast with the damaged side alongside the pier. Class was confirmed by a Lloyd's Register surveyor, and the vessel was allowed to proceed only after the severely buckled and partly missing railing, the broken and buckled sounding pipes, overflows and vent heads, the damage to the main deck (dents and penetrations) and the lifting gear from the gangway, which had gone overboard, had been repaired.

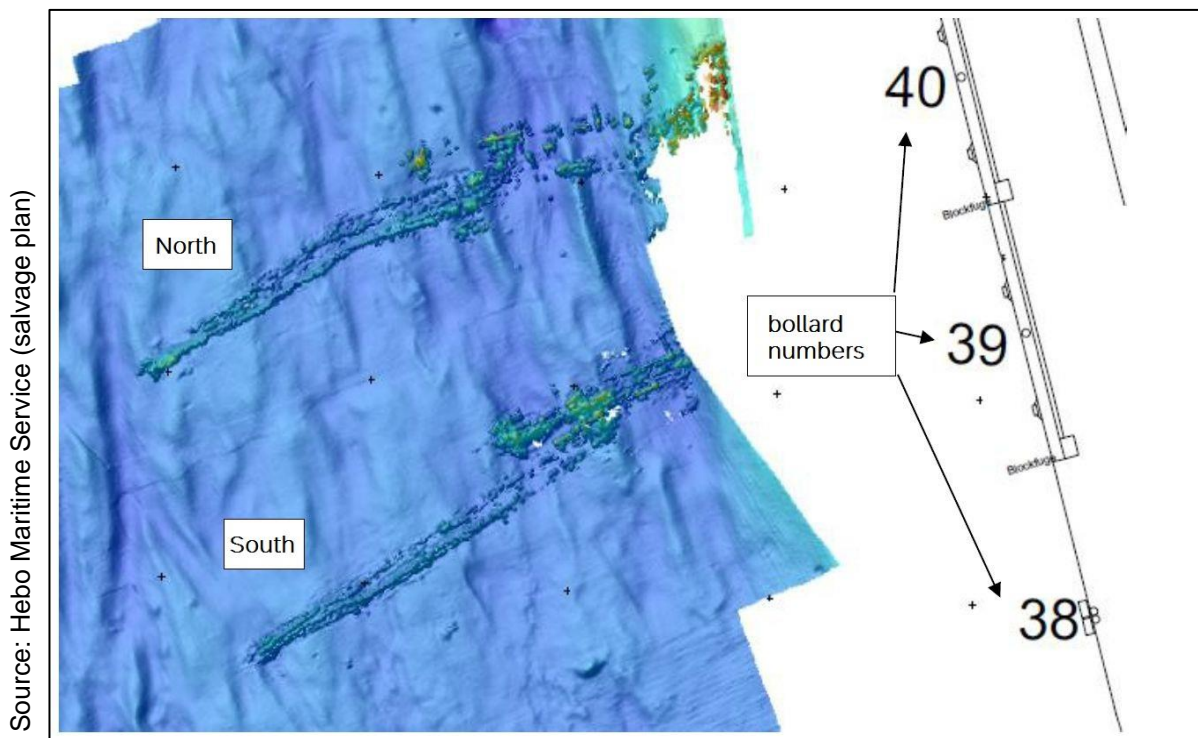
On 1 February, a first dive was carried out to the submerged cranes to determine the scale of the damage and possible necessary traffic restrictions. On 4 February, divers began pumping the operating fluids out of the cranes and sealing the oil leaks. They also removed large parts of the oil slick inside the oil barrier. On 8 February, the barrier was reduced to the area directly above the accident site, and a corridor was opened for passing traffic into the harbour basin.

Figure 14: Three-dimensional image of the surveyed harbour basin bottom with damaged cranes

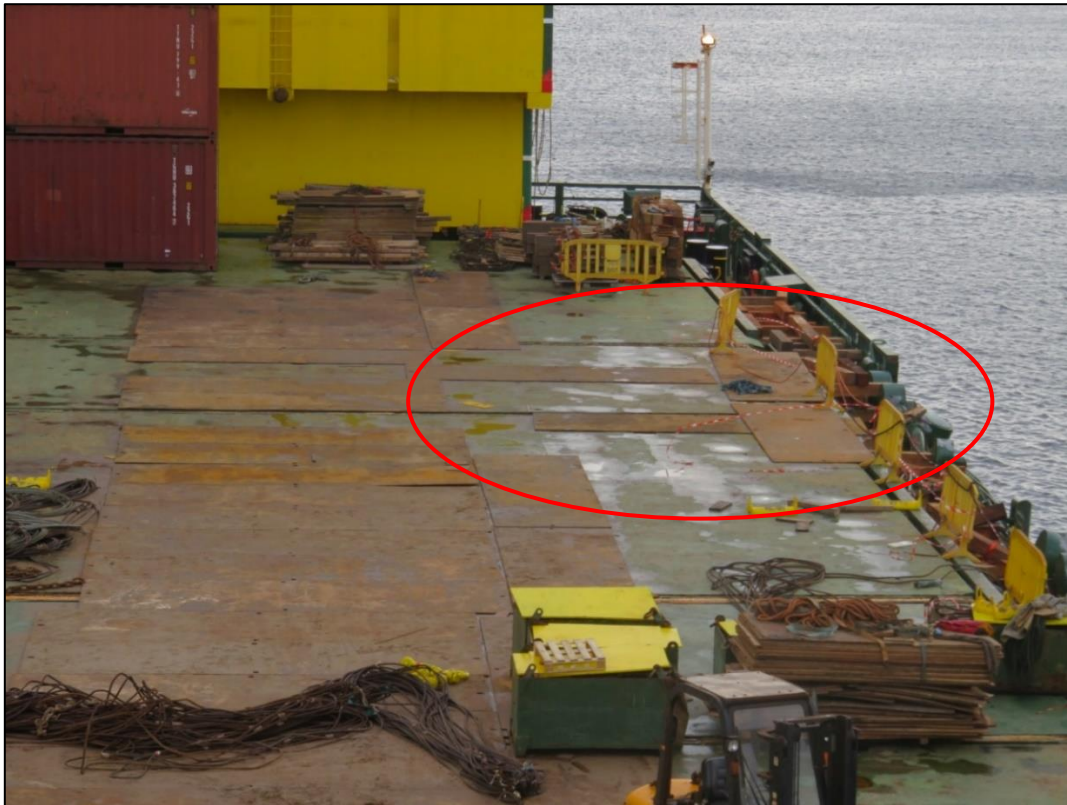
Figure 19: Position of the steel plates on deck after the accident
(view to aft)

A relatively large amount of sand was also found spread across the deck, a sample of which was taken.

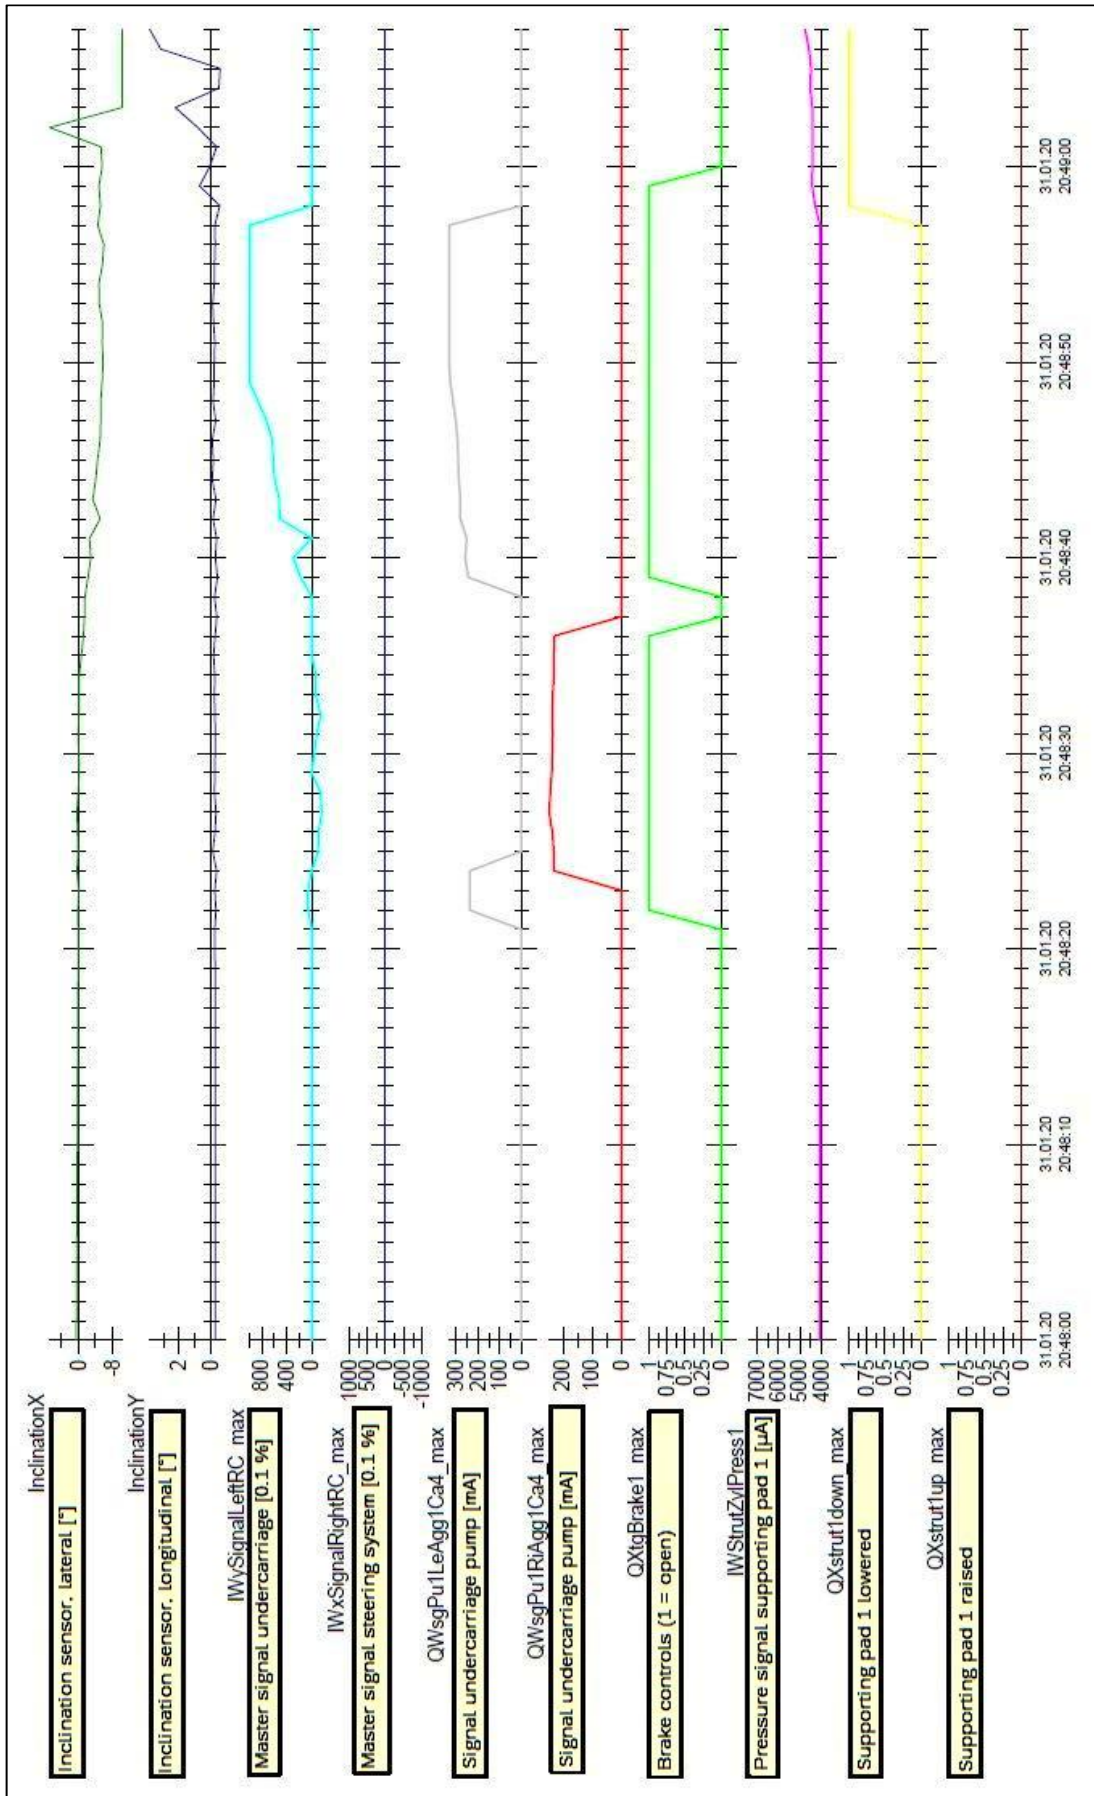
Figure 20: Summary: positioning and sensor signals of crane 2 in the minute leading up to the accident

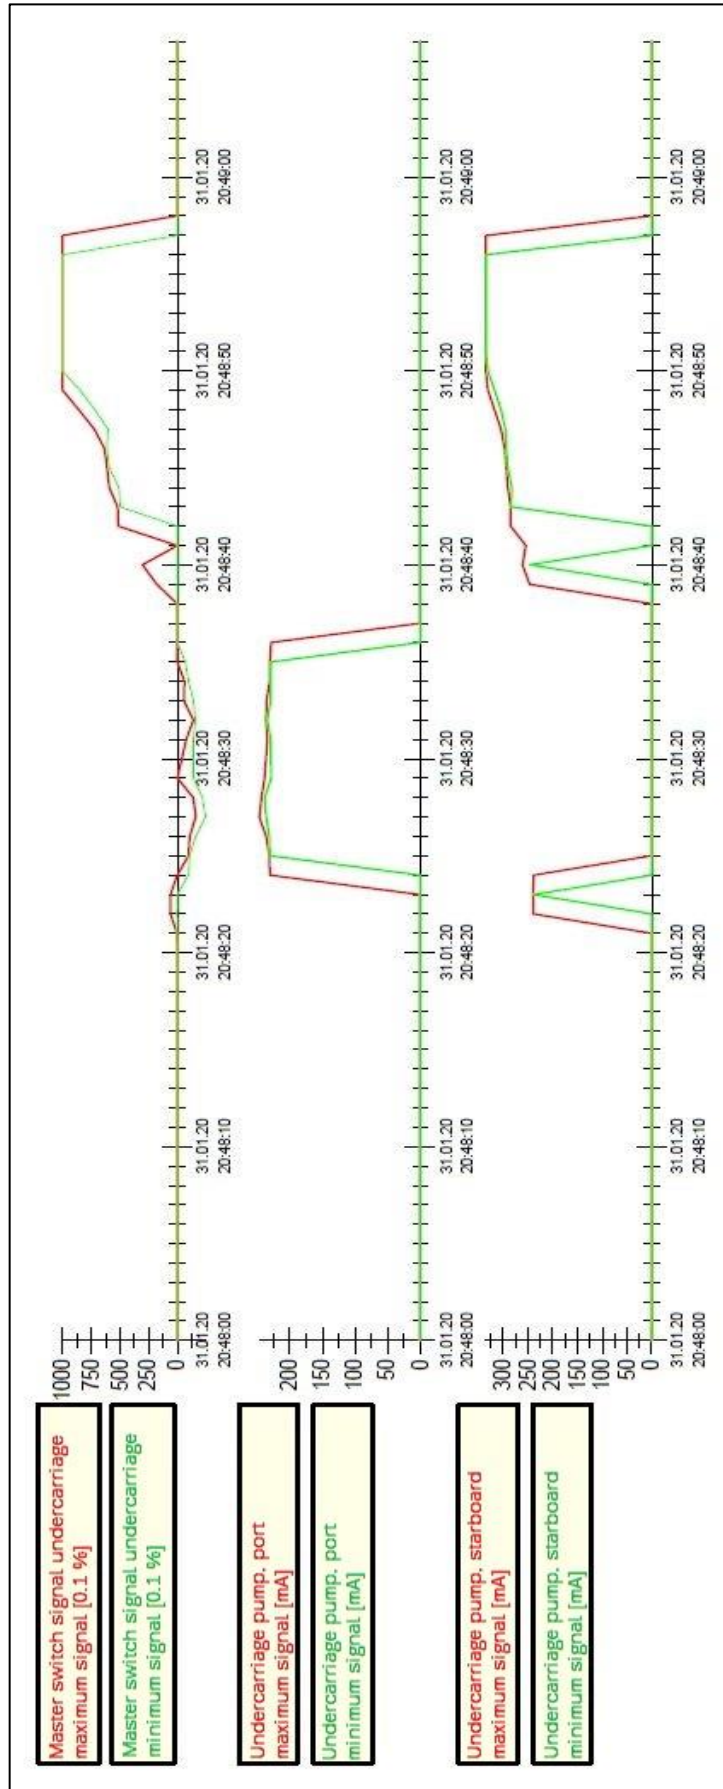
Figure 21 compares only the signals of the two running gear pumps and the master switch signal during the same period of time.

Figure 21: Detail: Crane 2 running gear actuation

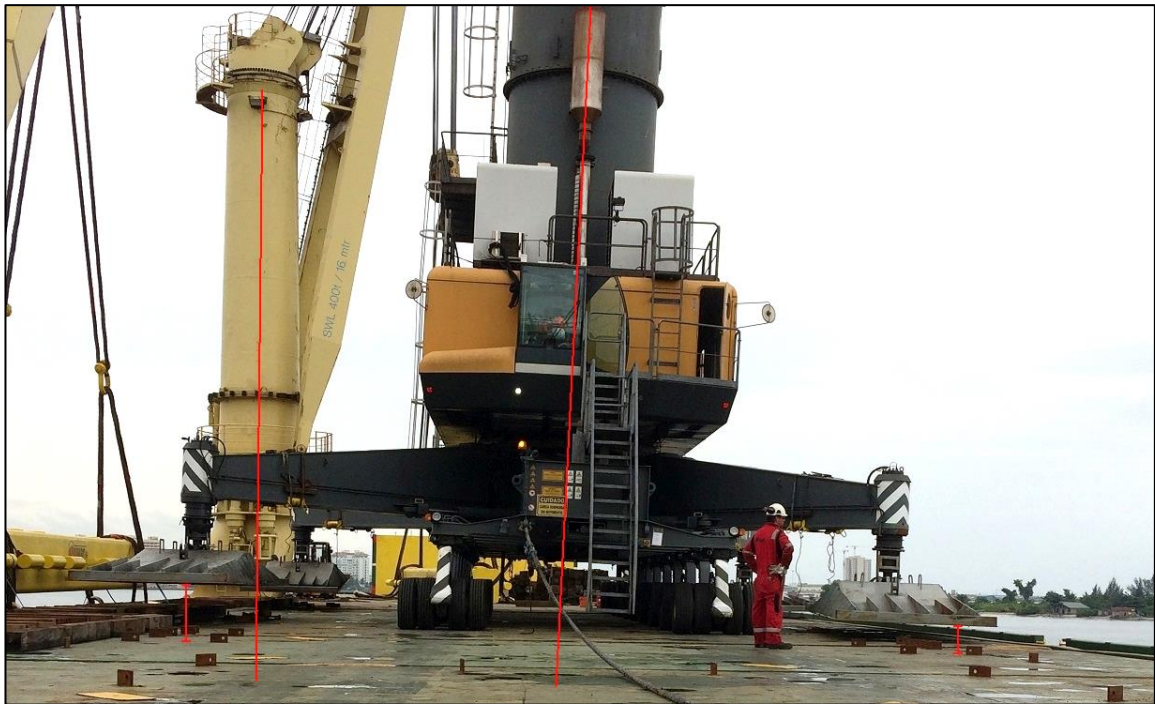
Figure 22: Loading of LHM 550 cranes on the following voyage (view of deck area)
 The tower of the ship's cargo-handling gear and that of the Liebherr crane are not parallel;
 the equally extended support cylinders have different distances from the deck

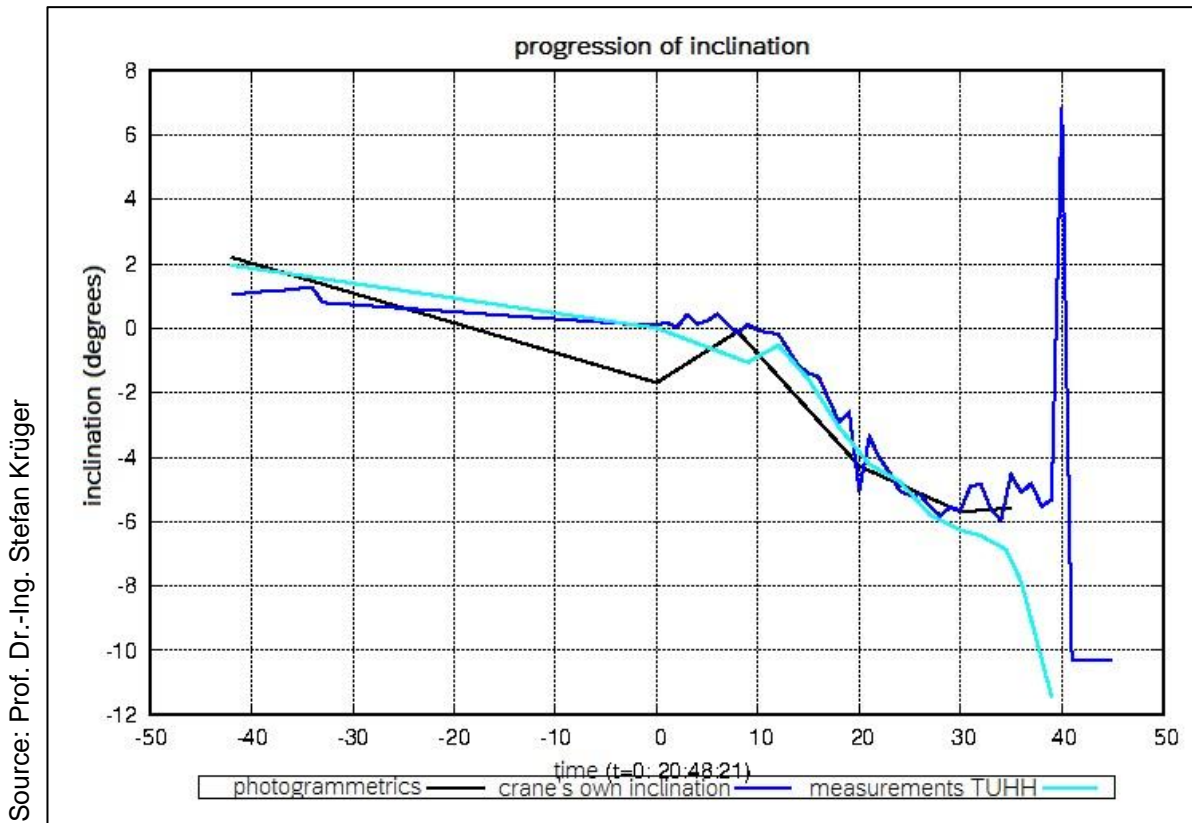
Figure 34 compares the angles determined by the IPI and the TUHH, as well as those of crane 2's inclination sensor over a period of almost two minutes. Over the course of the last movement of the crane up to the accident, an *increasing* heel is clearly visible – in contrast to the originally assumed heel that *already* existed at t_0 (which was refuted). The observed heeling motion does not seem to be linear, as one might expect for a crane travelling sideways at a constant speed, but rather resembles an oscillation.

Figure 34: Roll angle over time according to all three measurement methods

The first attempt to stop crane 2 was made 15 s after it was set in motion. The control lever was (unsuccessfully) moved to the neutral position for this purpose. Figure 34 shows that the JUMBO VISION was already heeling by about 1-2°, i.e. the limit for the maximum permissible transverse surface inclination for operating the crane may already have been exceeded.
