Collision between fishing vessel *Achieve* (HL257) and general cargo ship *Talis*, resulting in the sinking of *Achieve* off Tynemouth, England on 8 November 2020

SUMMARY

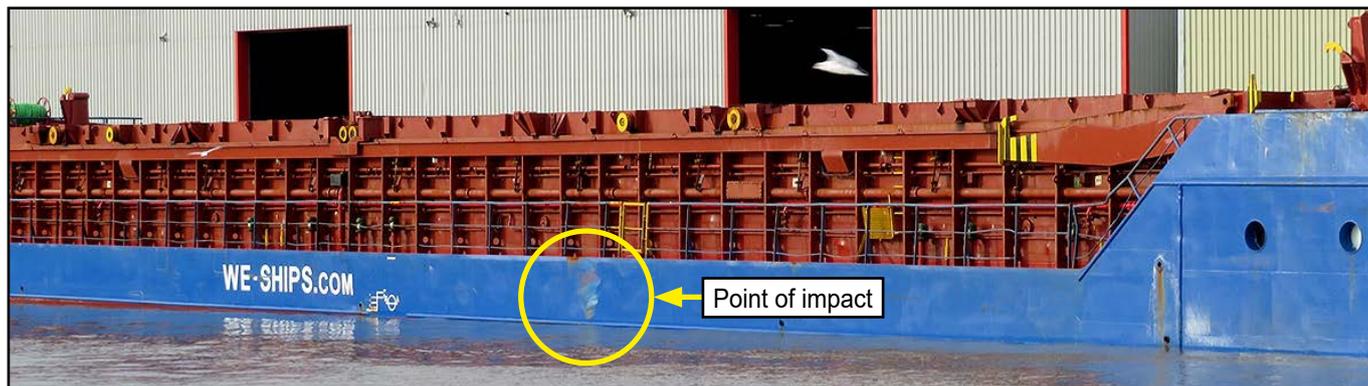
Figure 3: Damage to *Talis*'s port side

Talis's heading had not appreciably changed when, at 1541, *Achieve* struck the cargo vessel's port side. *Achieve's* skipper and deckhand were thrown to the deck by the force of the collision. The skipper went to the wheelhouse and immediately saw *Talis* disappear into the fog on his starboard side.

On board *Talis*, the C/O immediately put the helm to midships, switched to autopilot, and telephoned the master. The AB watched the fishing vessel drift past the stern until he lost sight of it in the fog. The master arrived on the bridge, pulled the engine control telegraph back to dead slow ahead, and was briefed by the C/O. *Talis's* master followed the guidance in the company emergency response card for a vessel involved in a collision. *Talis* continued on passage at reduced speed while the master made a damage assessment. The hull had suffered minor indentation and handrail damage (**Figure 3**) where *Achieve* had struck the hull. The crew checked the ballast tanks and confirmed to the master that watertight integrity had not been compromised.

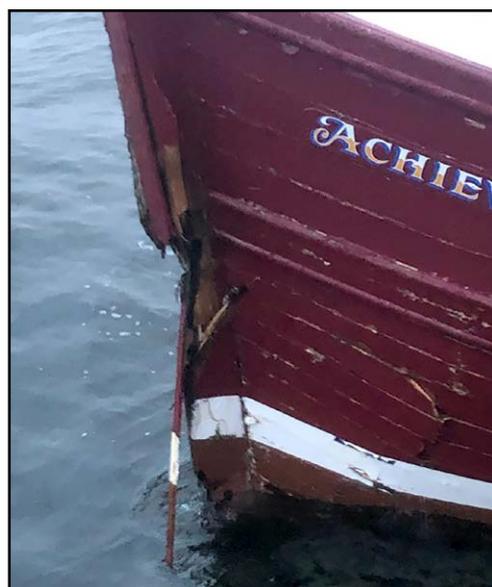
Figure 4: Damage to *Achieve*'s stem

On *Achieve*, the bilge alarms sounded shortly after the collision and both crew checked for water ingress. The deckhand discovered water in the engine compartment at the forward end of the vessel and entered the space to assess the damage. He saw several sprung planks around the stem (**Figure 4**) where water was flowing in. He considered starting the engine-driven bilge pump, but decided not to because its control was at the aft end of the space and he feared being trapped by the flood.

At 1544, *Achieve's* skipper called Humber Coastguard on very high frequency (VHF) radio channel 16 and advised them he had been in a collision and was taking on water. The VHF call was overheard by the *Talis* bridge team. The coastguard immediately tasked the Tynemouth RNLI all-weather lifeboat (ALB) to attend. Meanwhile, the deckhand considered reducing the water ingress by affecting temporary repairs at the stem but assessed it as impractical.

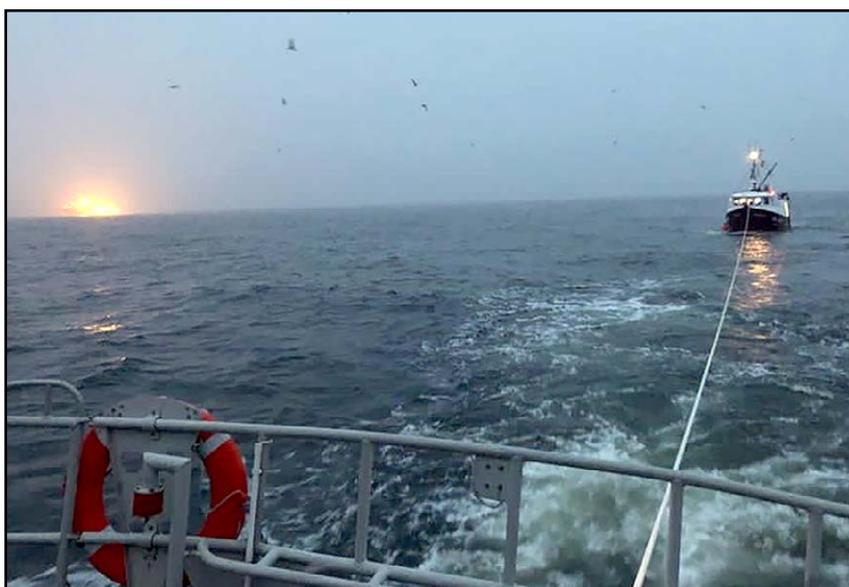
Figure 5: *Achieve* being towed by RNLI all-weather lifeboat

At 1605, the ALB arrived on-scene and transferred a salvage pump to *Achieve*. By 1610, the ALB crew and fishing vessel's skipper had secured a towline to the fishing vessel's bow (**Figure 5**). The ALB then headed to Tynemouth at slow speed with *Achieve* in tow. After about an hour, the fishing boat became unstable as more water flooded the hull and the skipper and deckhand abandoned to the ALB. The lifeboat released the towline and remained close to *Achieve* until, at 1810, it sank, 0.25 miles from the Tynemouth north breakwater in 18m depth of water. The ALB then returned to Tynemouth and landed the skipper and deckhand.

Achieve's skipper and the ALB coxswain's decision to tow the vessel was understandable given the port's proximity, and towing from the bow was the quickest method. However, this may have increased the water inflow, which resulted in the vessel sinking.

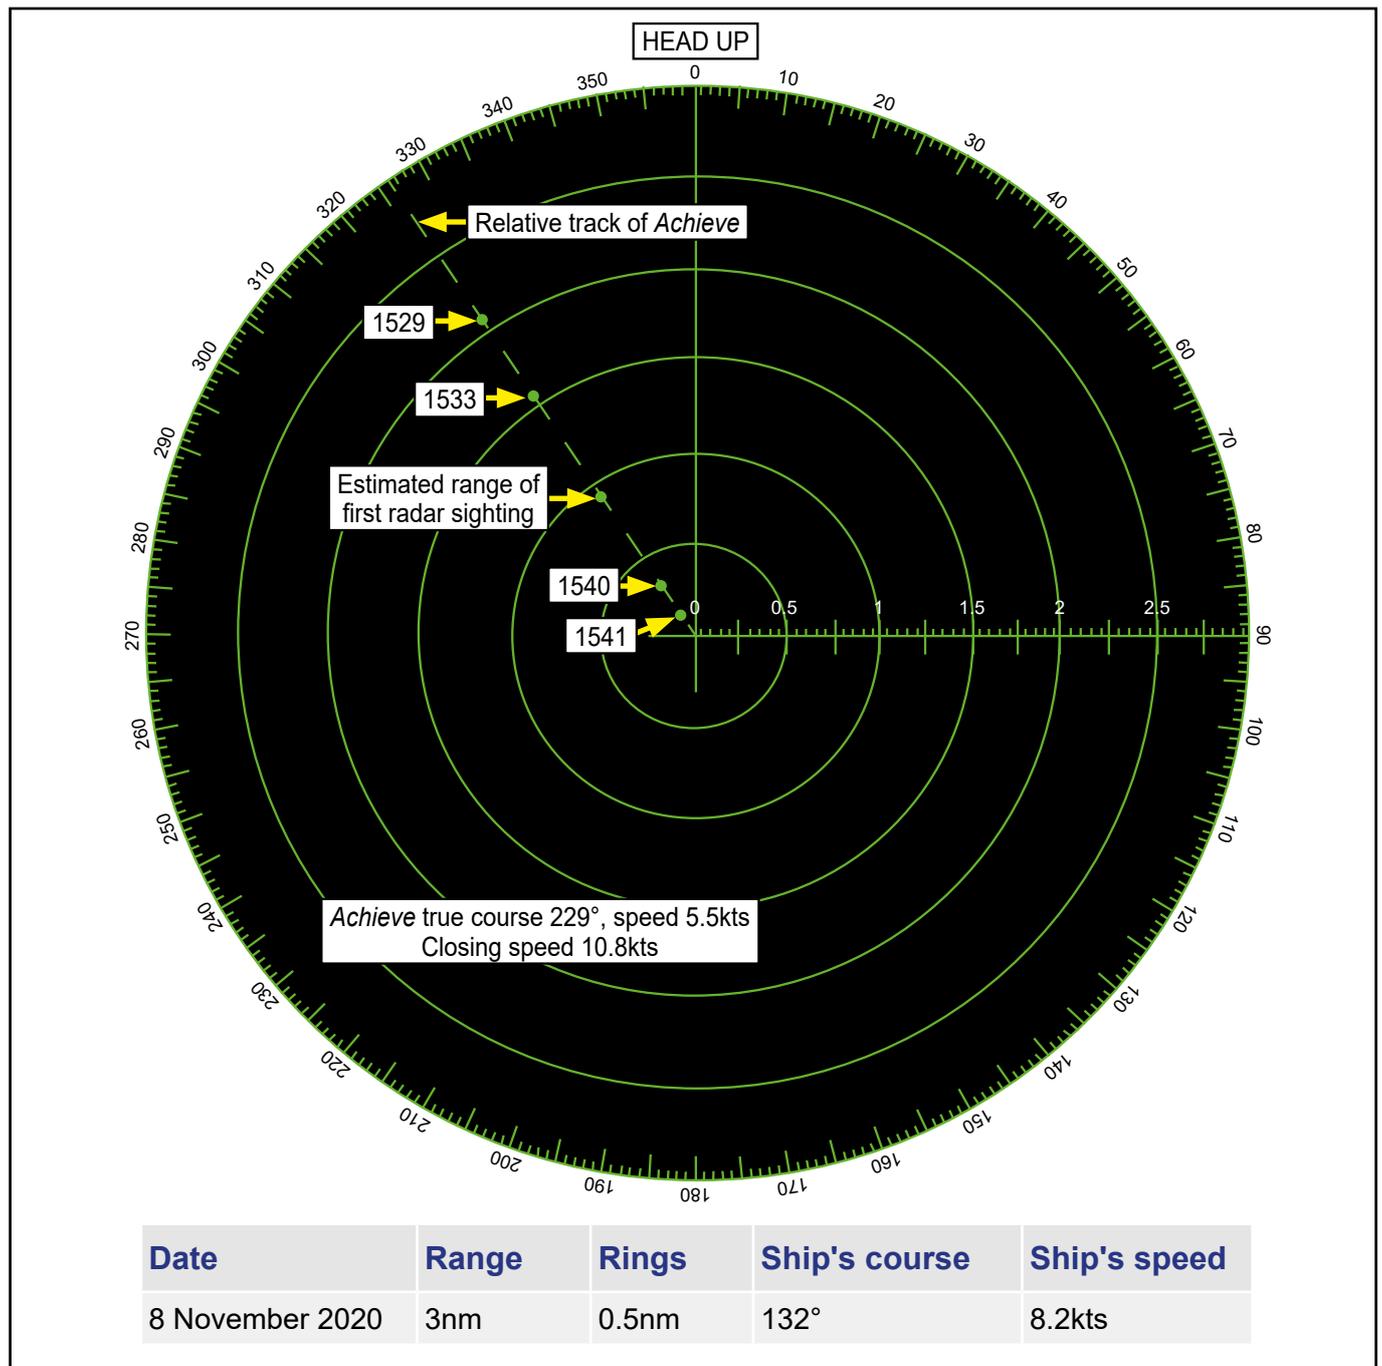
Figure 6: Plot of *Achieve*'s positions relative to *Talis*, recreated from third party VDR

A bulk carrier anchored off Tynemouth, 1nm away from the accident position, was fitted with a voyage data recorder (VDR)⁶, and MAIB recovered its data for analysis. Radar information was recorded and used to determine *Talis* and *Achieve*'s positions before the collision. MAIB plotted the positions (**Figure 6**) to determine the vessels' aspect and *Achieve*'s relative movement, as seen from *Talis*, prior to the collision.

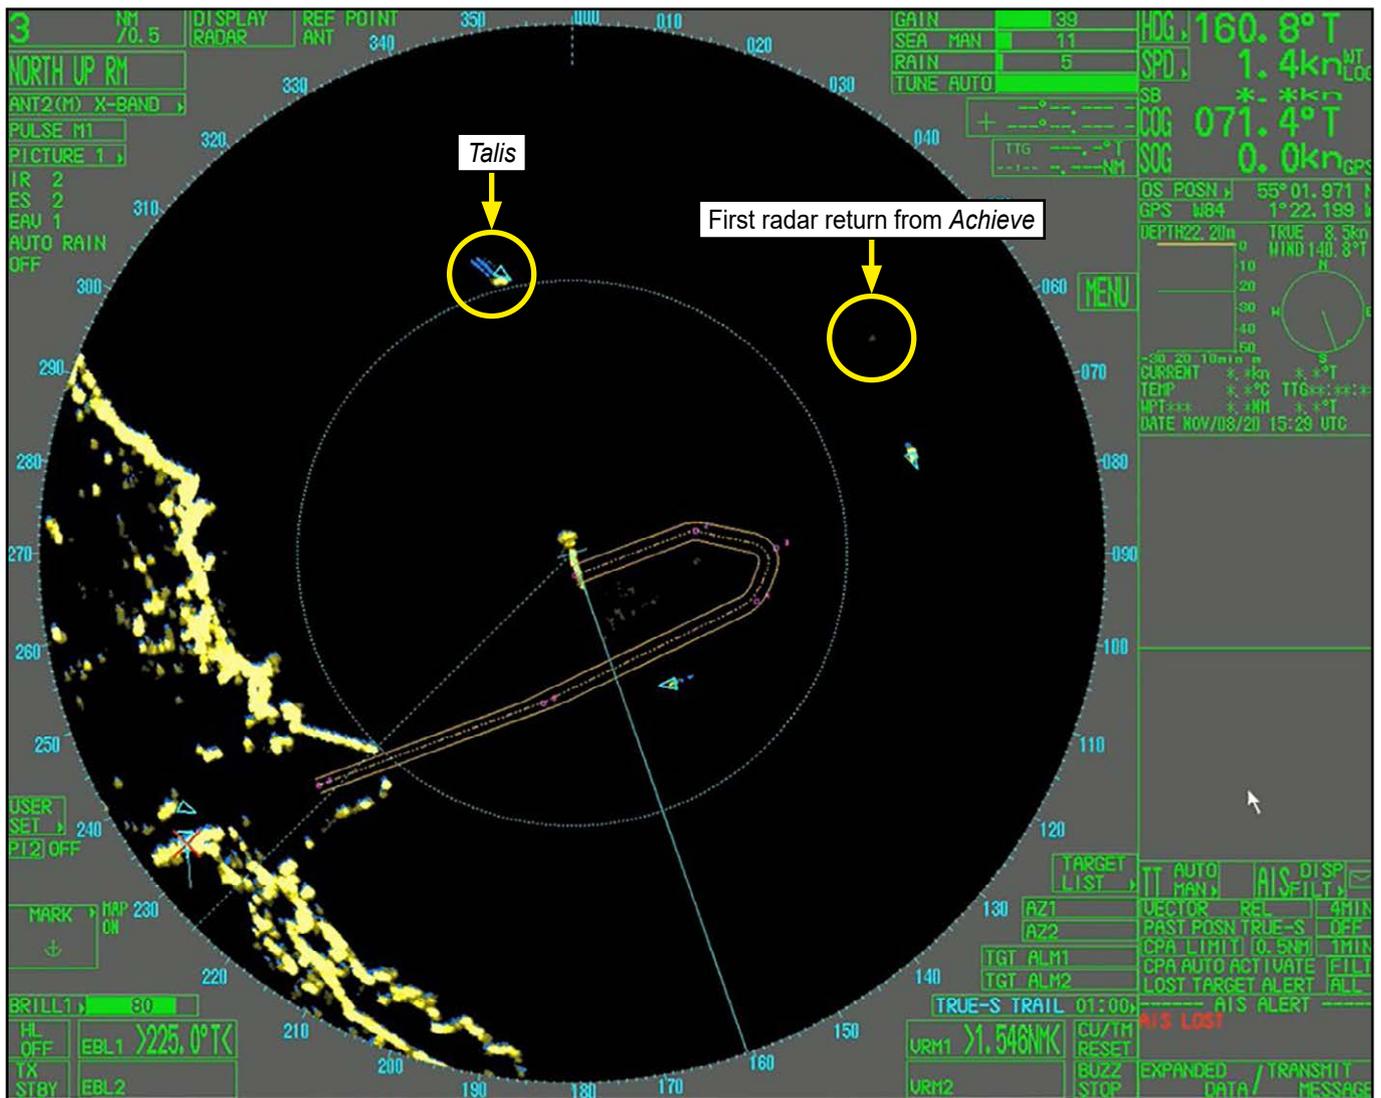
Figure 7: VDR radar image, showing first radar return of *Achieve* at 1529 UTC

A faint radar return appeared on the bulk carrier's radar at a range of 2nm (**Figure 7**) and sporadic returns were subsequently seen. Following the collision, *Achieve's* radar return became much stronger as its aspect to the bulk carrier changed.

Achieve was detected by the radar on board the bulk carrier at anchor off Tynemouth at a range of 2nm at that time when the fishing vessel's aspect provided for the weakest radar signal echo reception. The aspect that *Achieve* presented to the approaching *Talis* should have provided a better radar return on *Talis*'s radar, so detection at a range greater than 2nm should have been possible. *Achieve* was a wooden fishing vessel, so it is probable that, had the portable radar reflector on board been mounted on the vessel's mast, it would have increased the strength of the returning echo signal to *Talis*, thereby improving the chance of earlier detection.
