## **INVESTIGATION OF MAY 16, 2020 FATALITY**

LEASE OCS-G05800, EWING BANK  
BLOCK 826 PLATFORM "A"

GULF OF MEXICO REGION, HOUMA DISTRICT

January 10, 2022

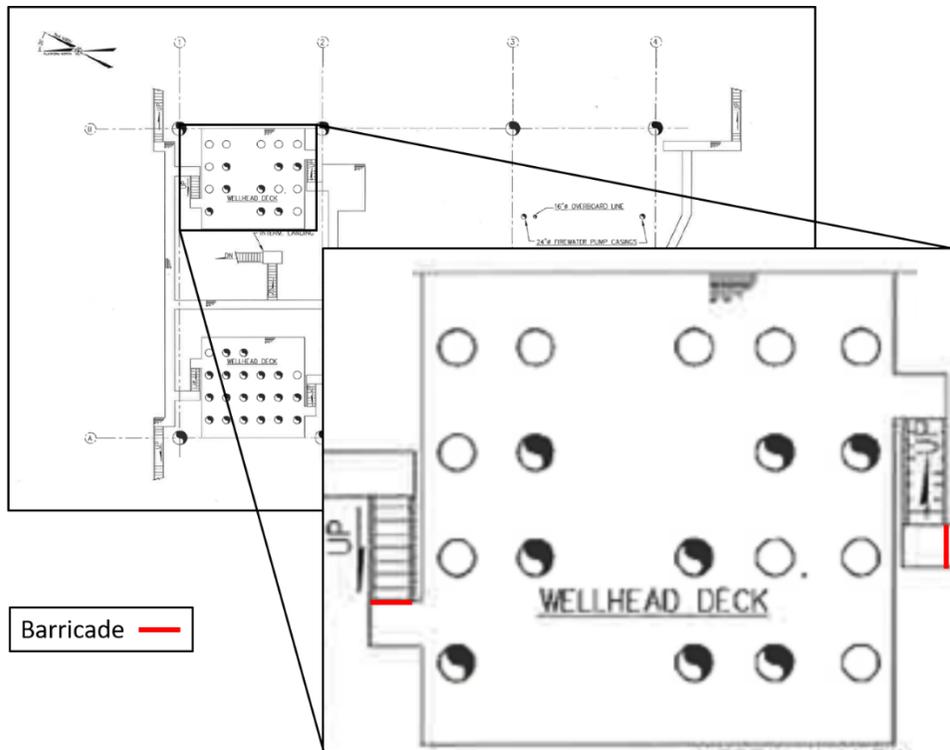
Figure 4 – Barricade locations preventing access to wellhead deck (more commonly referred to as the casing deck)

Following the November 2019 Level I Survey, Fieldwood sent their own personnel to conduct an audit of the platform in December 2019. The inspector of this audit recommended placing the casing deck out of service. According to the audit action items, operators put a hard barricade at both stairways used to access the deck until all the grating could be replaced (Figure 4).

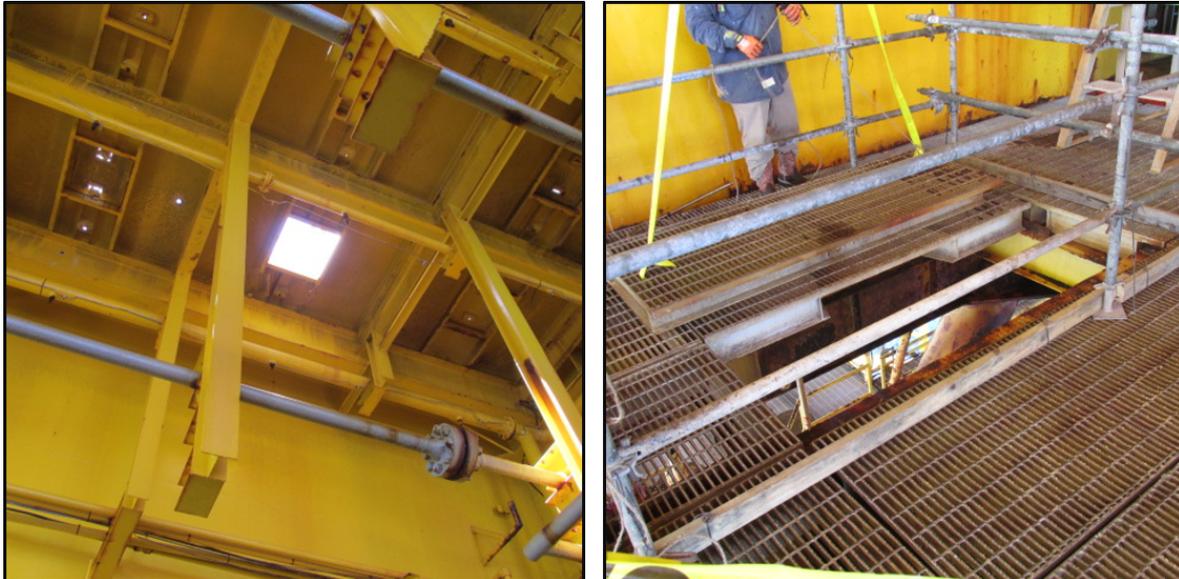
*Figure 5 – Lowering the grating*

On May 15, 2020, the construction crew planned to complete the task of replacing the grating, but due to a weather delay, they could not complete all the steps described in JSA. The job started with lowering new grating from the top deck to the casing deck. To accomplish this, the grating had to be guided through a hatch on the drilling deck and then through a section of removed grating on the production deck, before being placed in position on the casing deck (Figure 5).

Personnel were stationed on the drilling deck, production deck, and casing deck for this part of the job. According to interviews, the welder and the victim were on the casing deck to receive and position the grating, but neither wore fall protection during the job. While briefly in the well bay on the production deck, the construction superintendent failed to notice that the welder and victim were not wearing fall protection. Additionally, no one in the construction crew invoked SWA to call attention to the lack of fall protection.

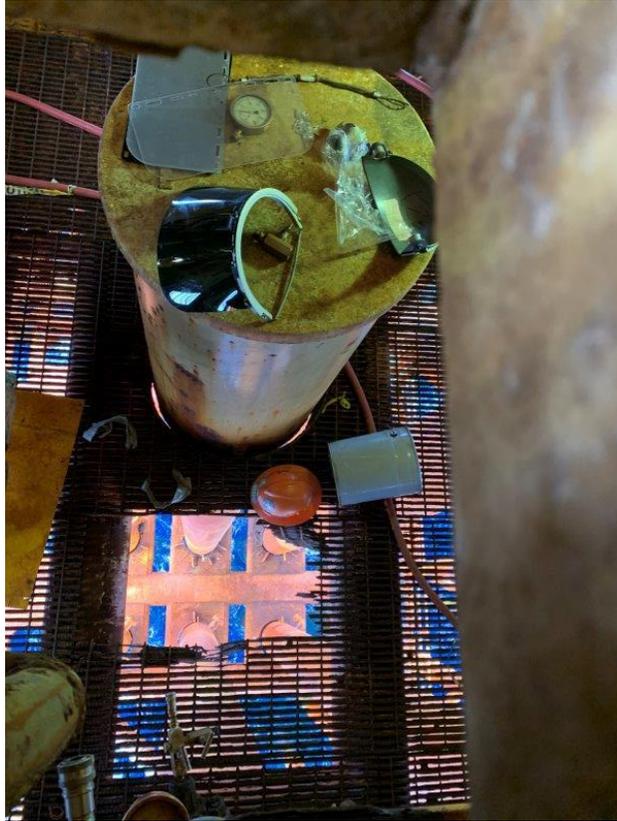
Figure 6 – Hole through which victim fell

At approximately 7:30 a.m., after the rigger and victim returned to the casing deck, again without donning their fall protection, the section of grating on which the victim stood parted (Figure 6). The locations of the construction crew members on the casing deck are shown in Figure 7.

Grating is made of crossbars (round bars) and bearing bars (flat bars). The width of a given piece of grating is integral to the amount of load it can handle. This is because the load is distributed to the bearing bars via the crossbars. Most of the grating on the casing deck was in a severely corroded condition and considered hazardous to walk on. With the crossbars cut and some rust removed, the grating no longer had adequate structural integrity. Statements made by construction crew personnel indicate that they did not consider that ripping the grating affected its structural integrity.

- All facility walking (and working) surfaces should be regularly inspected and maintained in a safe condition.
  - Grating should be replaced in a timely manner in accordance with the recommendations of NTL No. 2009-G32.
- Operators must perform an internal review of their contractors' SEMS Programs to suitably and adequately identify the gaps in a bridging agreement clearly assigning responsibility. These bridging agreements should be periodically reviewed to ensure continued effectiveness.

- Special emphasis should be given to SWA with no fear of reprisal.
- A clear delegation of authority should be communicated to all personnel.
- Construction crews should be trained in the dangers of compromised grating and the hazards associated with ripped grating.

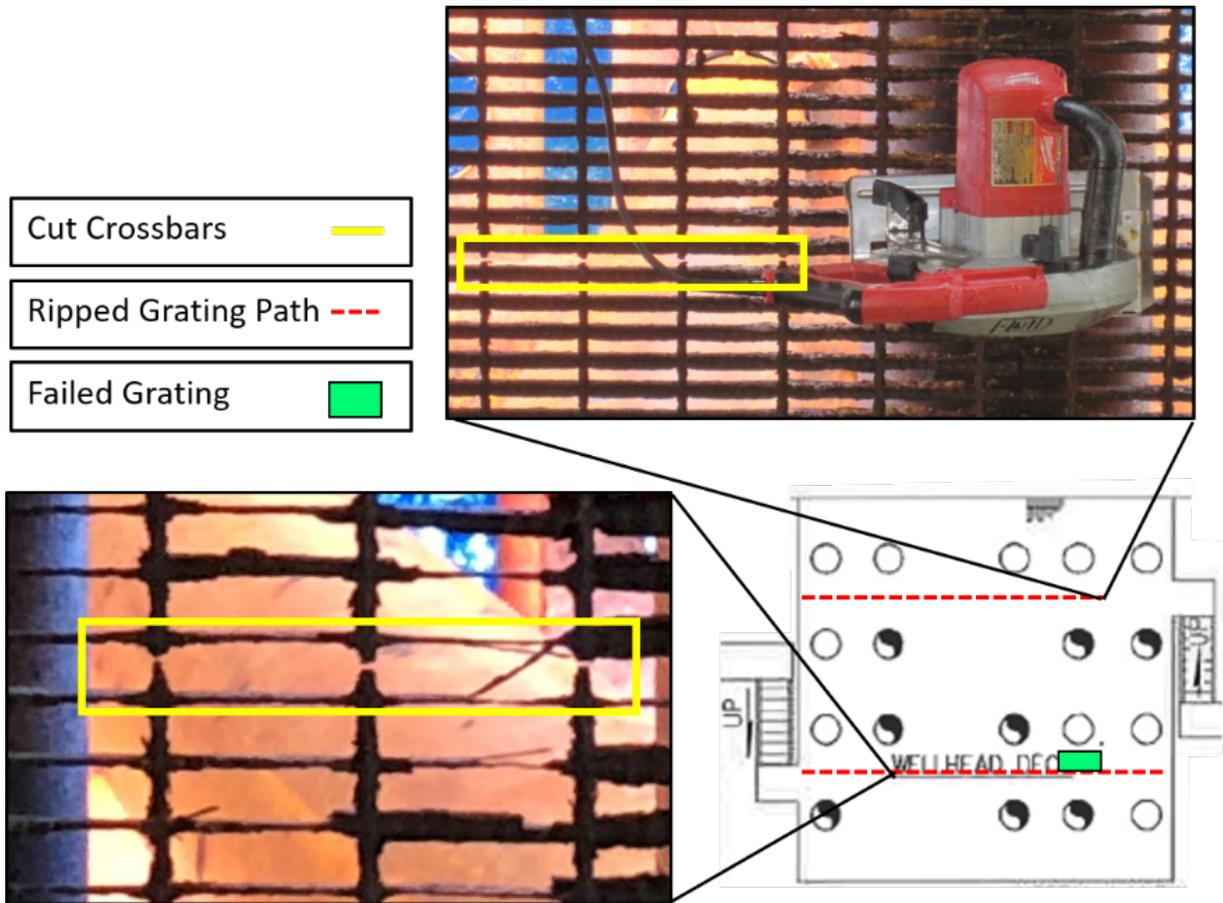
Figure 9 – Ripping the grating on the casing deck

the grating on the deck. Ripping grating is the process of cutting along the crossbars to make two sections of grating the same length but narrower in width. During the time that the rigger and victim were on the production deck to tighten the hammer union, the welder was able to rip the grating down two of the three straight-line corridors between the well casings, as seen in Figure 9.

- Personnel performing the job failed to adhere to the requirements of the JSA.
  - Although the JSA explicitly stated to rip the grating “a piece at a time,” personnel proceeded to rip the entirety of the work area, thereby weakening the structural integrity of the grating.

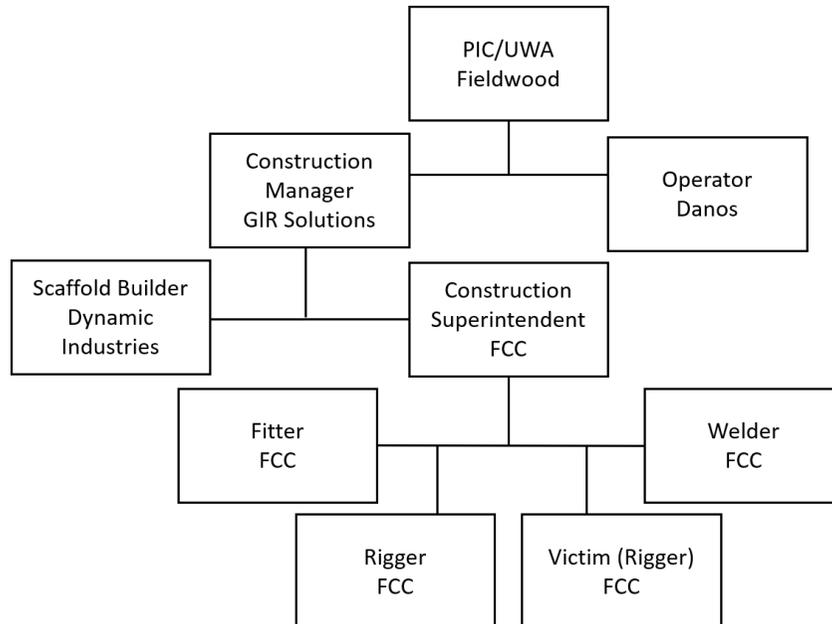
Figure 14 – Delegation of authority

The delegation of authority for personnel relevant to the incident on the facility at the time of the incident is shown in Figure 14. Upon arrival at the facility, the construction manager and construction superintendent signed an Ultimate Work Authority (UWA) agreement form for simultaneous operations with the PIC, confirming the PIC as the UWA. Fieldwood defines simultaneous operations as “when multiple operations or activities such as production [and] construction [...] occur simultaneously at offshore facilities.” Fieldwood’s policy also states that the “overall safety of the operations on the facility when simultaneous operations are being conducted” is the UWA’s responsibility. The PIC is also the final approval for JSAs.
