Investigation of December 2, 2020 Fatality, Lease OCS-P 216, Pacific Region, Los Angeles Block 6862

January 10, 2021

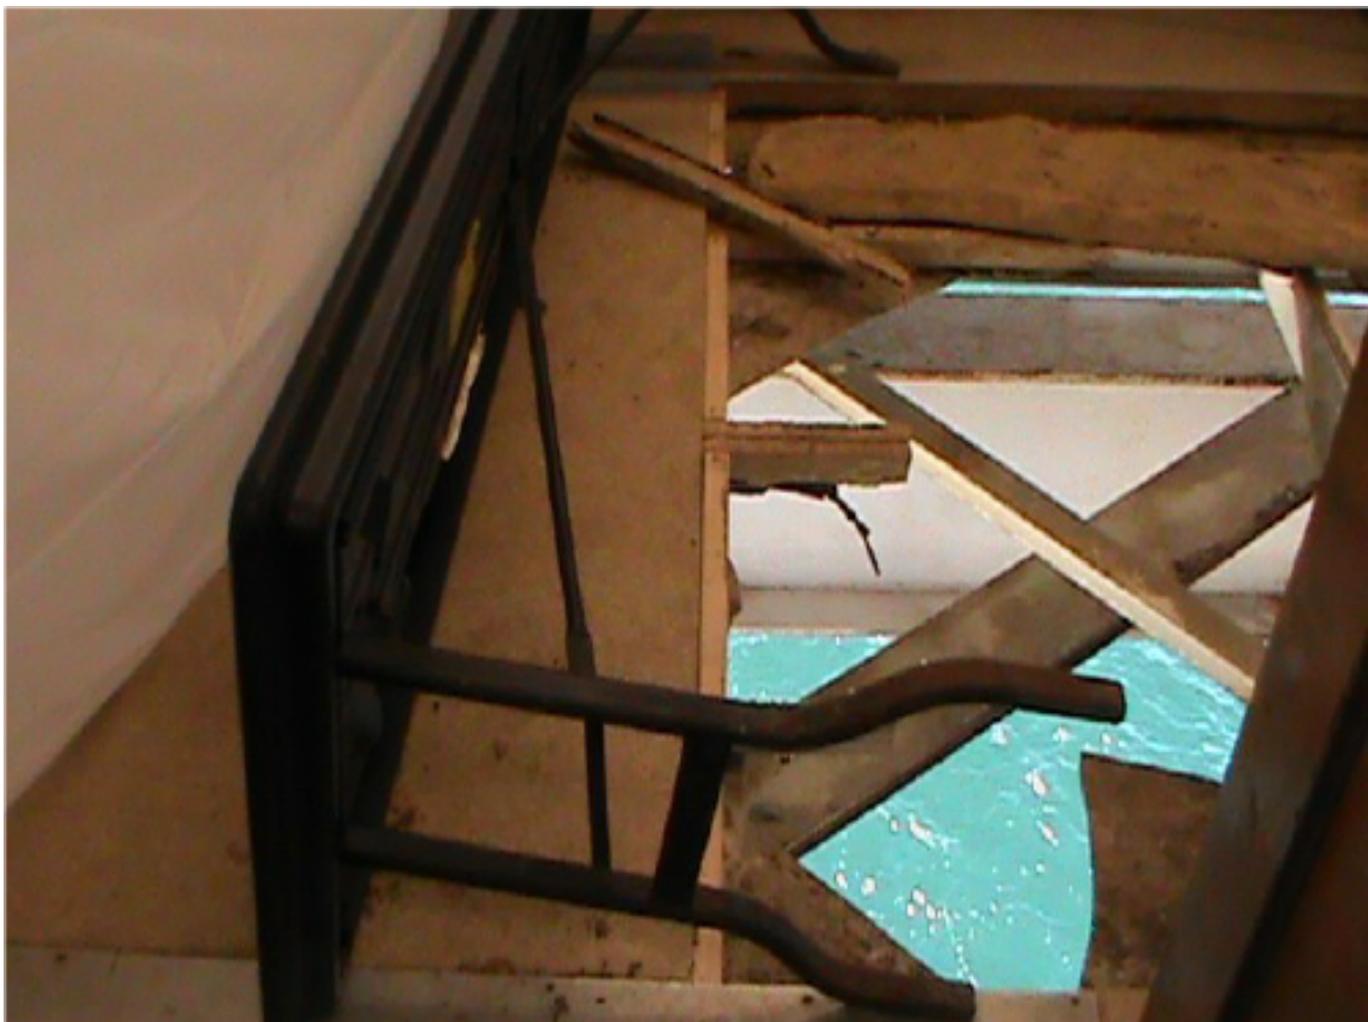
Figure 1. Galley flooring inside the living quarters.

A three-member construction crew, employed by DCOR, was repairing a section of the galley floor in the main living quarters, on the first floor, that had sustained water damage. The main living quarters building is located at the drill deck level. The flooring consisted of a layer of linoleum, a 4-by-8-foot sheet of 1-inch plywood, a 1.5-by-3-inch wooden floor joist, and a 5-millimeter composite flooring (moisture barrier) material set on top of a steel frame. The crew removed the damaged material in a 7-by-7-foot area of the galley floor, leaving only the 5-millimeter moisture barrier.

Based on findings of the investigation, the Panel concluded the cause of the fatality and serious injury was the failure of the construction crew and authorizing personnel to recognize that the 5- millimeter moisture barrier was not a walking/working surface, and that it could not support their weight. The victim and IP's combined weight caused the barrier to break, which resulted in them falling approximately 80 feet into the Pacific Ocean.

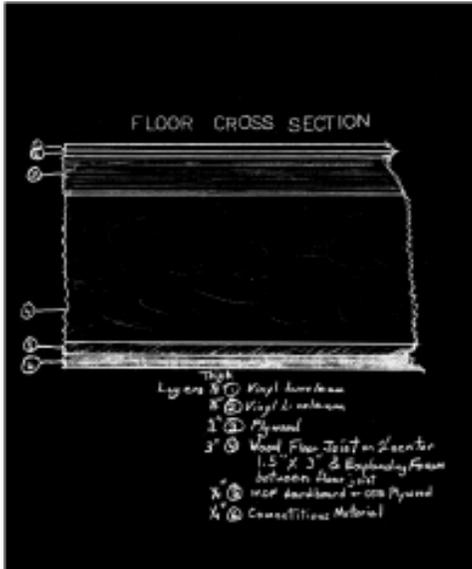
Figure 3. Cross-section of flooring (Source: BSEE)

Vinyl Linoleum - Linoleum is a standard heavy grade with two layers.

Plywood - Construction grade 1-in plywood 4-by-8-foot sheets.

Floor Joist - 1.5-by-3-inches wooden floor joists on a 2-foot center and spanning a length of 7 feet. The crew fabricated replacement joists by removing a half-inch piece from 2-by-4-inch framing lumber.

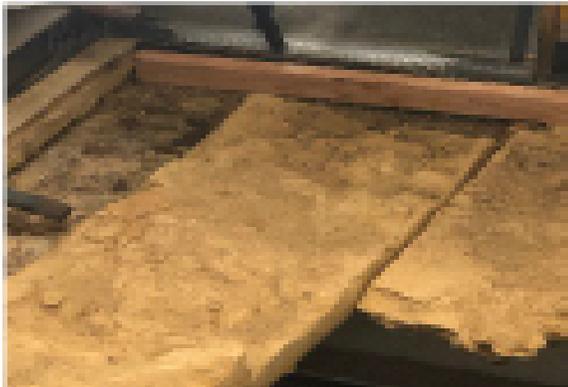
Figure 4. Insulation

Insulation in floor cavities have identification hallmarks of urea-formaldehyde foam insulation (UFFI), which easily crushes to a fine powder.

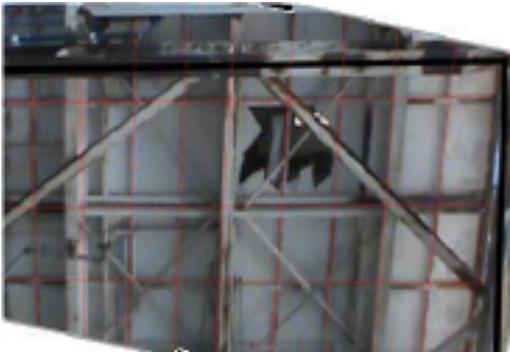
Figure 6. Steel frame

Steel Frame - The floor is supported by a steel frame fabricated on a 4-by-8-foot grid.
