IIMS 2021 Safety & Loss Prevention Briefings Compendium

A 100-PAGE COLLECTION OF WORLDWIDE MARINE
INCIDENT AND ACCIDENT REPORTS, LOSS PREVENTION
BRIEFINGS AND CASE STUDIES PUBLISHED IN 2021

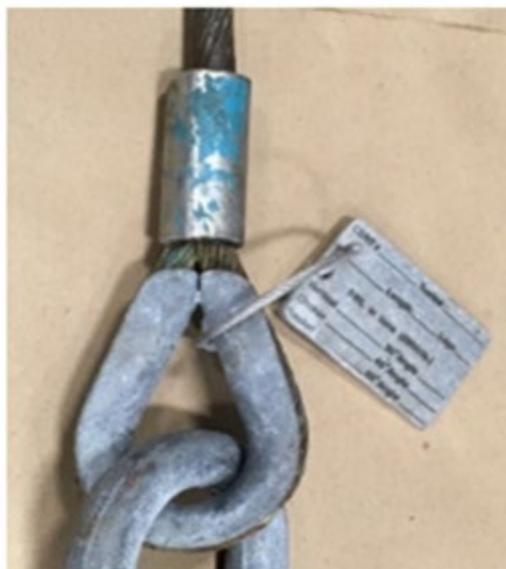
Figure 1: Fitting has a uniform appearance.

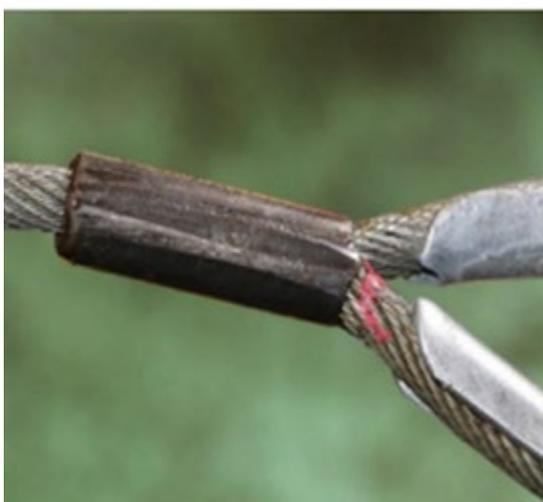
Figure 3: Fitting is deformed with "ridges" of extra material present from over-crimping.

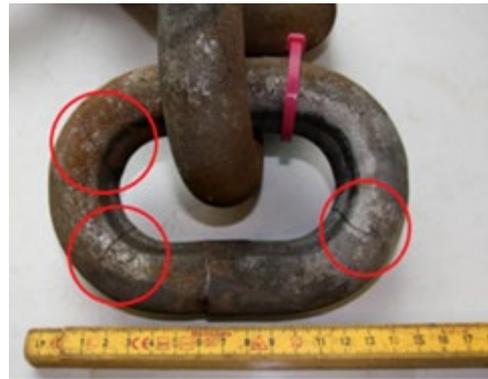
A chain link used in the lifting equipment of a fishing vessel showing fractures identified during inspection

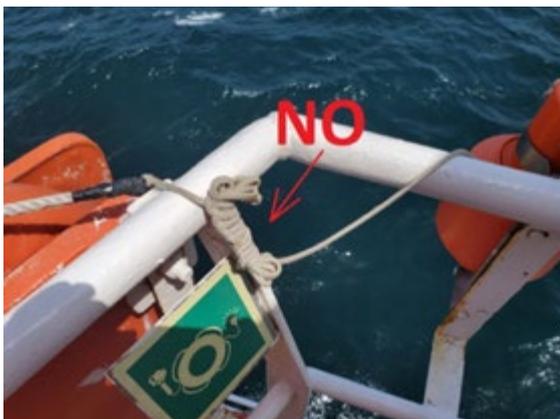
Shortened lanyard on MOB beacon

The practice of shortening the lanyards on MOB beacons was discovered by someone visiting a vessel. This was accordingly communicated to the Chief mate to be fixed.

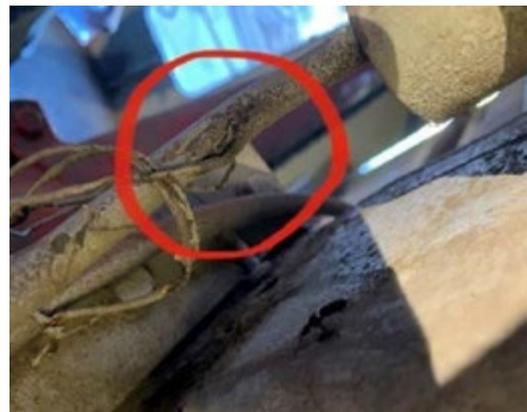
Damaged Electrical Cable

During a washdown of a vessel's cargo hold a crew member noticed arcing from around two electrical cables near the cargo hold light. Upon closer investigation he noticed a piece of tie wire connected to the cables was glowing red. The crew member immediately stopped hosing down and turned the water supply off and notified the ship's electrician.

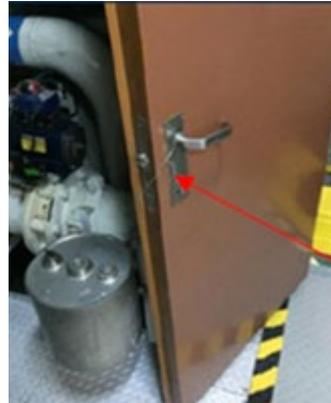
1: Fire door held open by wire

A fire door in the engine room was observed to be wired open – it was being kept open with piece of wire.

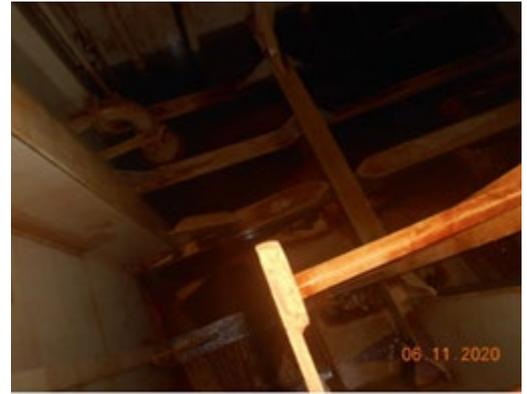
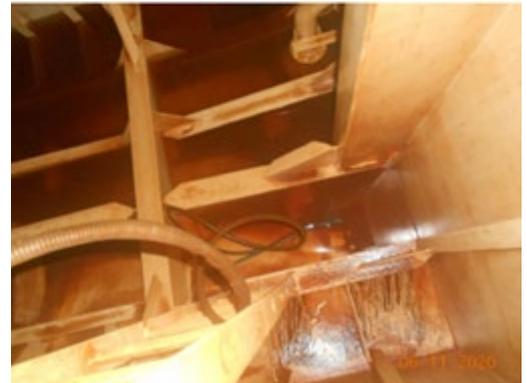
Sludge Accumulation in Fresh Water Tank

During inspection of a fresh water tank, it was discovered that there was significant sludge accumulation in the tank. Based on the condition of the tank, it was seen as more than likely that other tanks would be similarly affected and that the cause was due to a common source of water. Sludge build-up in fresh water tanks, hoses and pipes can lead to the prevalence of bacteria that may pose a health hazard.

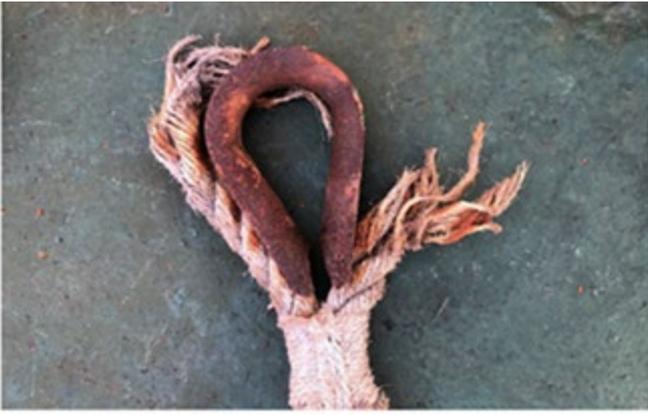
Failure of natural fibre rope in embarkation ladder

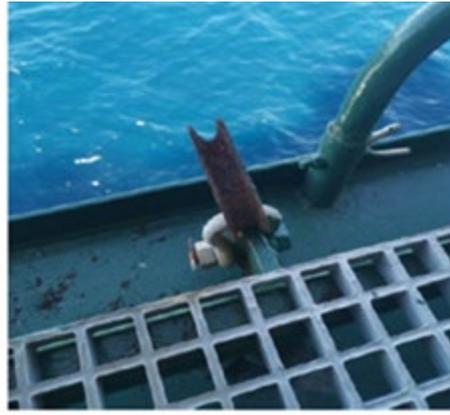
Failure of cordage

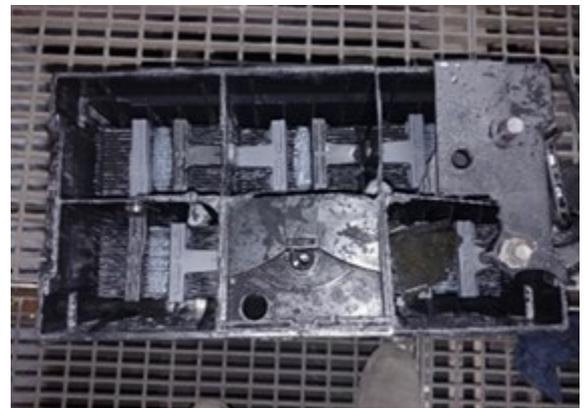
Lead-acid battery explosion

A lead-acid battery blew up when an engine was started. The incident occurred when, after conducting pre-start checks on a generator, the 2nd Engineer attempted to start the engine. As the lube oil pressure reached start pressure and the starter motor engaged, there was a loud bang from behind the engine in the vicinity of the port side battery box. The 2nd Engineer on investigating, found that one of the batteries in the bank for the generator had suffered a critical failure resulting in the top of the battery case being destroyed. He left the space immediately in case of release of hydrogen gas and woke the Chief Engineer to inform him of the incident.

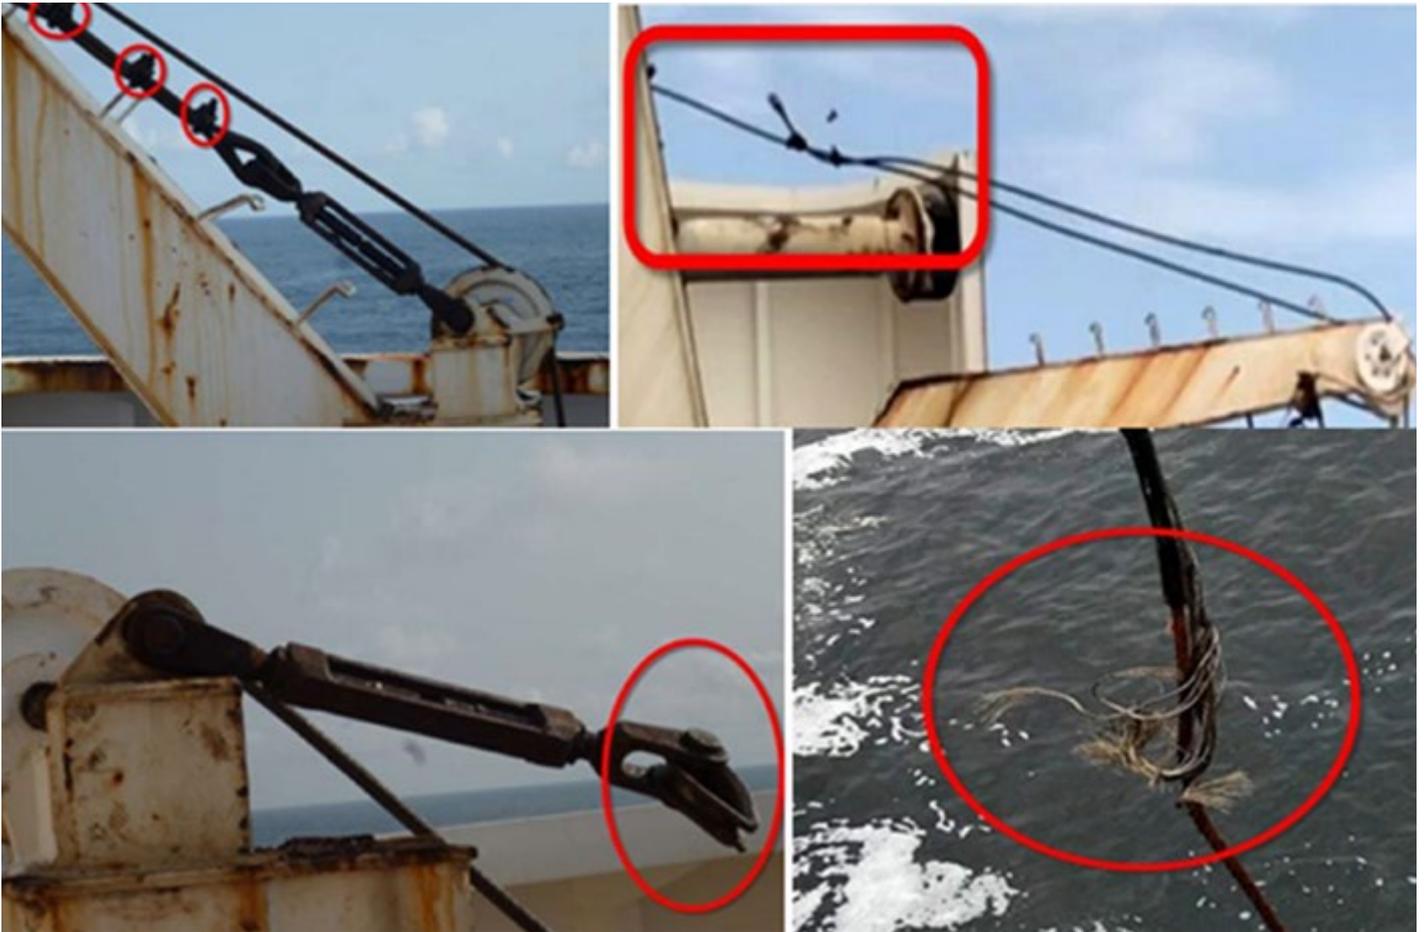
Lifeboat wire rope failure

During a five-yearly 110% load test of a lifeboat, taking place under third party supervision, the forward fall wire failed, resulting in the lifeboat falling and flipping upside down landing in the water below. There were no personnel onboard during testing and no injuries were reported. The lifeboat was recovered to shore.

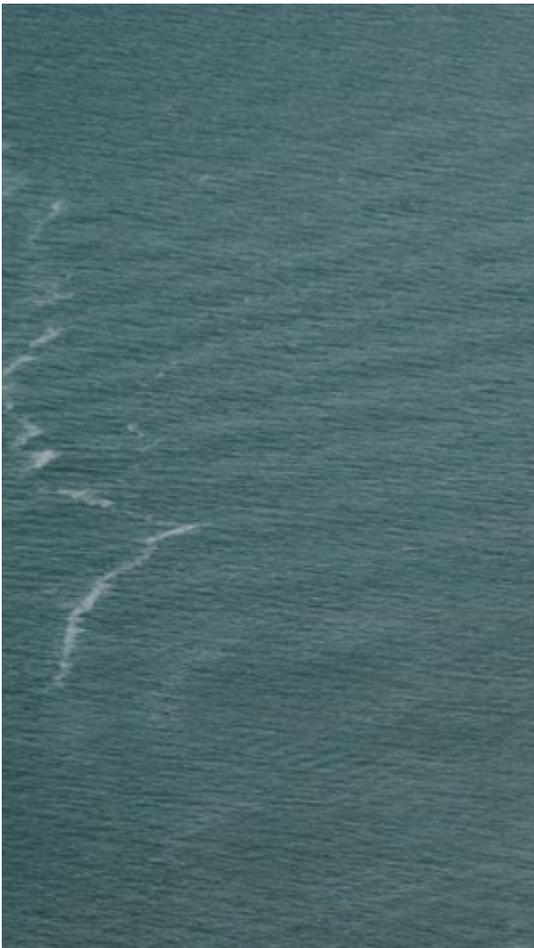
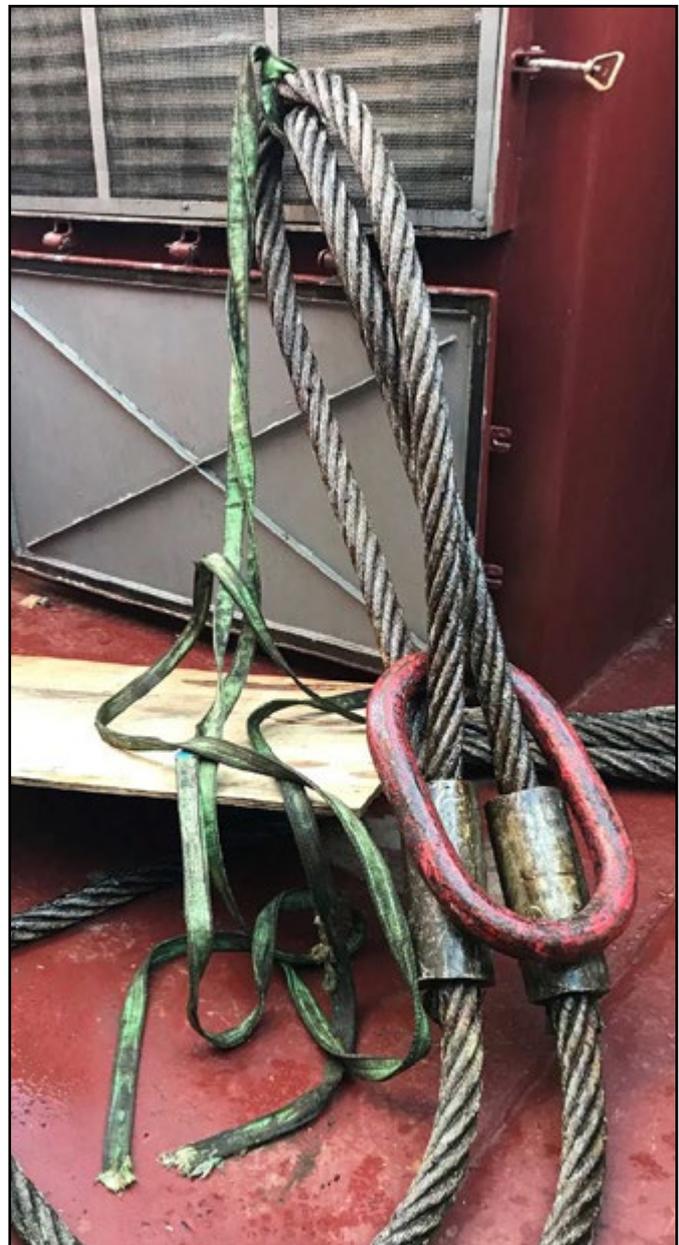
4. All fixed and loose lifting gear should be regularly inspected and documented. The purpose of inspections is to check that the gear is being maintained in a satisfactory condition for safety-related operational use. After the accident, it was discovered that the fibre sling in use was in a poor condition (Figure 2) and had not been recorded in the vessel's lifting gear log. Although the breaking load of the sling was sufficient to hoist the lifting gear, it should have been disposed of due to its poor condition.

Figure 2: The broken fibre sling, still attached to the lifting gear, after the accident

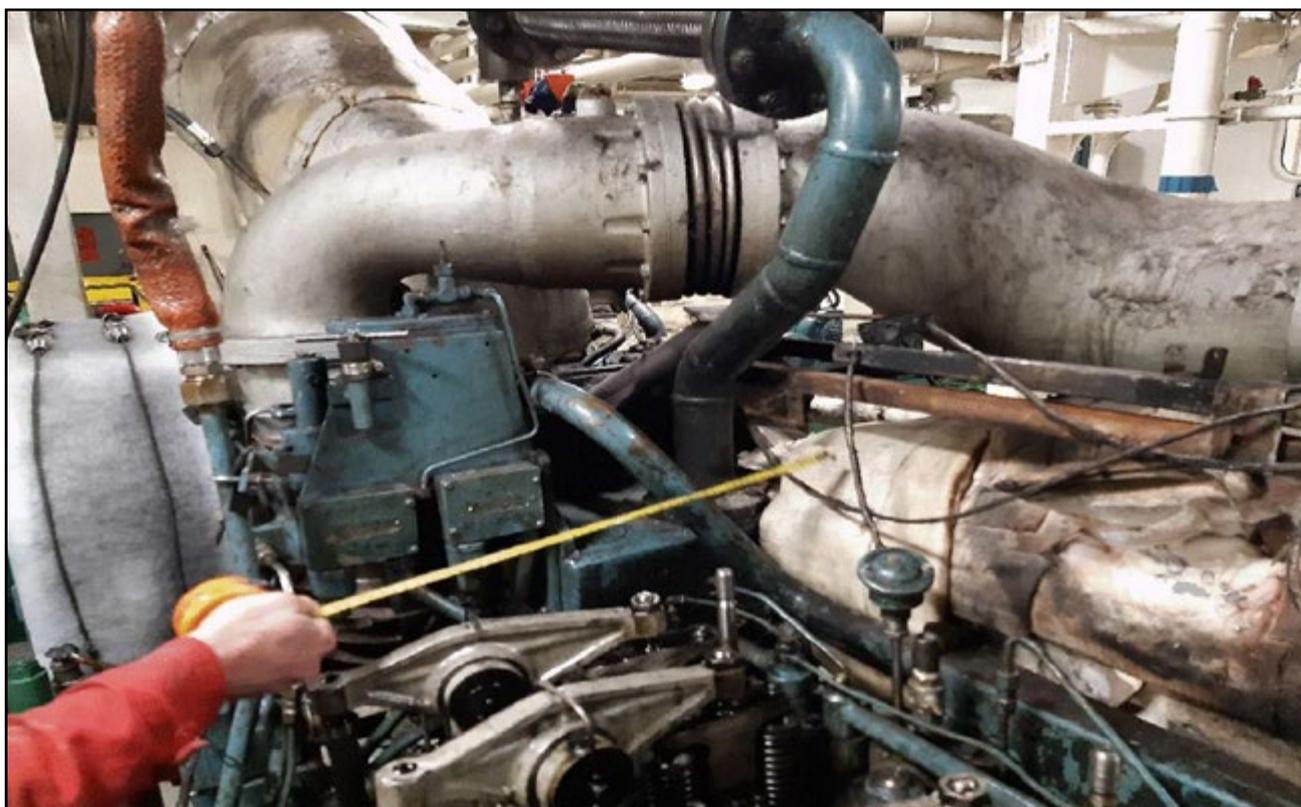
The company investigation later identified that during maintenance work on the main engine cooling system a pipe had been removed to allow a leak to be repaired by replacing a seal. This was not a planned task, and no risk assessment or method statement had been produced. When the pipe was removed, around 5 litres of water had drained from the top of the crank case breather box, and some oil residue inadvertently washed into the lagging. Main engine runs conducted alongside after the repair had not produced sufficient heat to ignite the oils. However, when the main engine was run under load at sea, the increased temperature produced was enough to cause a fire.

Figure: Location of lagging that ignited indicated

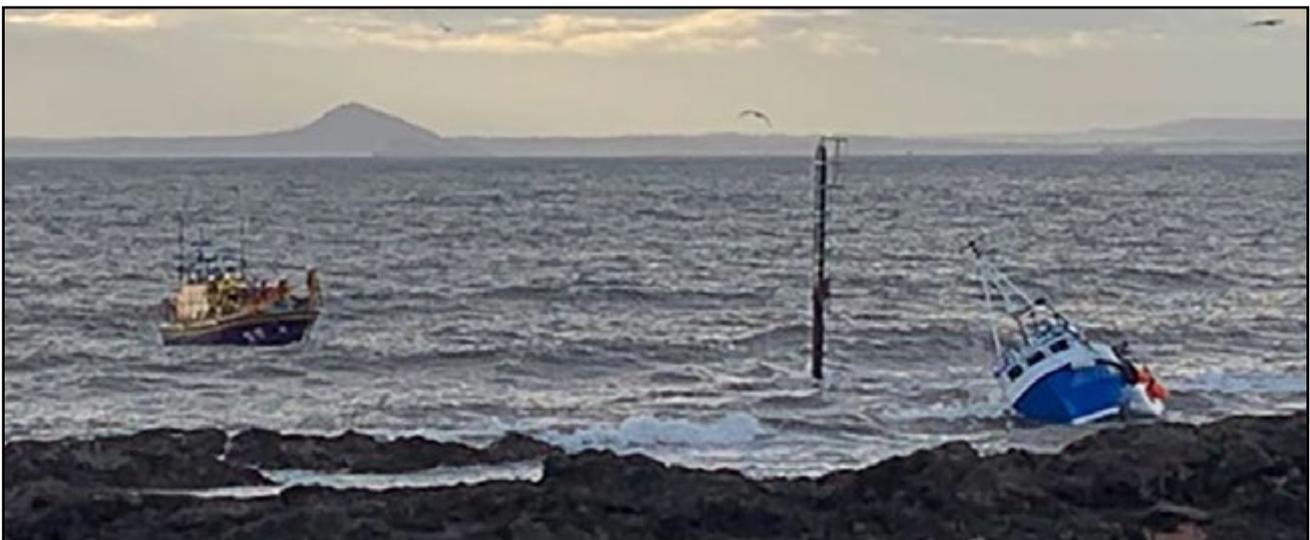
The fishing vessel's propeller was almost certainly fouled by a line from an unmarked creel fleet that had been laid close to the harbour entrance. The propeller wound this in tightly, jamming the shaft and stopping the engine. With no way of quickly clearing the fouled propeller, and poor holding ground for an anchor, there was little more the skipper could do.

Figure 1: Fishing vessel aground on rocks

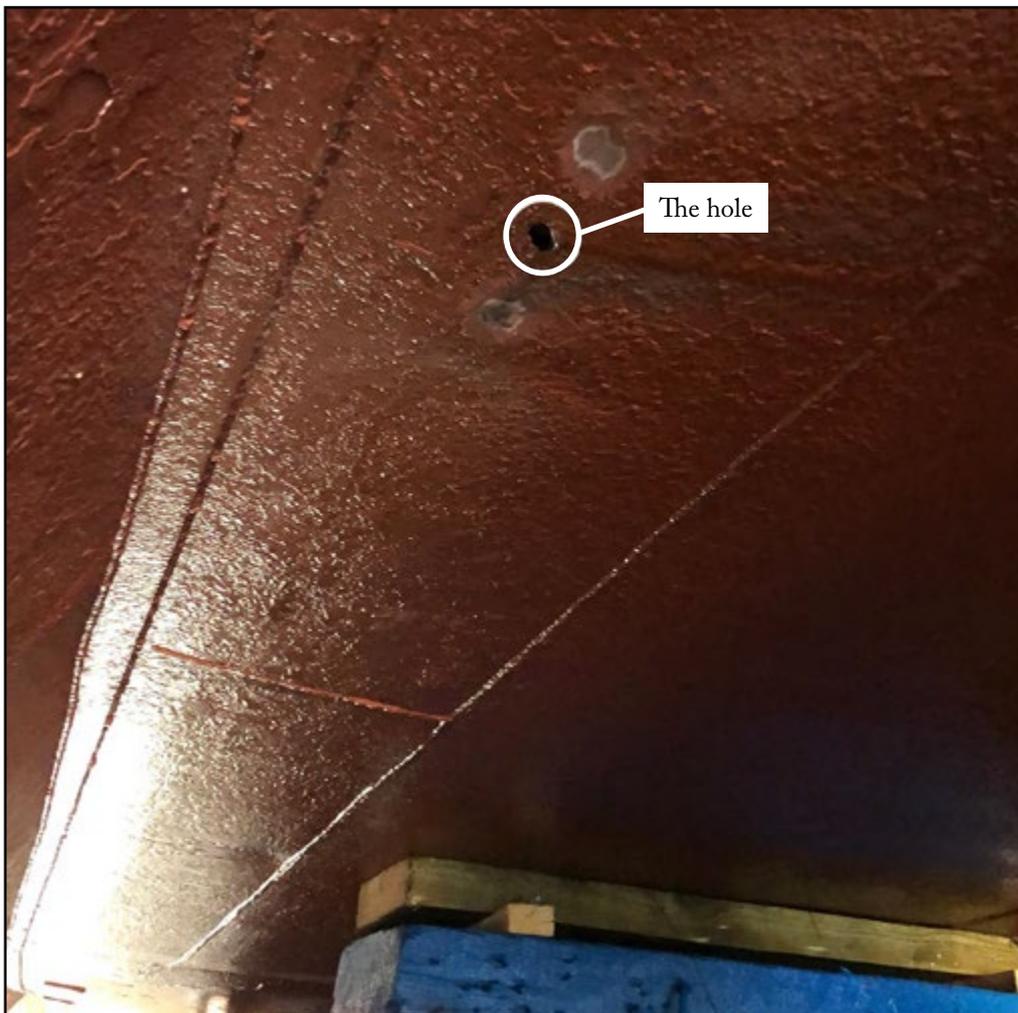
When the helicopter arrived, it lowered its powerful, petrol-driven salvage pump. Once this pump was set up and running, the situation was brought under control. As the water level reduced, the engineer was able to gain access to the fish hold's bilge well where the suctions were blocked by debris. The fishing boat then made its way safely back to harbour under its own power, escorted by the lifeboat. When the fishing boat was lifted out of the water, a 25mm diameter hole was found in the shell plating under the fish hold (see figure).

Figure: The 25mm hole in the fishing vessel's shell plating, observed when the vessel was lifted out of the water.

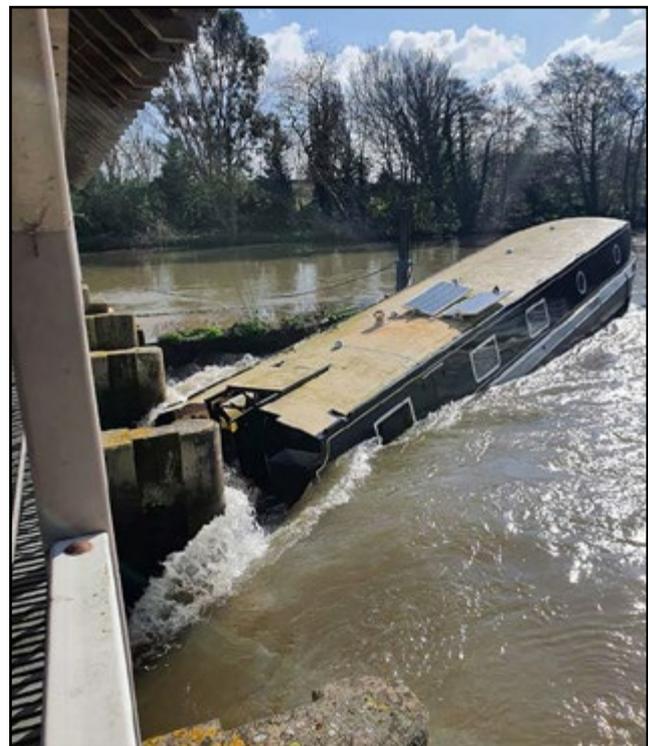
With the river in full flood and flowing through the guard piles and over the weir, the narrowboat eventually broke free of its temporary moorings and was carried into the weir sluice (Figure 1). The boat started to take on water and partially sank. As this now posed a flood risk hazard due to the narrowboat partially blocking the weir, the river authority mobilised its local tug to tow the narrowboat from the weir in order to prevent further damage. However, during their attempts to tow it clear of the area, the narrowboat continued to rapidly take on water and it eventually sank in the navigable part of the river before the tug could tow it out of the way.

Figure 1: Narrowboat partially sunk on weir

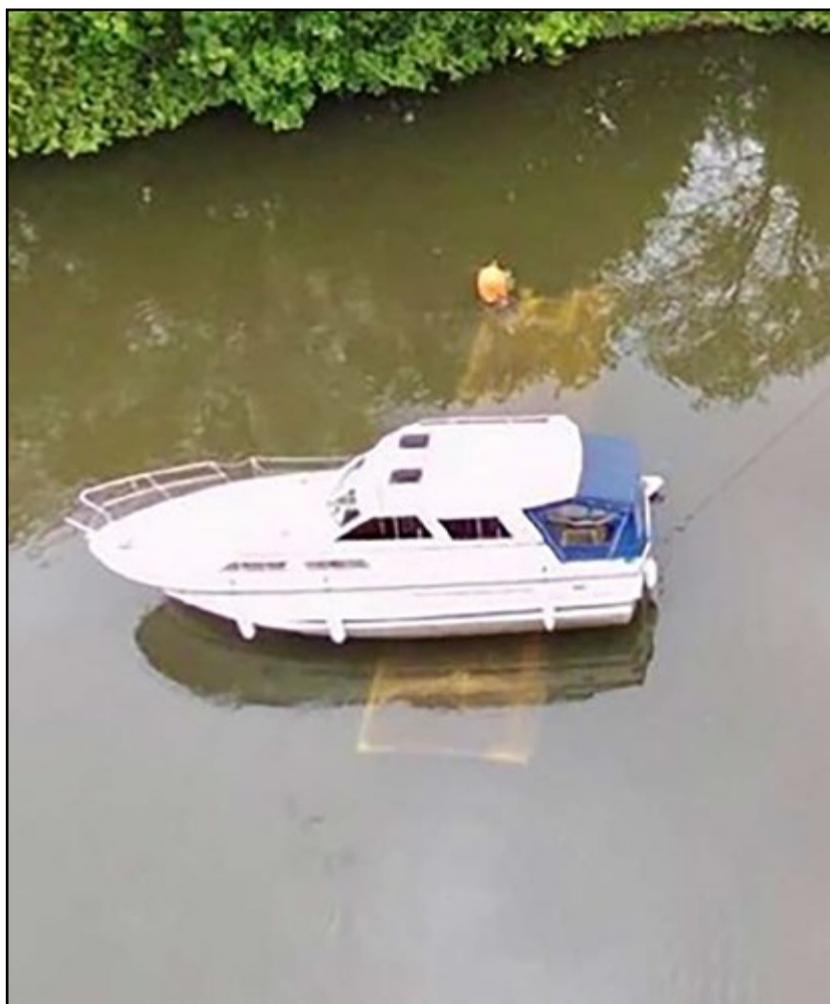
Figure 2: Motor cruiser grounded on submerged wreck

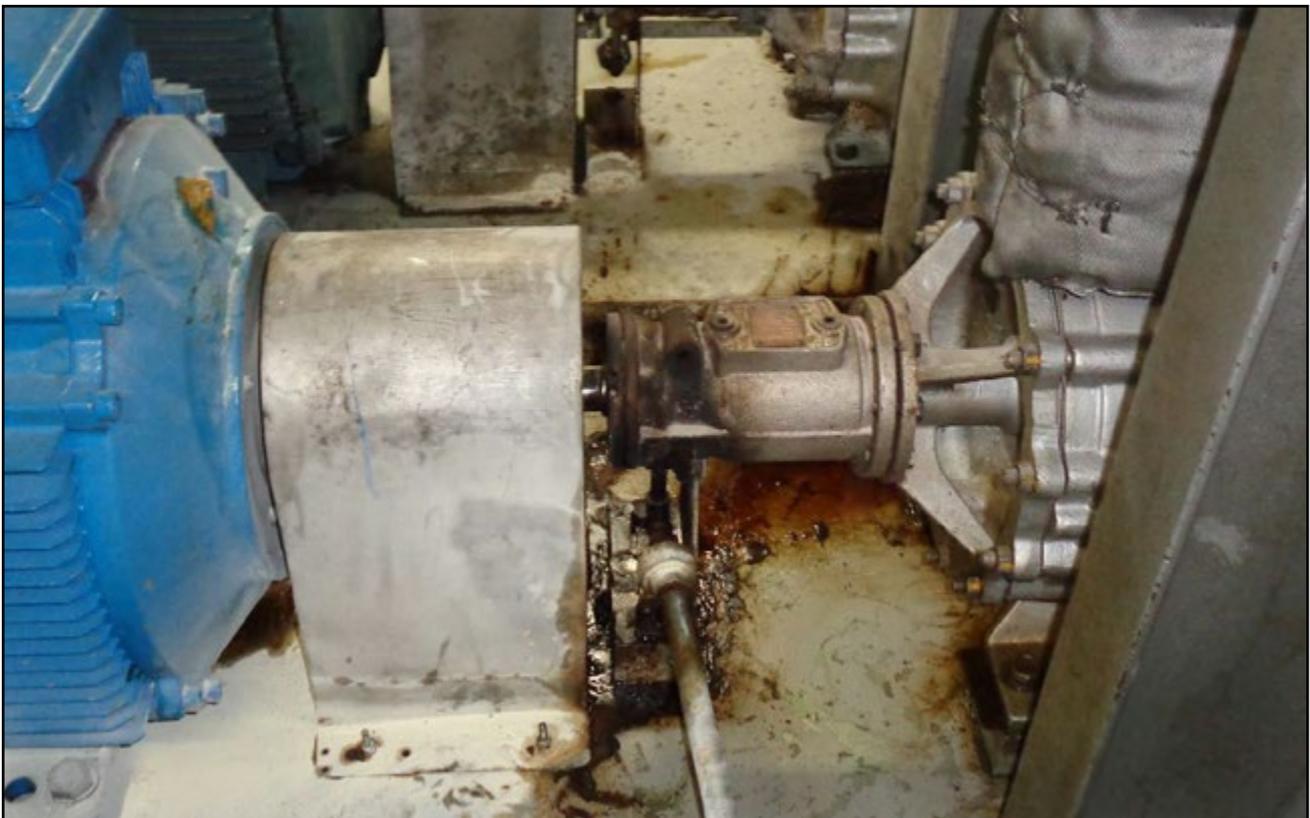
The cause of the fire was later found to be a failed pump bearing that had overheated, damaging the adjacent mechanical seal. The failure of the seal resulted in oil spraying out and igniting on the bearing's hot surfaces.

Figure: The scene of the fire, showing the fire damage around the coupling and leaked oil

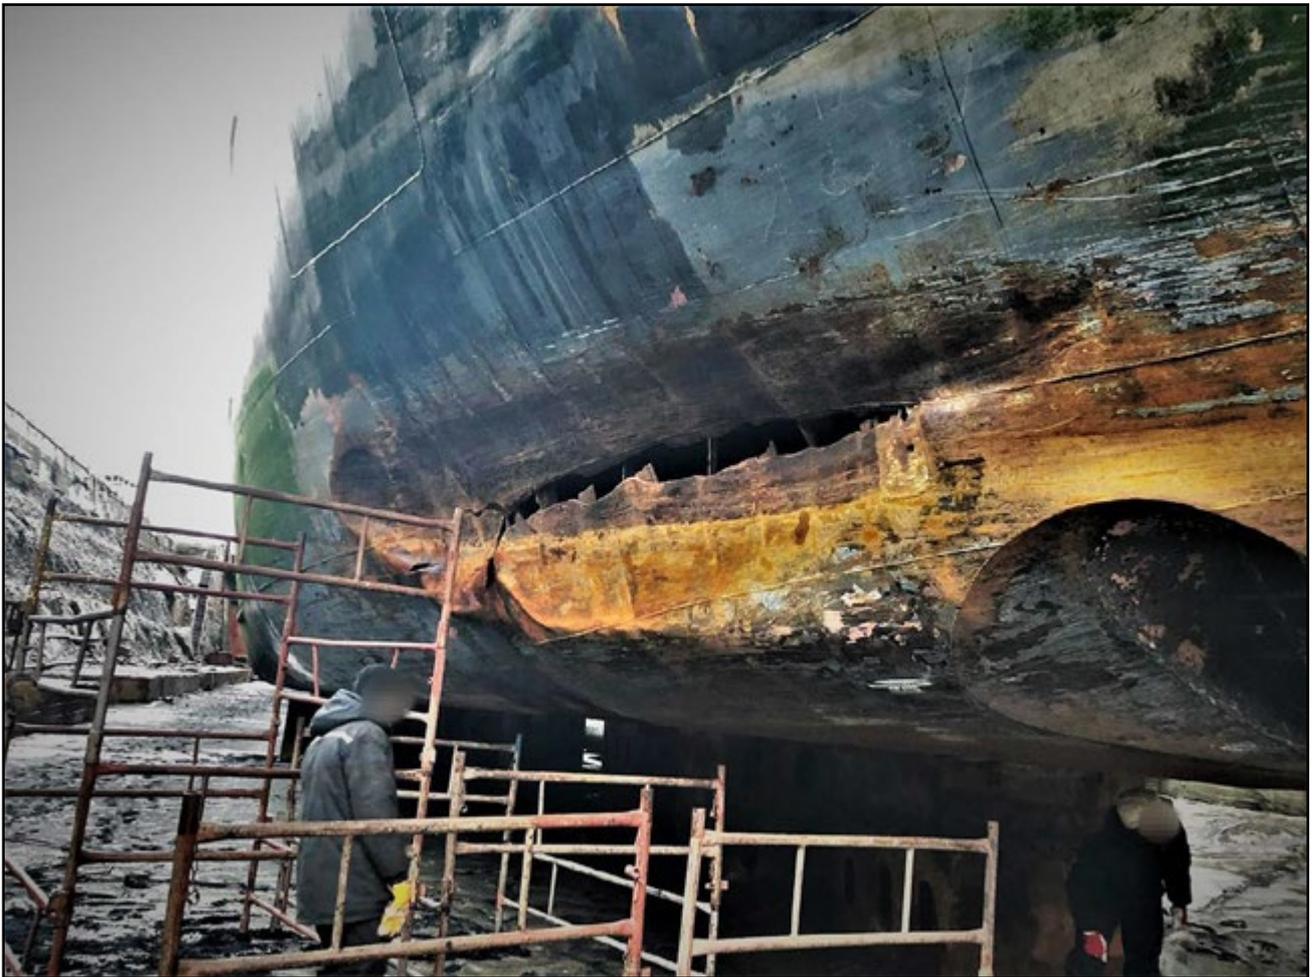
Figure: Damage to the general cargo vessel's hull plating

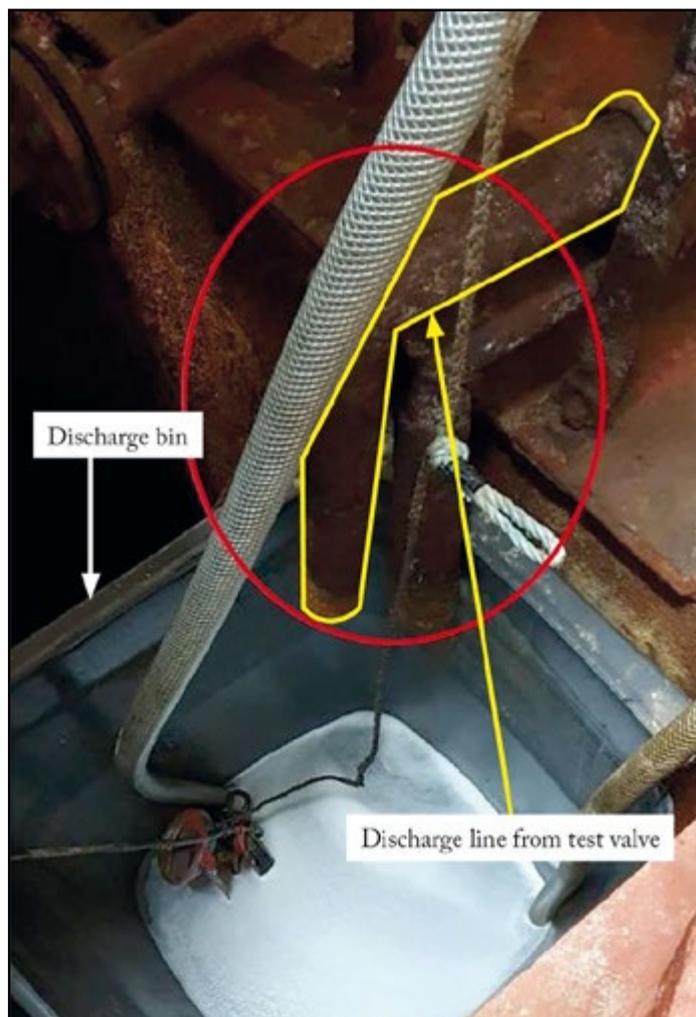
Figure 1: The discharge line from the test valve into the bin

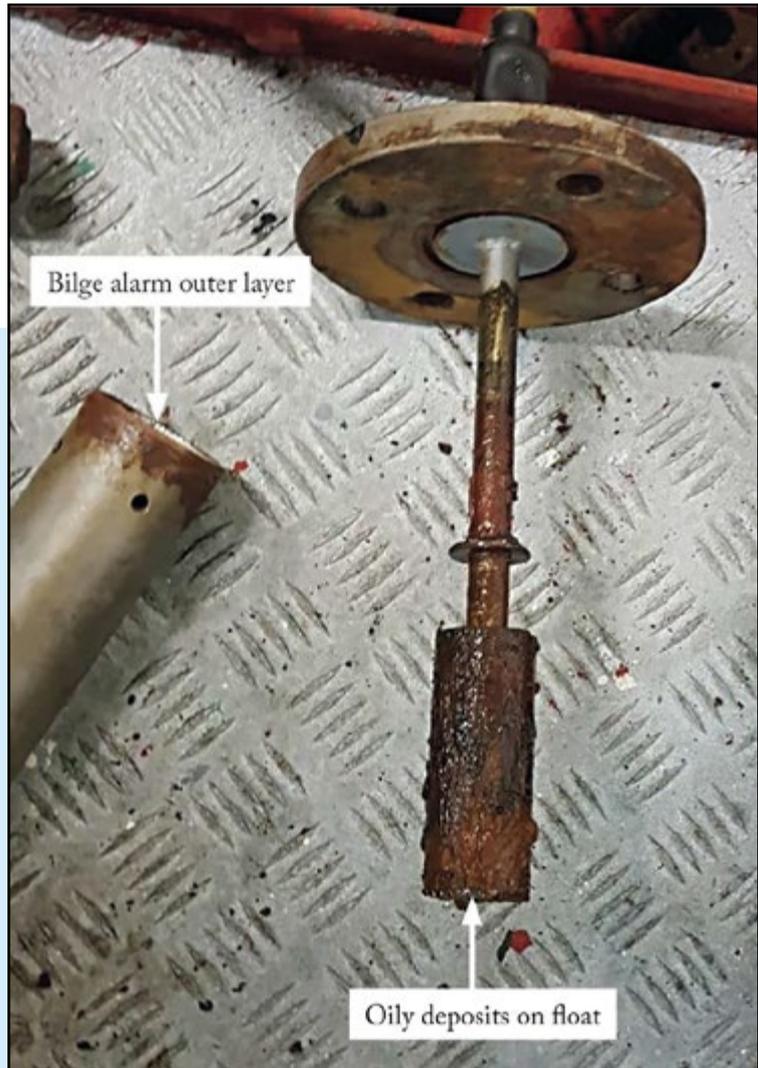
Figure 2: The disassembled bilge alarm, showing the build up of oily deposits on the float
