RISK ALERT

Dangers of working in and around Cargo Holds

Written by
Taslim Imad
Loss Prevention

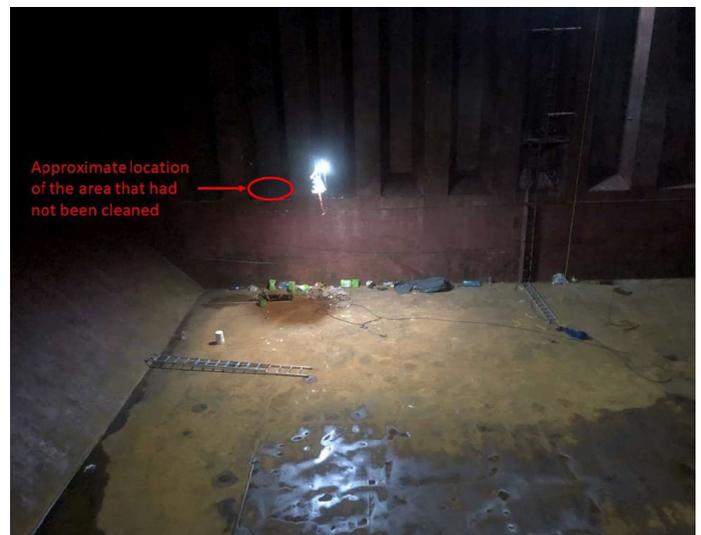
Cargo Hold No. 2 showing the approximate location of the accident.
(Source – [RMI investigation report](#))

Neither the Bosun or the AB could clean this area from the tank top and the AB decided to use a portable ladder that had been left in the hold from the previous working day. The portable ladder was not secured but held by the Bosun. The AB took the spray gun for the high-pressure washer, climbed the ladder and washed the dirty area. It was whilst descending the portable ladder that the AB fell 3 - 3.5 meters on to the steel deck, suffering serious head injuries. The AB died later that day.

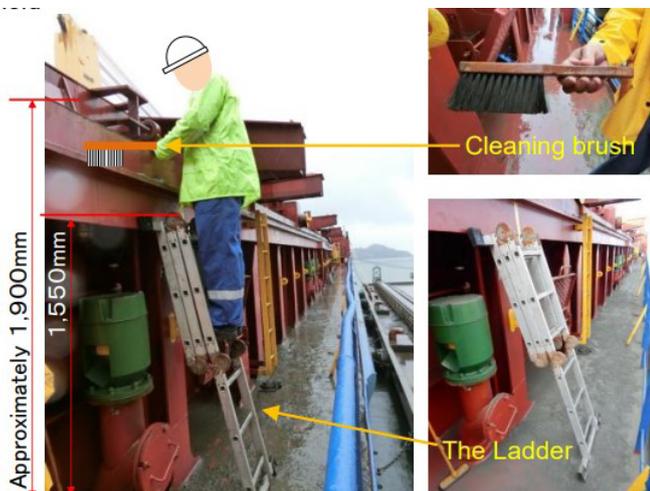
Cargo Hold No. 2 showing approximate location of the accident. (Source – [JTSB investigation report](#))

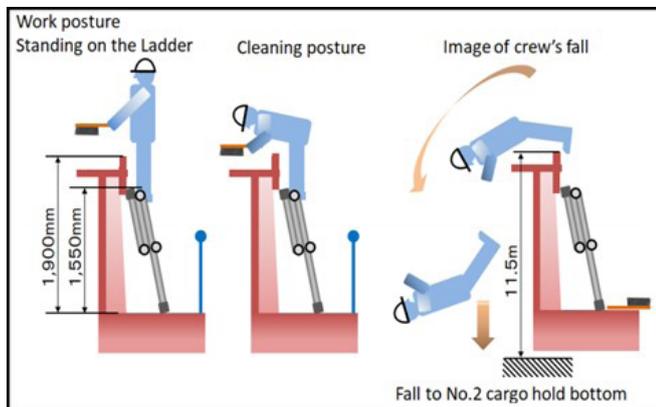
Work posture on the ladder and fall position at the time of the accident. (Source – [JTSB investigation report](#))

The AB, from his thigh and upwards was seen to be higher than the top of the hatch coaming and he was reported as having an unstable body posture. He fell forward, twisting his body as he tried unsuccessfully to clutch the upper hatch coaming with his left hand but fell from the hatch coaming to the bottom floor of the cargo hold. The AB was fatally injured.

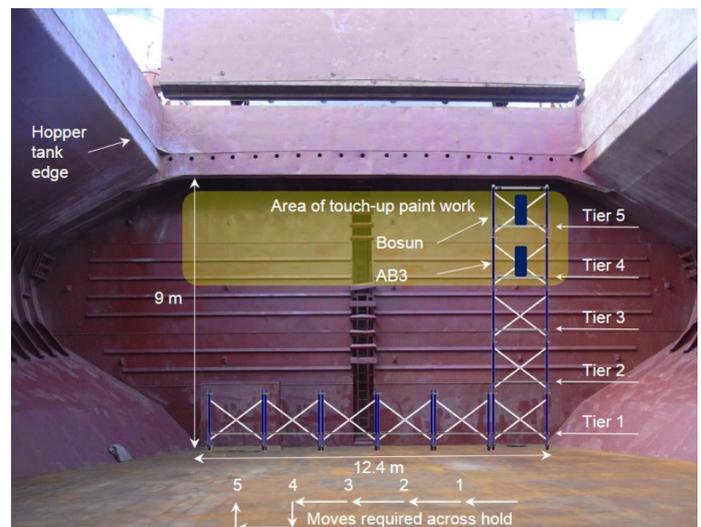
Cargo hold No. 4 scaffold arrangement and moved (Source – [Australian Transport Safety Bureau](#))

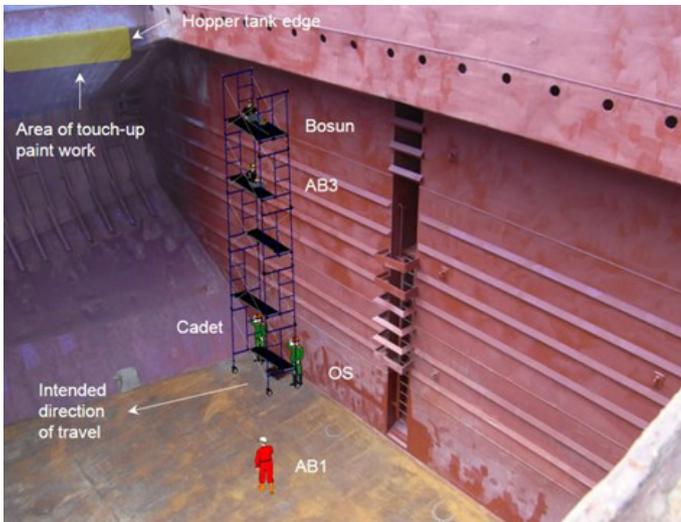
Cargo hold No. 4 scaffold arrangement and crew member at completion of work and direction of next move.

After lunch the crew returned to cargo hold No. 4, but the C/O did not return, he was resting in preparation for bridge watchkeeping duties. Painting in cargo hold No. 4 resumed and, as in the morning work session, the crew used a mobile scaffold tower to access higher areas of the bulkhead. However, during the afternoon session, the correct procedures were not followed and the two crew on the scaffold tower remained unsecured both whilst working and during repositioning of the tower. After painting of the aft bulkhead was completed, it was decided to paint the hopper tank edge, subsequently the scaffold tower was moved with the unsecured crew still on it. During this repositioning the scaffold tower became unbalanced and toppled forward onto the tanktop. The two crewmembers on the scaffold tower were seriously injured in the fall and were evacuated to a hospital ashore for treatment.

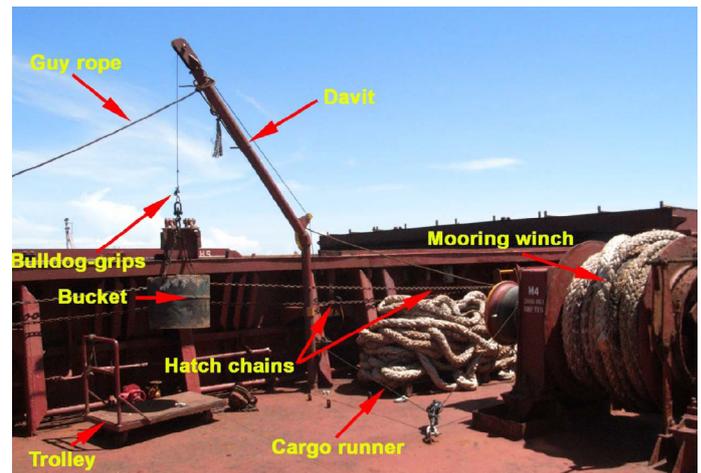
Portable cargo hold davit in position in Cargo hold No. 8

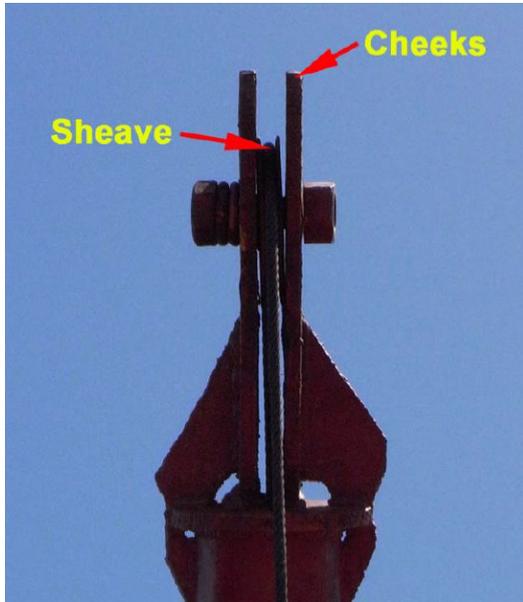
Davit Head - (Source – [Australian Transport Safety Bureau](#))

The bosun pulled on the bucket, trying to unsuccessfully to release the shackle from the davit head. The bosun pulled again on the bucket and on this occasion the davit moved. As the davit moved the bosun lost his balance, falling about 25 m into the empty cargo hold, landing on the tank top below resulting in the loss of life.

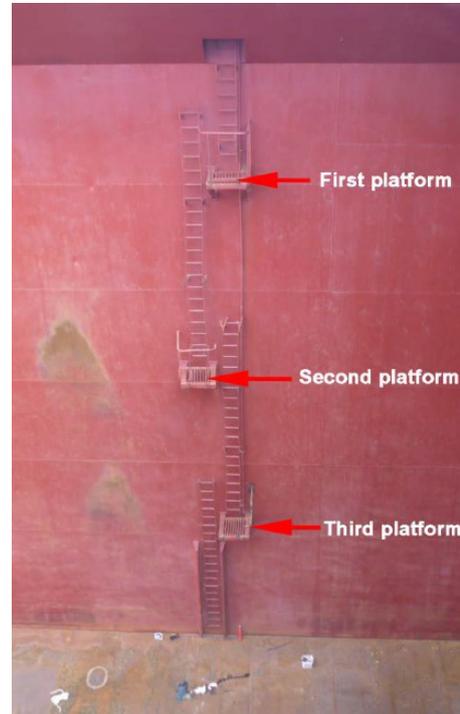
Ladder arrangement of Cargo Hold No. 5
(Source – [Australian Transport Safety Bureau](#))

After the lunch break, the storekeeper and OS lowered a small portable welding machine, the repaired hand railing and a bucket filled with tools to the second platform of the cargo hold. The storekeeper climbed down to the second platform (without a safety harness) and moved the equipment while the OS remained on deck. The OS could only see as far as the second platform because of the lighting, so he lost sight of the storekeeper at about this time. Approximately 5 minutes later, the OS heard a noise that sounded like something falling. He shouted to the storekeeper but received no reply so climbed down to the first platform to check what had happened. When he reached the platform he could see the storekeeper lying on the tank top. The OS climbed out of the hold and ran for help. The ship's staff tended to the storekeeper but his condition did not improve and he died as a result of his injuries.

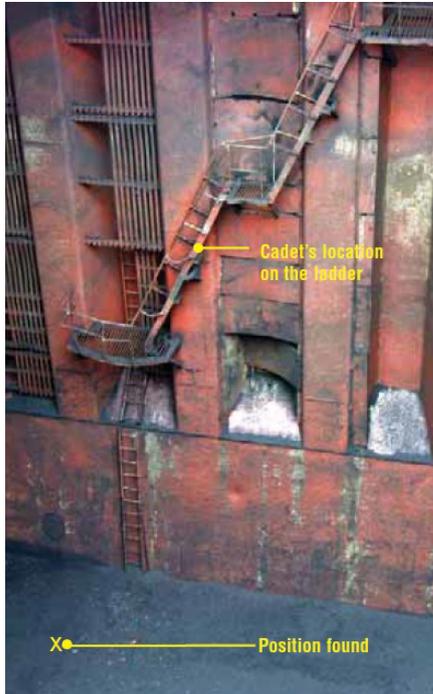
Ladder arrangement of Cargo Hold No. 6
(Source – [Australian Transport Safety Bureau](#))

On the day of accident, preparations were made to crop and replace damaged handrails on ladders in the forward part of cargo hold No. 6. The repair team, consisting of Chief Engineer, the first oiler and an engineer cadet, starting from the uppermost horizontal platform in the cargo hold, began identifying which handrails were to be cropped and once identified, began cropping damaged rails and welding new handrails. All three wore safety equipment, including safety harnesses. The engineer cadet, while standing about two metres above the C/E, suddenly fell approximately ten metres into the hold. He landed near the base of the lower vertical ladder and died from his injuries before Medivac could be effected.

The fall was not witnessed; however, evidence suggests that the cadet was leaning out over the handrails to observe the repairs and that he lost his balance. The cadet was wearing cotton gloves that would have afforded little grip when holding the new galvanised pipe handrails. The cadet had previously been wearing a safety harness but had released this to pass some materials to the chief engineer. His safety harness was not secured at the time he fell.
