Issued February 15, 2022

MIR-22/03

Grounding of Fishing Tender Barge *SM-3*

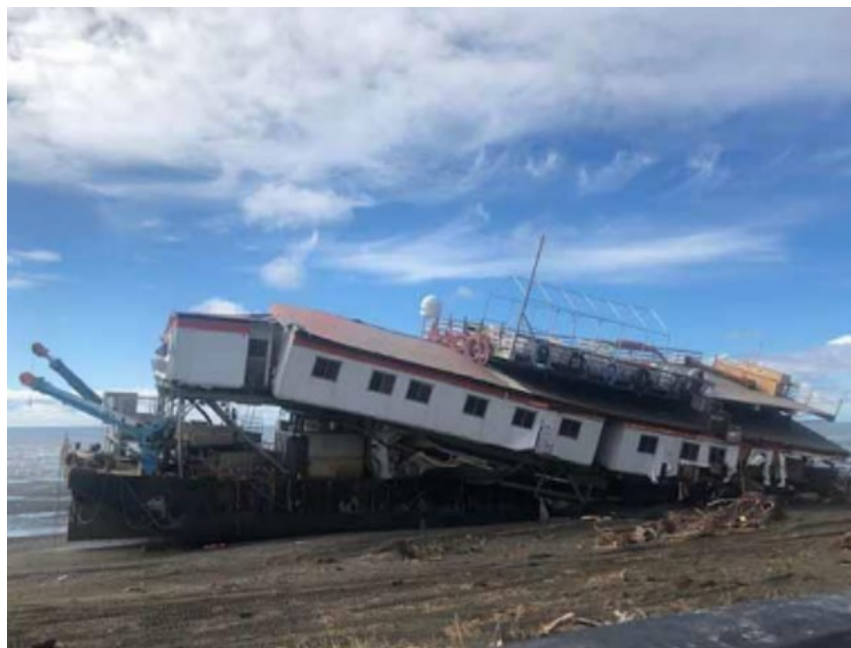
Figure 6. *SM-3* after the grounding. (Source: Alaska Marine Surveyors, Inc.)

On September 3, a marine surveyor attended the grounded barge in Ekuik. The surveyor's preliminary damage report stated that the barge's hull sustained structural damage in the engine room. Additionally, the superstructure, which included the top, berthing, and main decks, had collapsed on and crushed the fish house, and the entire superstructure was shifted to the starboard side partially on the beach. The report stated that there was an extensive debris field, which extended 1.5 miles on each side of the barge, and a slight diesel odor. The cost to repair the barge and replace equipment was estimated to be \$4.5 million.
