Investigation Report 282/20

Serious Marine Casualty

**Grounding of the RUBINA
after steering gear failure
on the River Weser
on 27 August 2020**

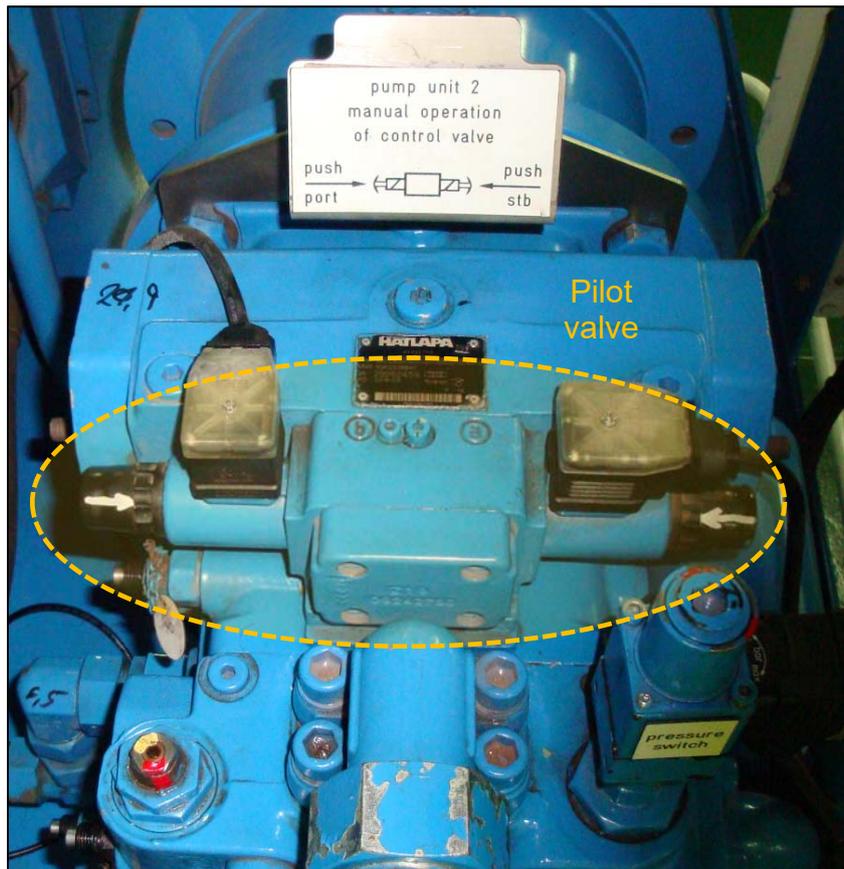
Figure 10: Steering pump 2's pilot valve, incl. brief guide for the emergency control

The cause of the non-responsive rudder was found to be a pilot valve of steering gear pump no. 2, which had stuck in an open position for a while. It was not possible to establish conclusively what had caused the pilot valve to stick.

The **pilot valve** actuates the **main pump's** control piston. Depending on the valve position (and thus the angle of the **axial piston pump's** sliding disc), the hydraulic oil is directed into the chambers at the flow rate necessary for a steering gear movement to port or starboard. It sets the required rotation of the rudder blade in motion. Therefore, manual operation of this **valve** is one possible emergency steering mode.

It was suspected that the valve had stuck due to a tiny contamination, e.g. a very small piece of metal filing. This had probably jammed the sliding surface of the valve's control piston, and later come loose during the manual emergency operation (directly at the valve). It could not be found afterwards. According to the service engineer, it is known that this can happen. He was not able to establish the ultimate cause of the problem.

- Since no faults were found on the automation side, a mechanical problem must have caused the accident.
- The pilot valve of pump no. 2 apparently stuck in an open position for a while due to a small contamination. Briefly, it remained fully open and pumping to the starboard side.

Steering pump no. 2 must have been the source of the problem (the 'Overload' alarm had triggered there). Therefore, the RUBINA's chief engineer decided to replace this pump completely as a precaution, following the recommendation of the service engineer. This was carried out on 18 September 2020 in the next port (Houston). It was purely a precautionary measure deemed necessary in view of the accident (the service engineer had not been able to detect any damage to the pump).

After careful troubleshooting, the rudder pump with the stuck valve was completely replaced, as mentioned above. This exceeded the measures that would have been necessary following the service engineer's troubleshooting, but was consistent with his recommendation. The RUBINA's rudder has not jammed again since then.

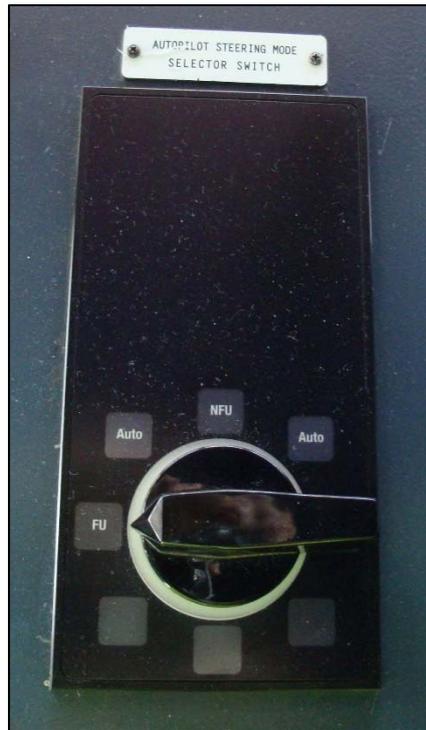
Figure 12: Steering mode selector switch
(FU: hand wheel; NFU: tiller; auto: autopilot)

What occurred on the RUBINA was an *unintended and automatic* activation of the override. The helmsman had put the hand wheel to midships, but the rudder remained at 15° starboard ('steering failure').

Due to this unchanging system deviation, the override automatically engaged after three seconds, and the Steering Failure Alarm sounded. This means that NFU mode (and thus the NFU tiller) was activated, even though the hand wheel was still selected as input device (steering mode selector switch was on FU, see Figure 12 and Figure 17). The closed-loop control was therefore inoperative from the moment the alarm sounded, and none of the switching contacts for the originally selected FU mode had an effect. In other words, the rudder orders via hand wheel had no effect from this point on.

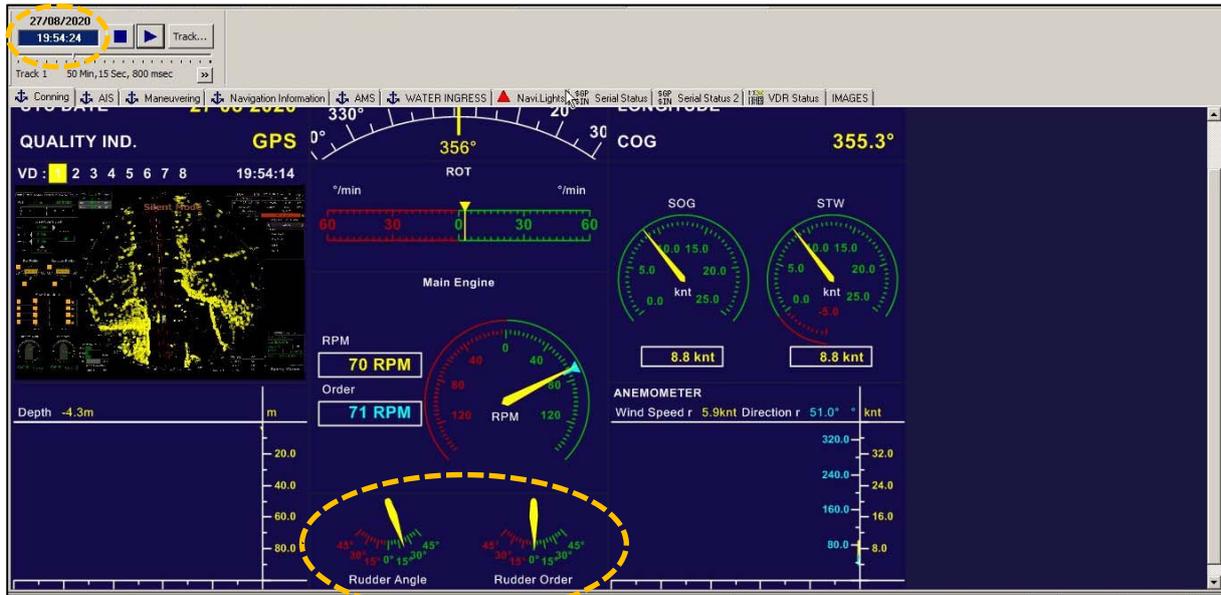
Figure 14: VDR: Non-responsive rudder (first occurrence)²⁸
(215424 local time)

For example, the system deviation between the rudder angle of 15° starboard and the rudder order (midships) on the hand wheel at the time it first occurred is clearly visible (see Figure 14).

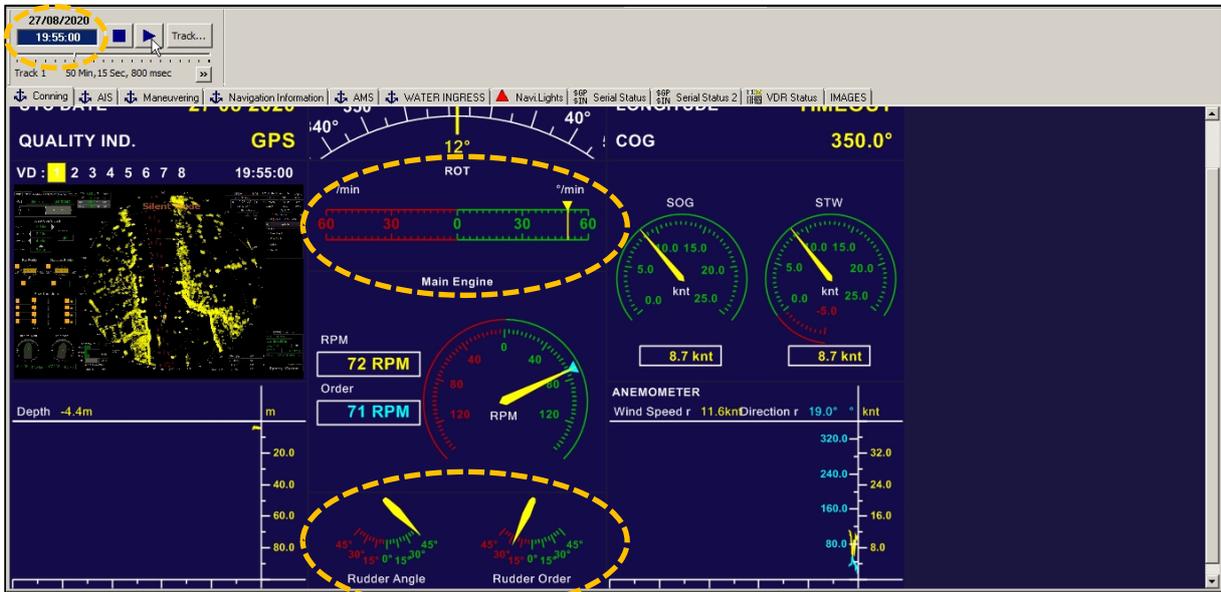
Figure 15: VDR: Hard-over rudder angle and ROT about 30 seconds later (215500 local time)

About 30 seconds after failing to respond for the first time, the rudder had already deflected to the hard-over angle (despite the hand wheel position in the opposite direction – see rudder order). The ROT is already about 50 °/min. (For both see Figure 15.)

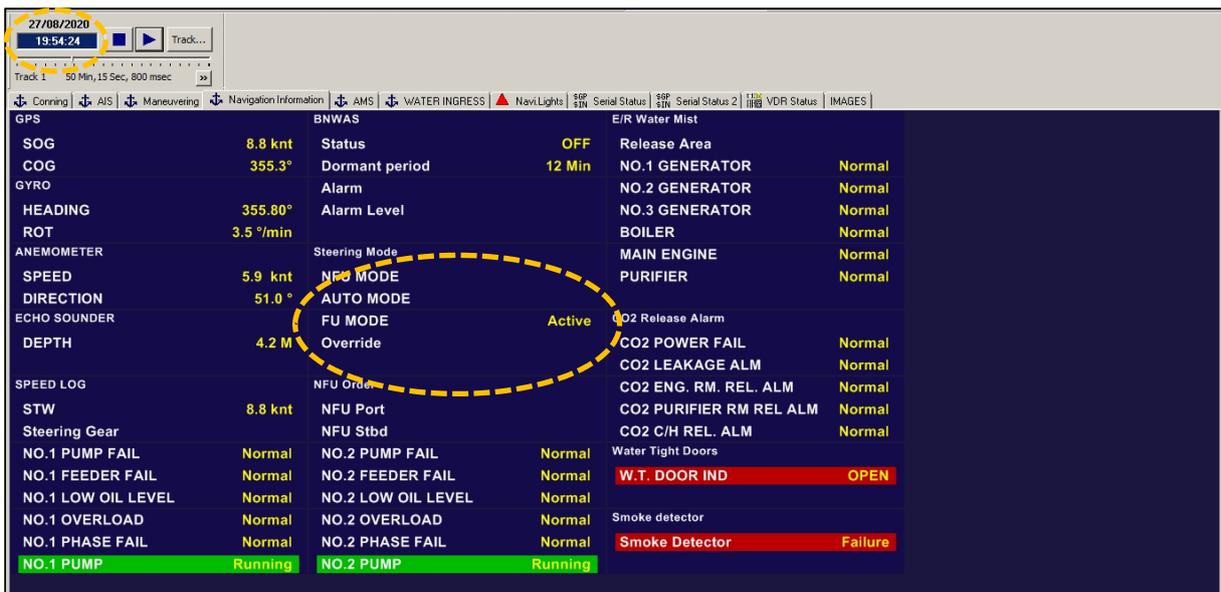
Figure 16: VDR: Non-responsive rudder (first occurrence) (215424 local time)

(The closed-loop control is still trying to compensate for the system deviation and is not indicating any kind of failure.)

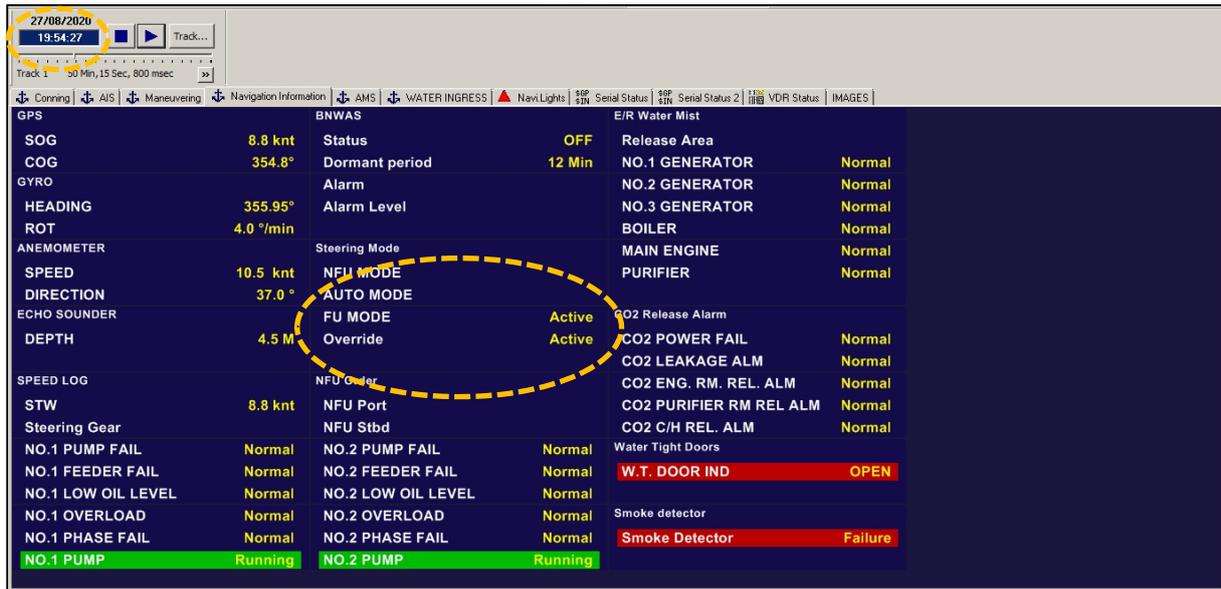
Figure 17: VDR: Override about three seconds later (215427 local time)

(Since the closed-loop control was unable to resolve the problem, the first emergency steering stage, i.e. the override, was activated.)

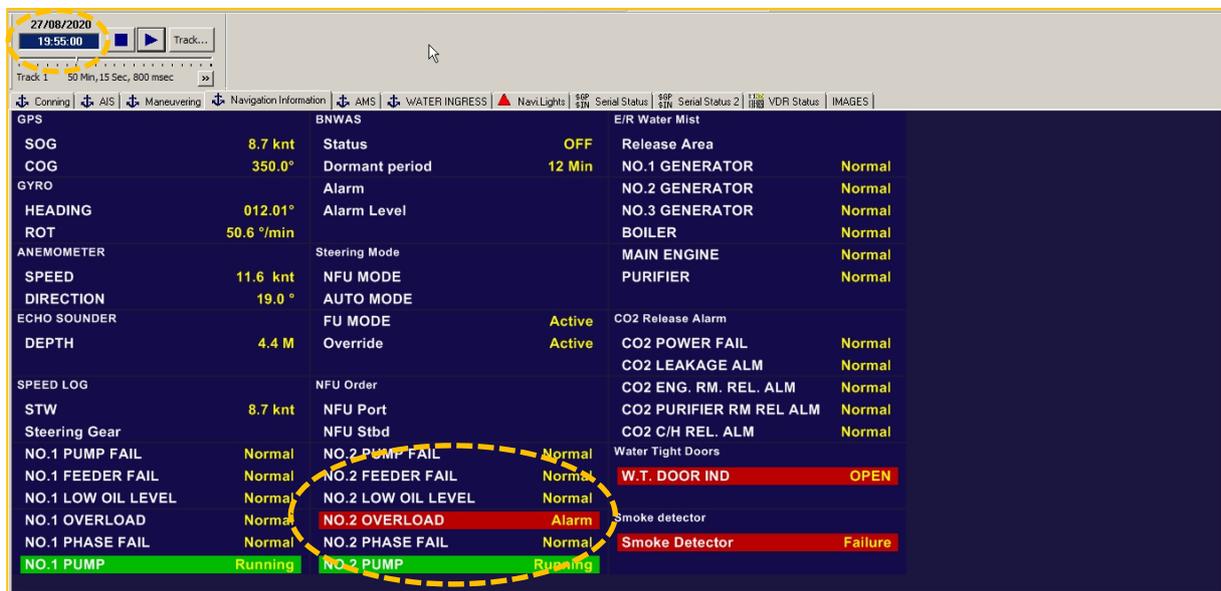
Figure 18: VDR: Steering gear pump alarm (215500 local time)

A good 30 seconds after the first occurrence, the 'Pump No. 2 Overload' alarm first showed (Figure 18)²⁹.

²⁹ On the alarm panel on the bridge, it only showed up as a general steering gear alarm.

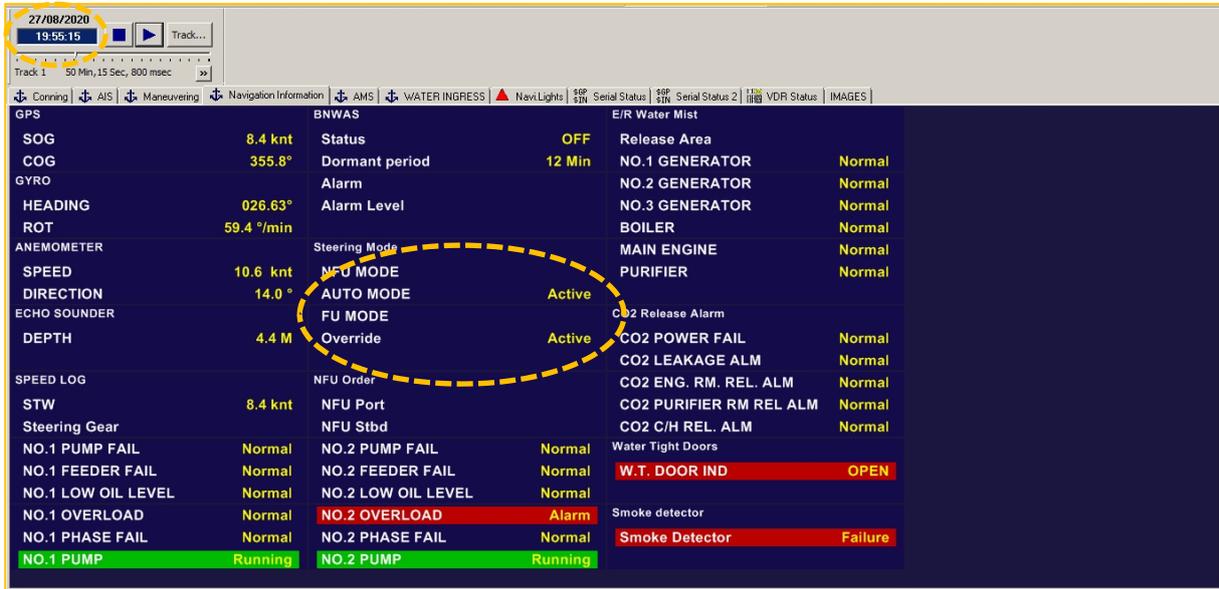
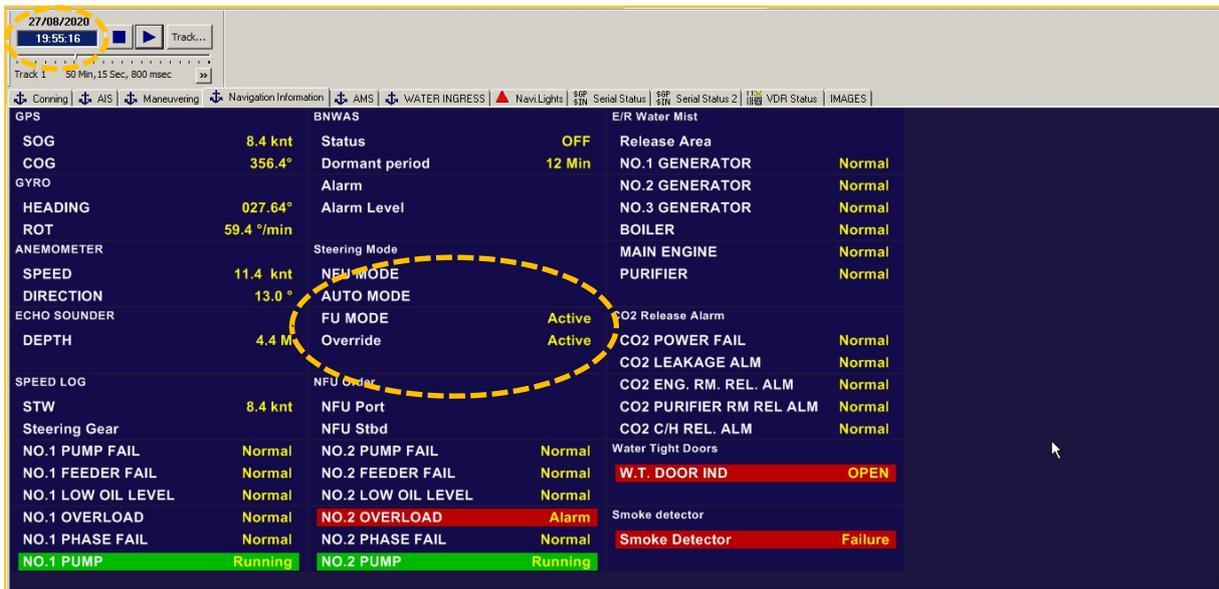
Apparently, several unsuccessful attempts were made to regain control of the hand wheel by switching to 'Auto' steering mode and immediately back again. The VDR data clearly show this (Figure 19 and Figure 20).
