Issued March 23, 2022

MIR-22/10

Fire aboard Fish Processor *Aleutian Falcon*

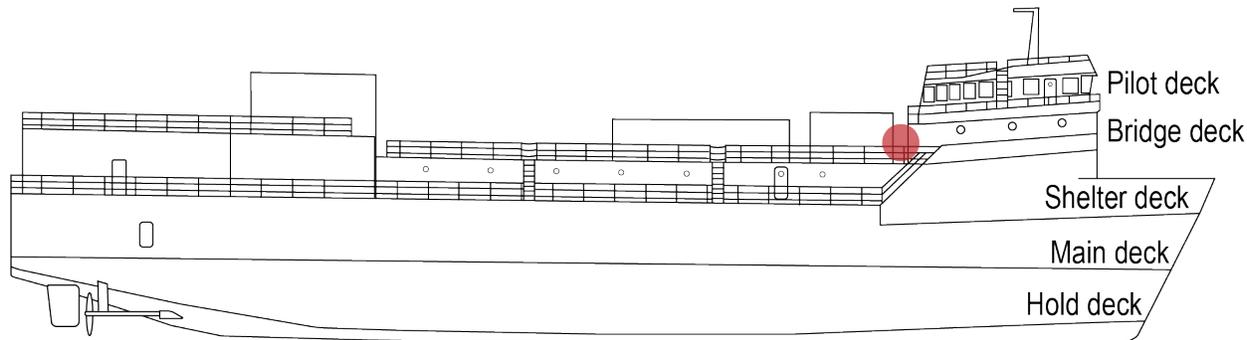
Figure 3. *Aleutian Falcon* profile, with initial location of fire indicated with a red circle. (Background source: Trident Seafoods)

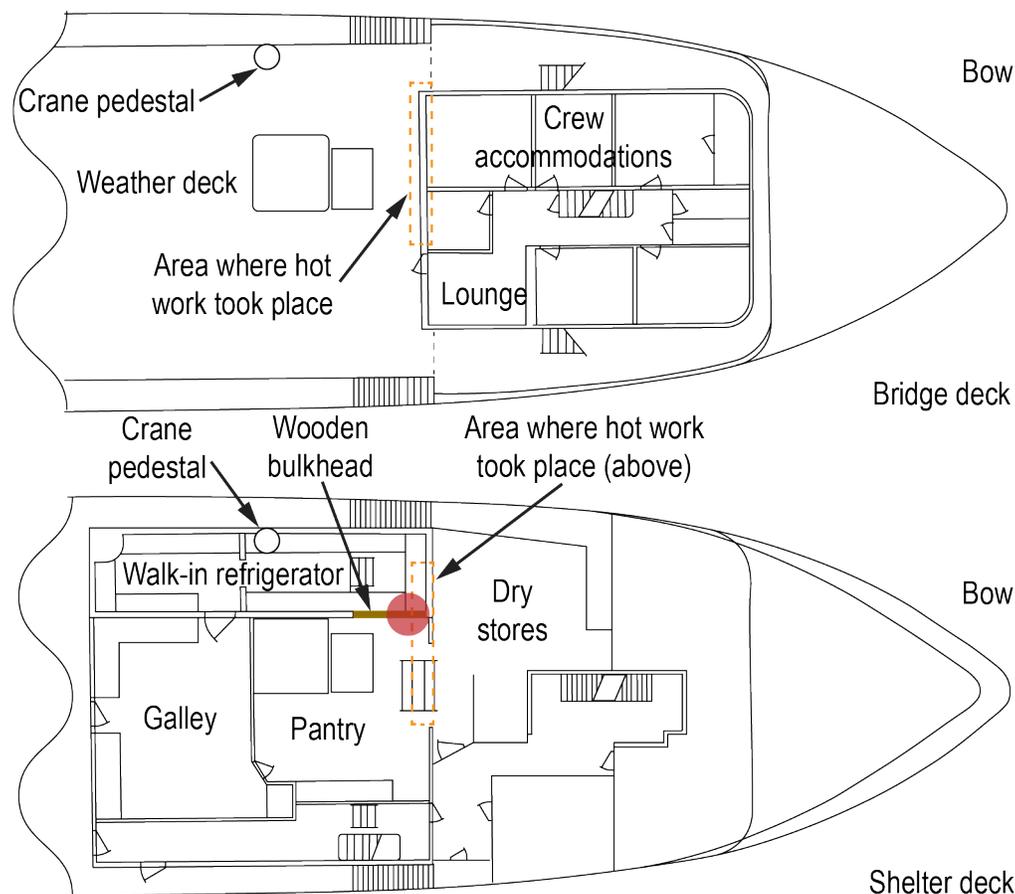
Figure 3. Bridge and shelter deck arrangements of *Aleutian Falcon*. The area of the bridge deck where the deck was being cut is highlighted with orange dashed lines. The area where the fire began on the shelter deck is indicated by a red circle. (Background Source: Trident Seafoods)

Based on the damage to the vessel's walk-in refrigerator and dry stores area, as well as the ATF's preliminary findings, the fire's most likely area of origin was near the longitudinal wooden bulkhead located forward in the walk-in refrigerator space, adjacent to the pantry, and aft of the dry stores area, located directly below the area where hot work had been completed for the day. The hot work would have produced sparks and slag that likely traveled from the deck above (overhead) into the wooden bulkhead separating the walk-in refrigerator and pantry, igniting the combustible materials in the area, as well as the bulkhead, and allowing for a smoldering fire to become established. Because of the fire's location, it would have likely gone unnoticed by a fire watch before they departed the vessel about 1 hour after work was completed for the day about 1631. Once the fire developed further, it was likely detected by the vessel's fire-detection system hours later; however, the system would have alarmed only in the pilothouse, an area that was unmanned at the time, so no one was alerted. The shipyard had a security guard who walked by the ship at 2122, but he did not notice anything unusual. Because no one was aware of the fire, it continued to grow and spread, until it became large enough for a passerby to report it about an hour later. The delay in recognition allowed the fire to expand to a point that responding firefighters could not enter the vessel, and the *Aleutian Falcon* was extensively damaged above the waterline.

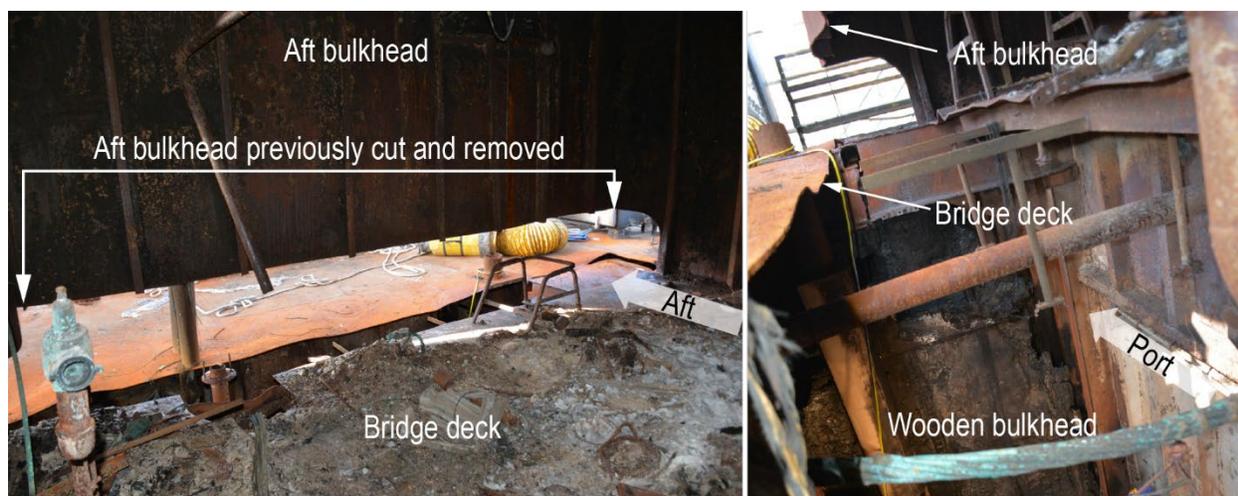
Figure 4. *Aleutian Falcon* bridge deck post-fire, depicting hot work area on the day of the casualty. (Background source: Bureau of Alcohol, Tobacco, Firearms and Explosives)

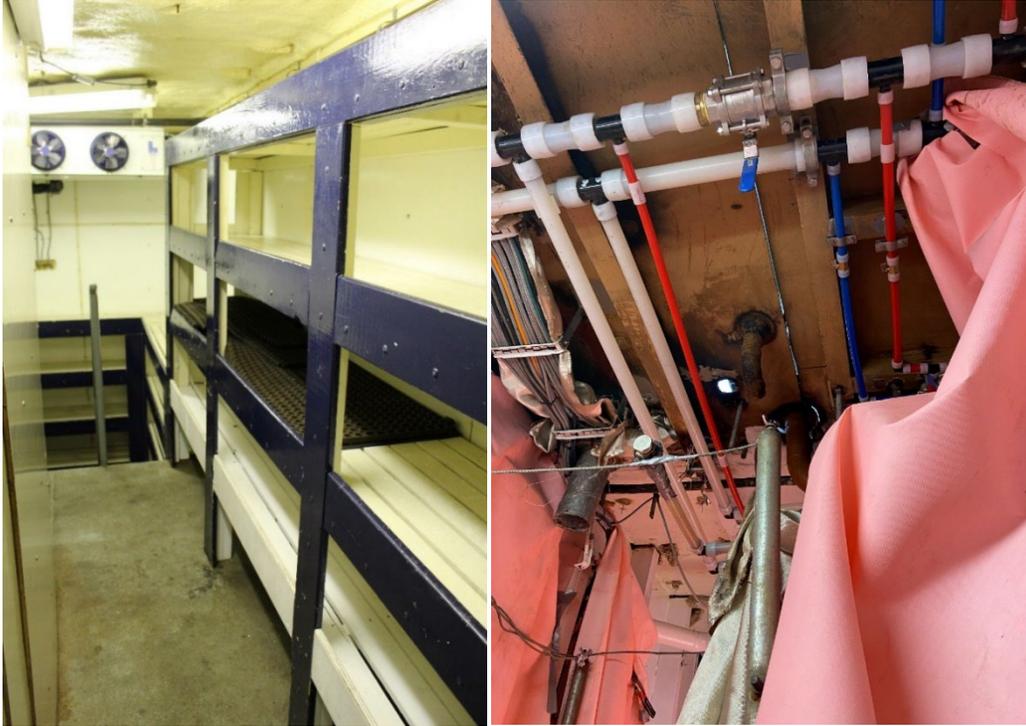
Figure 6. Pre-fire photos of the forward portion of the walk-in refrigerator (*left*) looking forward, showing overhead evaporator, wooden shelving, and step-down area, and the dry stores area (*right*), looking to port and overhead, containing draped pink fire blankets. (Source: Trident Seafoods)

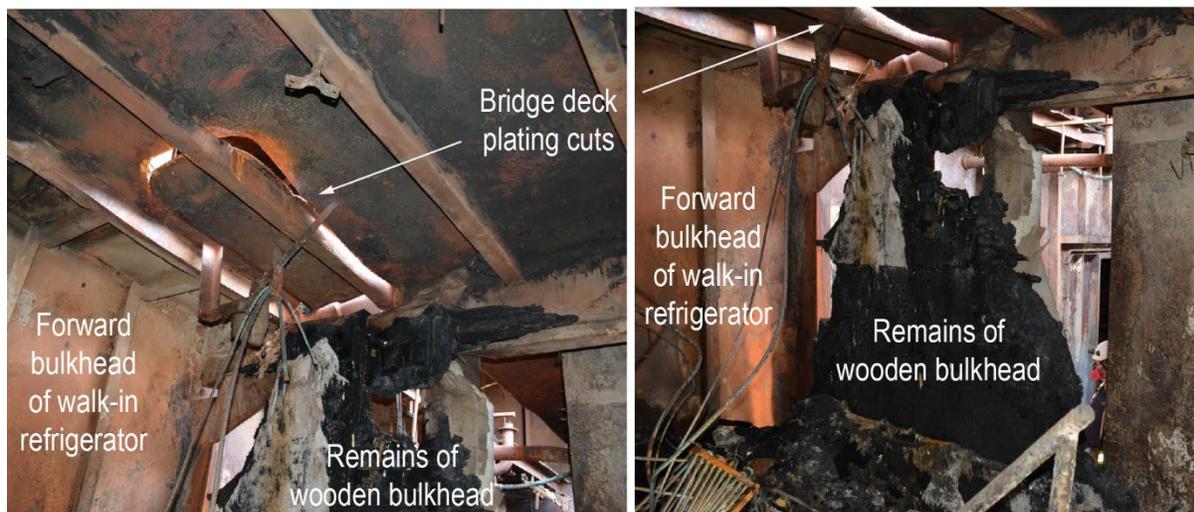
From March 1 to 3, fire investigators from the Bureau of Alcohol, Tobacco, Firearms and Explosives (ATF) examined the *Aleutian Falcon* at the request of the US Coast Guard. On July 16, the ATF issued a preliminary report; they determined that the fire was “accidental” and that the ignition source was hot slag from the hot work being performed in the walk-in refrigerator area and pantry, including the bulkheads of the spaces, which ignited combustibles such as cardboard, plywood, and polyurethane insulation. Release of the preliminary report and additional materials related to the investigation were prohibited by the ATF.

Figure 8. Forward end of *Aleutian Falcon* walk-in refrigerator after the fire. (Background source: ATF)
