SAFETY INVESTIGATION REPORT

REPORT NO.: 05/2022

MT SEASCOUT Explosion leading to equipment and structural damages in position 21° 07.1' N 059° 31.9' E 18 March 2021

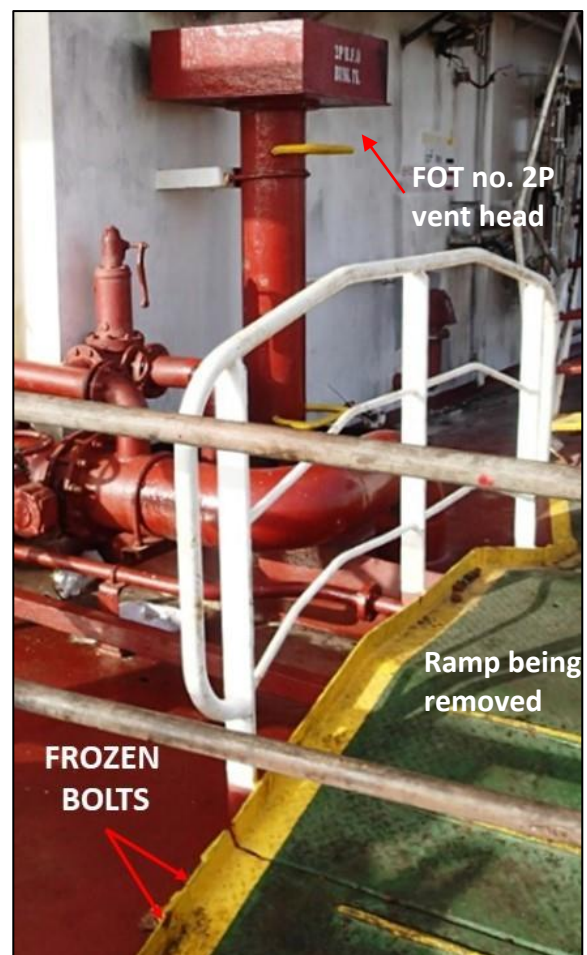
However, by the time the pumpman and the AB arrived at the technician's position, they observed smoke coming out of the vent of FOT no. 2P (Figure 3). The pumpman directed everyone to move away and clear the area. At around 1833, while the pumpman, AB and the technician were running towards the midship store to get fire-fighting equipment, the pumpman and AB saw a flash and flames from the air vent, followed by a loud explosion.

Figure 3: The location of occurrence

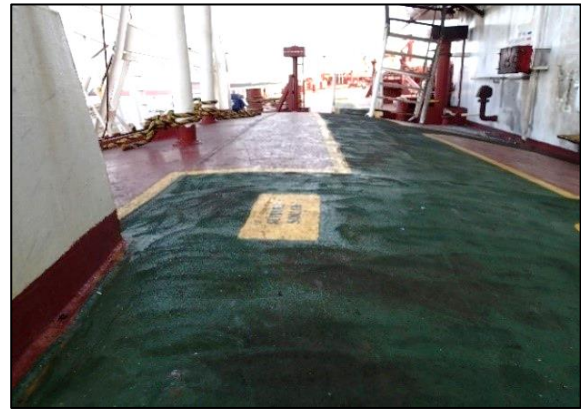
- deck deformation between frames 28 and 46 (Figure 4);
- buckling of the side shell and internals between frames 28 and 46, in way of the main deck to the second deck;
- buckling of the forward bulkhead inside FOT no. 2P;
- buckling of the aft bulkhead inside FOT no. 2P;
- misalignment of the port side lifeboat davit;
- damage to the foundation of no. 1 liferaft; and
- damage to the stairs leading to the lifeboat platform.

Figure 4: Bulging of the open deck, directly above FOT no. 2P

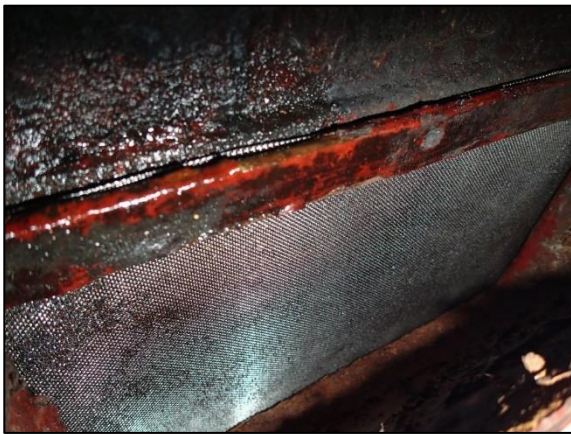
The safety investigation considered that spark(s) and high temperature particles⁷ either passed through the mesh of the flame arrestor, or landed inside the save-all of the tank head, leading to the explosion. Oily / waxy residues on the flame arrestor (Figure 5), found after the accident may have contributed to the flame propagation at the tank's vent head and into the tank.

Figure 5: The flame arrestor of the vent head of FOT no. 2P after the occurrence, indicating oily / waxy residues

4. Oily / waxy residues on the flame arrester (Figure 5), found after the accident may have contributed to the flame propagation at the tank's vent head and into the tank.

- The planned maintenance schedule was updated to include bimonthly inspections of the vent heads, for the removal of any accumulated oily and waxy residues.

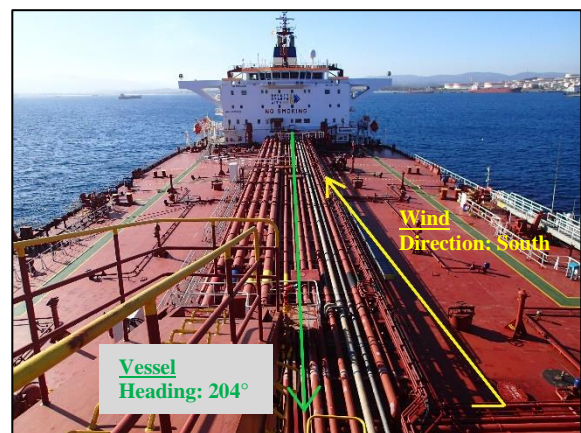
Figure 6: Wind direction relative to the vessel's heading

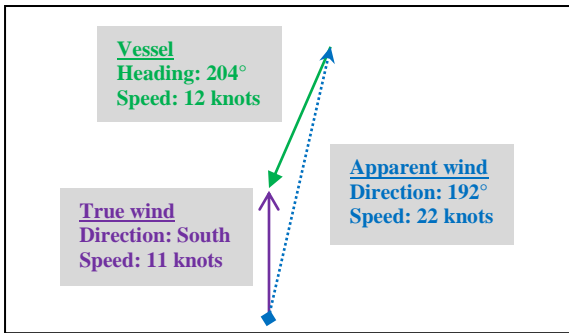
Heating up of the fuel closer to its flashpoint must have resulted in an increased generation of gases, which would ultimately be vented to the atmosphere via the tank's vent head. It so happened that for most of 18 March 2021, the vessel was heading on a course of 204° (T), at a speed of about 12 knots. Wind was blowing from the South at a speed of 11 knots (Figure 6). This would have created an apparent wind of around 22 knots approaching the vessel at a close angle on its port side (Figure 7).

Figure 7: Sketch indicating the approximate apparent wind experienced by the vessel at the time of occurrence.

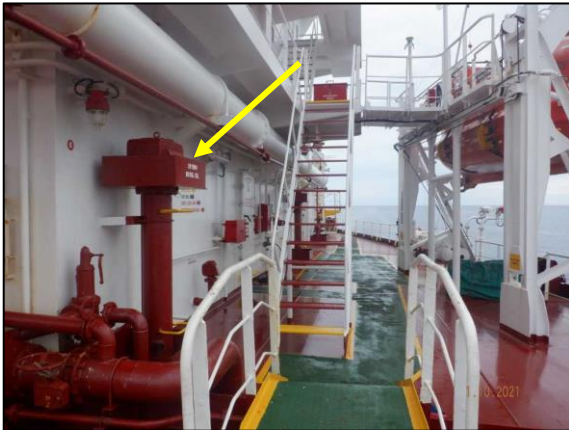
Considering that FOT no. 2P vent head was in a somewhat protected location, *i.e.*, against the port side bulkhead of the accommodation block (Figure 8), the safety investigation hypothesized that the direction of the apparent wind would have not been effective to disperse the vapours emanating from, and around the vent. One must also bear in mind that due to the motions of a vessel at sea, and the variable characteristics of the true wind itself, the direction and speed of the apparent wind would not be constant but would tend to fluctuate.

Figure 8: The vent head of FOT no. 2P against the accommodation block on port side

7. The vessel was experiencing an apparent wind of 22 knots from her port bow. This wind did not assist in the dispersion of the concentration of the flammable gas at the vent head. This suggested that the vent head was somewhat protected from this wind and/or the formation of eddies affected the dispersion of flammable gas.

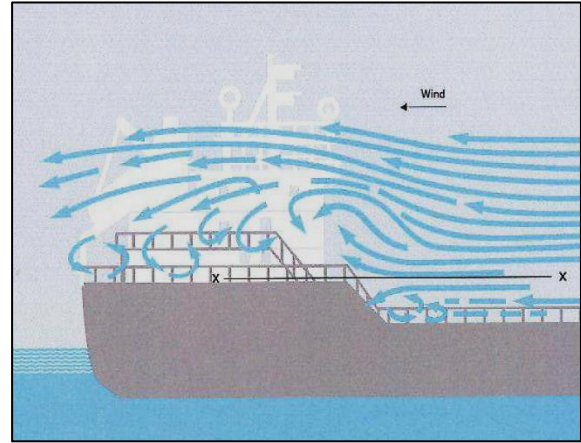
The safety investigation also considered the semi-protected location of the vent head, which may have led to the formation of eddies in its vicinity (Figure 9). This would have increased the risk of ignition of the vapours due to their concentration in one

area. The ISGOTT⁸ cautions on how eddies formed by turbulence (produced by obstructions to the wind flow), would adversely affect the effective dispersion of emitted vapours.

Figure 9: Typical pattern of airflow around the accommodation block

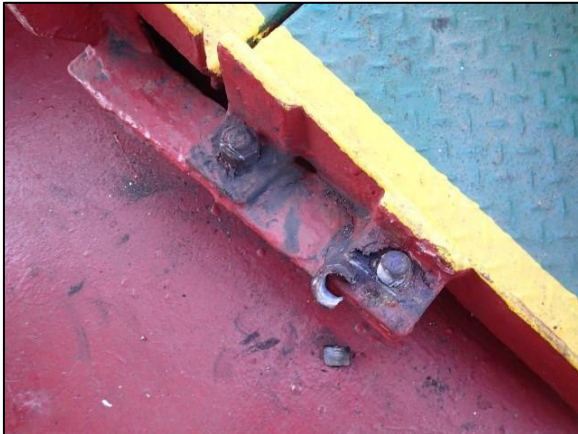
he took an angle grinder from one of the workshops, with the intention of cutting off the two remaining bolts (Figure 10).

Figure 10: One nut had been successfully cut by the angle grinder, before the explosion occurred
