Breakaway and grounding involving *CSC Friendship*.

Port of Brisbane, Queensland, on 27 February 2022

ATSB Transport Safety Report

MO-2022-003

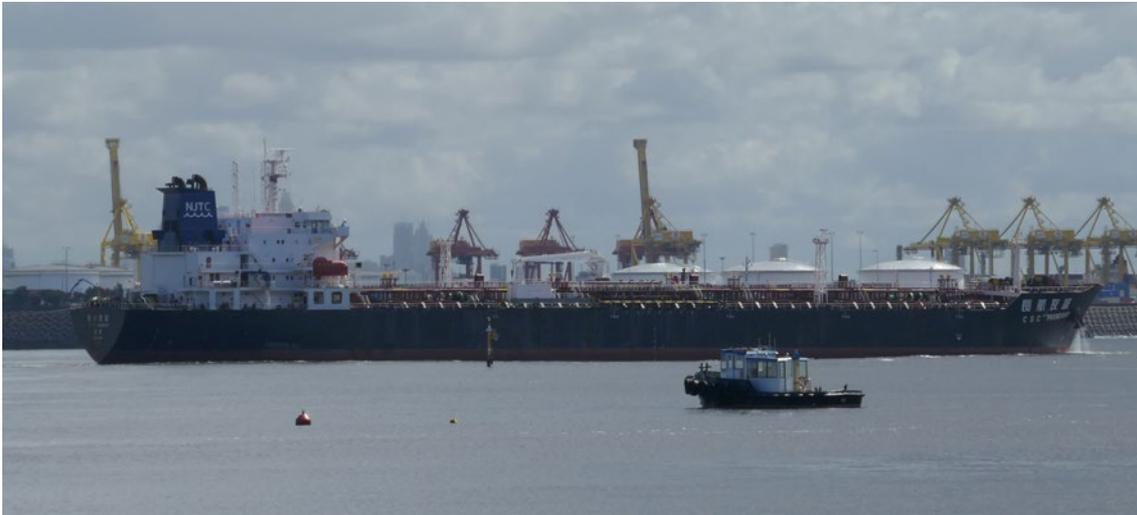
Figure 1: *CSC Friendship* arriving in Port Botany, New South Wales after the occurrence

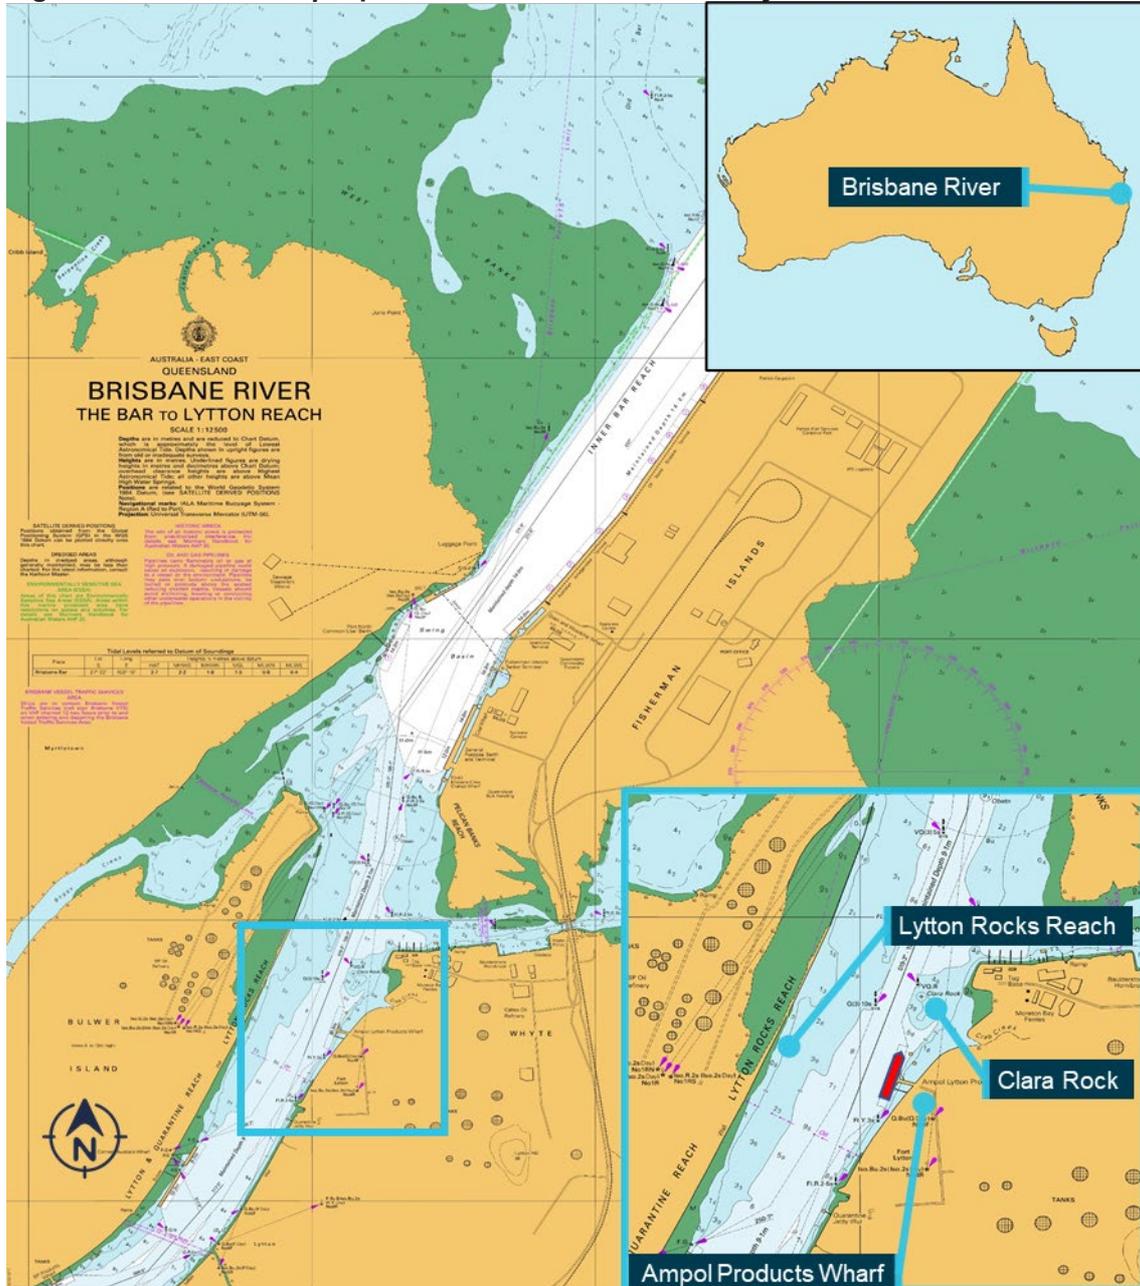
On the evening of 27 February 2022, the Hong Kong flagged product tanker *CSC Friendship* (Figure 1) was secure head-down¹ alongside the Ampol Products Wharf in Brisbane (Figure 2). It had completed loading of 25,000 tonnes of diesel oil and 7,000 tonnes of gasoline, which was bound for Adelaide.

Figure 2: CSC Friendship's position at berth in relation to Lytton Rocks Reach

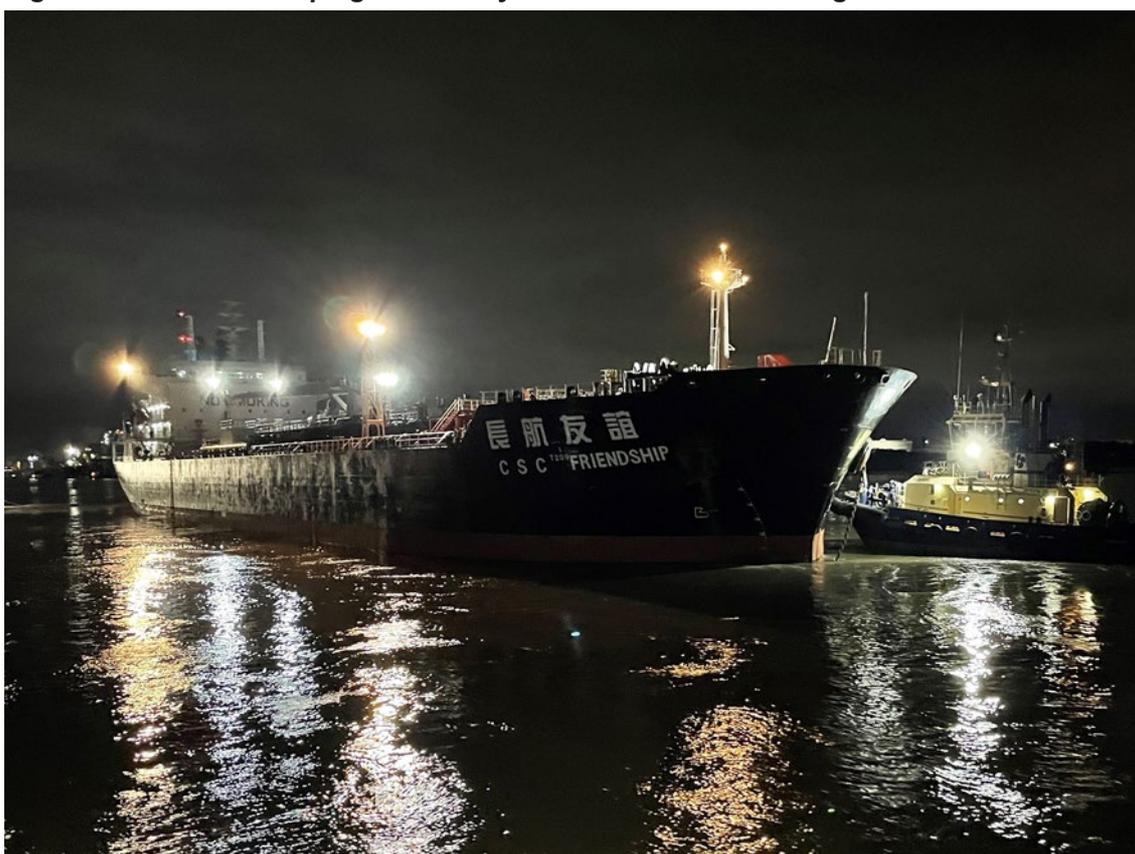
About 0028 on 28 February, with the 2 tugs unable to hold the ship alongside and the river current not abating, *CSC Friendship* broke free of the berth. The ship was swept downstream, across the channel and grounded east of and abeam Clara Rock beacon at Lytton Rocks Reach (Figure 3). A short time later, the additional tug, *Svitzer Newstead*, arrived.

Figure 3: *CSC Friendship* aground at Lytton Rocks Reach with tug in attendance

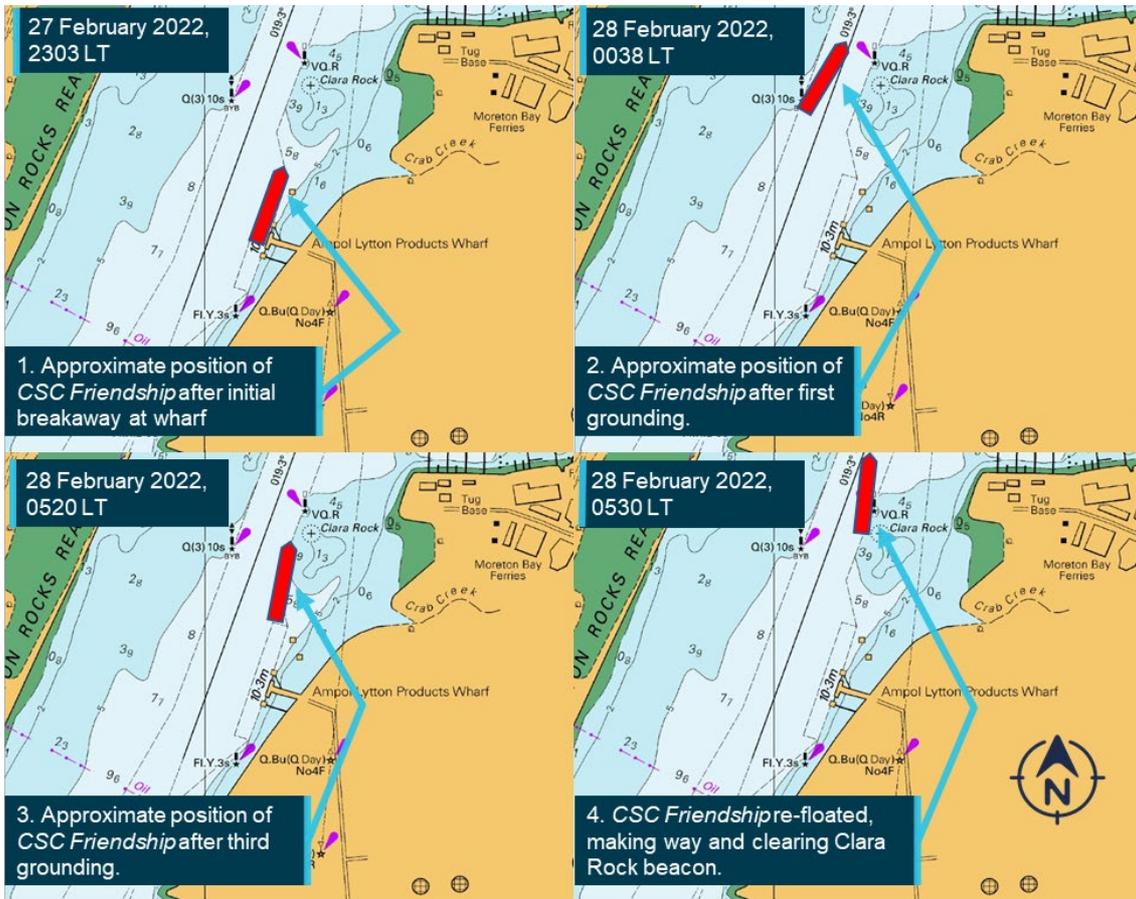
(Figure 4, top right). The pilot stopped engines and stood down the tugs, requesting one remain on station while the others managed their crew’s fatigue ready for another attempt at high tide.

Figure 4: Overview of *CSC Friendship*’s positions during the occurrence

quarter, the stern sheered rapidly starboard towards the Ampol berth and ran aground on the starboard quarter (Figure 4, bottom left).
