Collision involving the bulk carrier *Goliath* and tugs *York Cove* and *Campbell Cove*

Devonport, Tasmania on 28 January 2022

ATSB Transport Safety Report

MO-2022-002

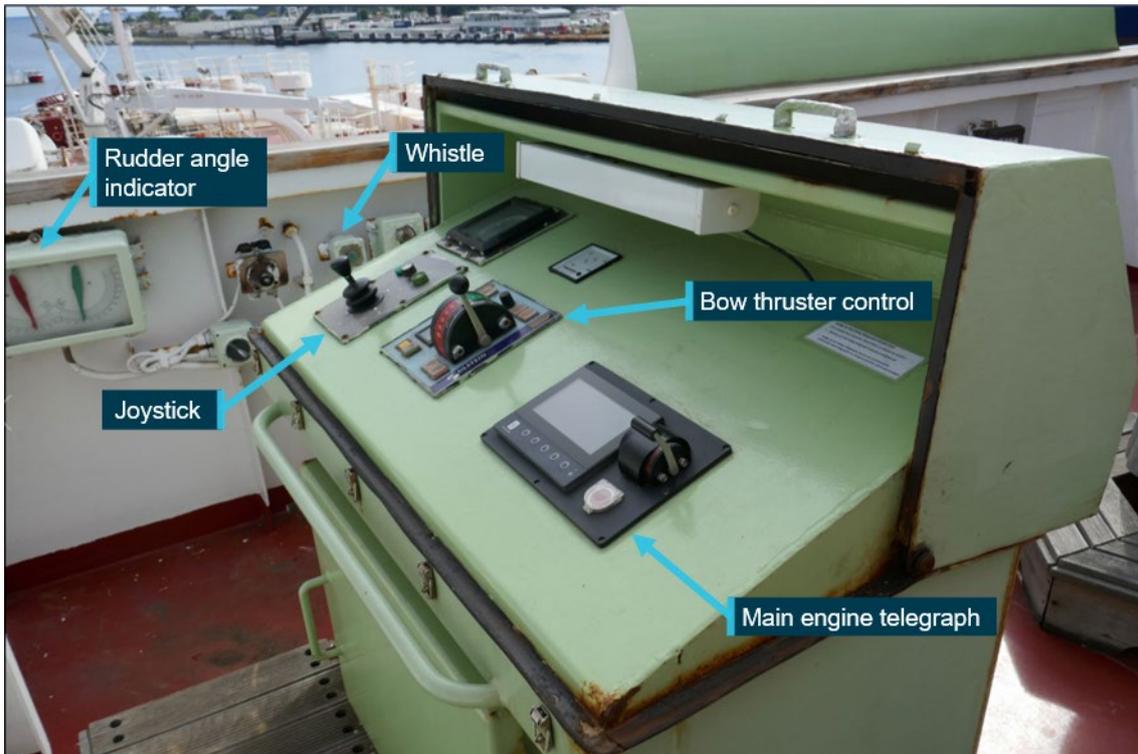
Figure 4: *Goliath's* port bridge wing conning station (looking forward)

As the ship's speed continued increasing, the master checked the rudder angle indicator located in front of the port wing console and found that both rudders were still amidships and not at the angles corresponding to the VecTwin joystick setting as expected. The master called out to the second mate that the steering was not in VecTwin steering mode and immediately placed the engine telegraph to 'stop'.

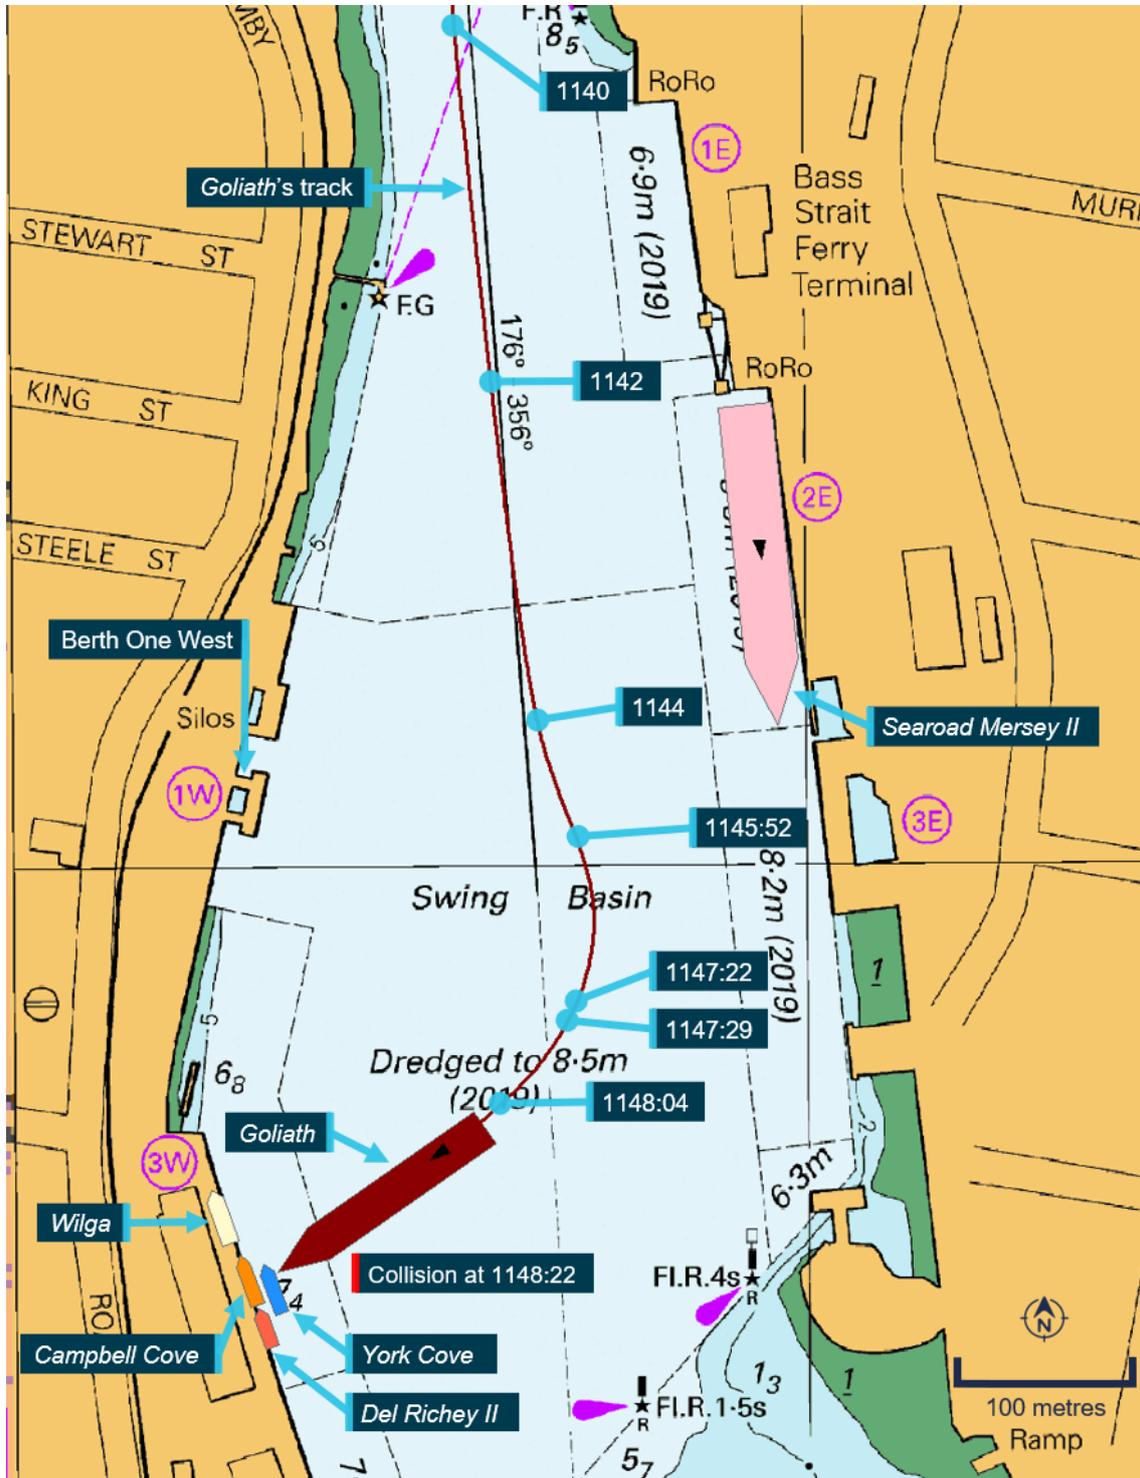
Figure 5: Section of chart Aus 164 showing Goliath's track and sequence of collision

As the manoeuvre progressed, the master felt that the ship was not swinging as expected and closing with two tugs moored at berth number Three West ahead. In an effort to arrest the ship's movement ahead, the master set the VecTwin joystick to the 'astern' setting⁷ and, at 1147:22, put the main engine 'half ahead'. A few seconds later, at 1147:29, the master used 'full ahead', but the ship's movement ahead continued to increase, with the speed now about 2.9 knots. Meanwhile, the bosun had begun reporting rapidly decreasing clearances to the tugs ahead. The bridge engine telegraph data logger shows that at 1147:41, the telegraph was placed at 'half ahead' before quickly being returned to 'full ahead'.⁸ At 1148:04, the master placed the telegraph at 'navigation ahead' (that is, maximum available rpm) as the ship's speed increased to 4 knots.

At about the same time, at 1148:22, *Goliath* collided with the two tugs while moving at a speed of 4.7 knots (Figure 6). The ship struck the tug *York Cove*'s amidships area on its starboard side. *York Cove* was moored outboard of and alongside the tug *Campbell Cove*. Both the tugs were severely damaged and began to take on water almost immediately. The tug *Wilga* and the fishing vessel *Del Richey II*, berthed to the north and south of the two impacted tugs respectively, were not impacted.

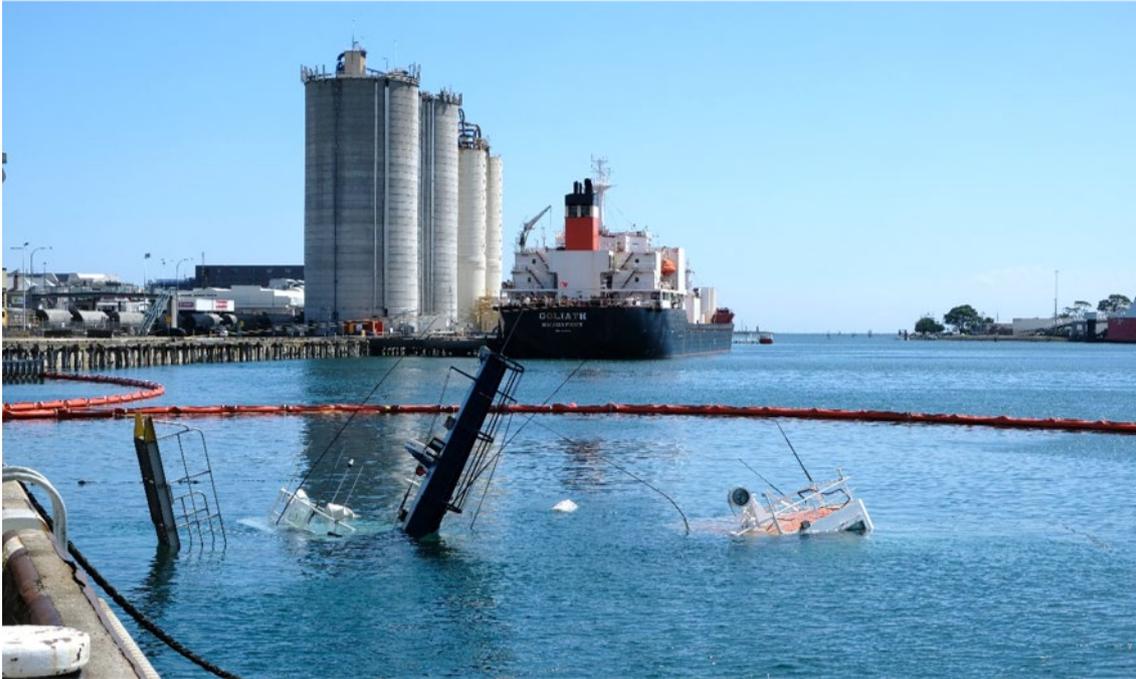
Figure 7: York Cove and Campbell Cove submerged alongside berth number Three West

By about 1700, both tugs had sunk in about 7 m of water alongside berth number Three West (Figure 7).

As a result of the collision, and subsequent sinking of the tugs, both *York Cove* and *Campbell Cove* were subsequently declared a constructive total loss (CTL).¹² Damage sustained by *Goliath* included deformation of the bulbous bow shell plating and internal structural members and, a non-penetrating crack in the bow’s starboard shell plate. The ship was detained by AMSA in Devonport while inspections, temporary repairs and other regulatory actions were carried out. On 4 February *Goliath* was allowed to sail to Melbourne for further repairs. On 10 February, after additional repairs and meeting other regulatory requirements, the AMSA detention was lifted and *Goliath* returned to service.

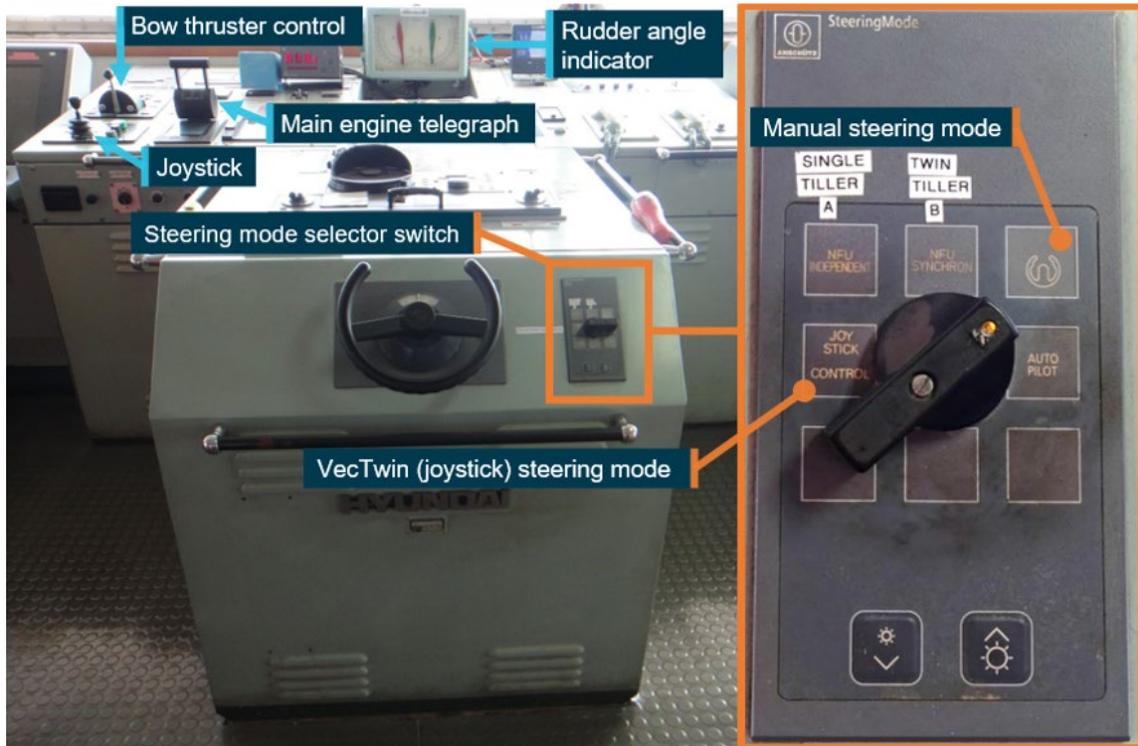
Figure 8: *Goliath's* wheelhouse, steering console and steering mode selector switch

On board *Goliath*, the second mate had run back into the wheelhouse, checked the steering mode selector switch on the steering console and found that it was still in manual steering mode. The second mate immediately switched it over to VecTwin (joystick) steering mode while the master placed the engine at 'half astern' followed by 'full astern' and, by 1148:31, at 'emergency astern'.

The mode of operation was selected by means of a manually operated selector switch on the bridge steering console (Figure 8). Rudder angle indicators were installed in the wheelhouse, one each on the port and starboard bridge wings, and in the steering gear room.
