# Investigation report

Report	
Report title Investigation of undesirable incident on Troll C on 24 October 2021 – revised	Activity number 001085030

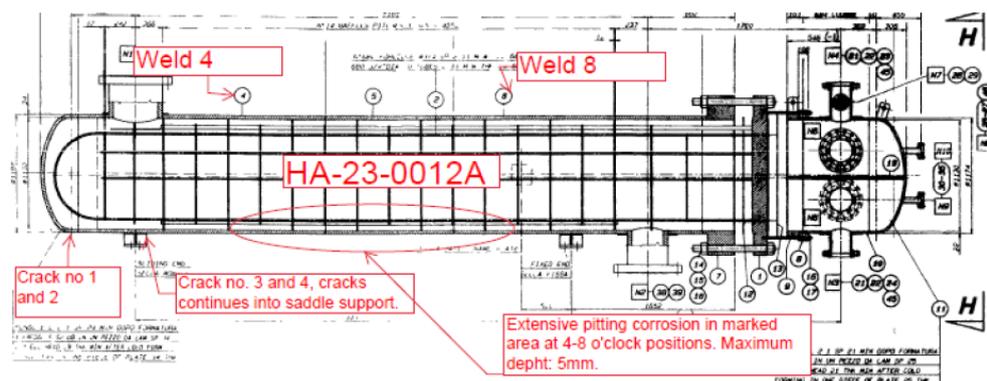
#### HA-23-0012A, skadeomfang etter utført inspeksjon

Possible leak sites on Troll C were inspected visually and cracking was later identified by penetrant testing on the outside of the cooler shell after the surface had been cleaned – first on the HTA cooler, where the leak was initially discovered, see figures 8 and 9, and then on the HTB cooler where the cracking was not as extensive.

Figure 8: Areas with crack indications and corrosion. (Equinor)

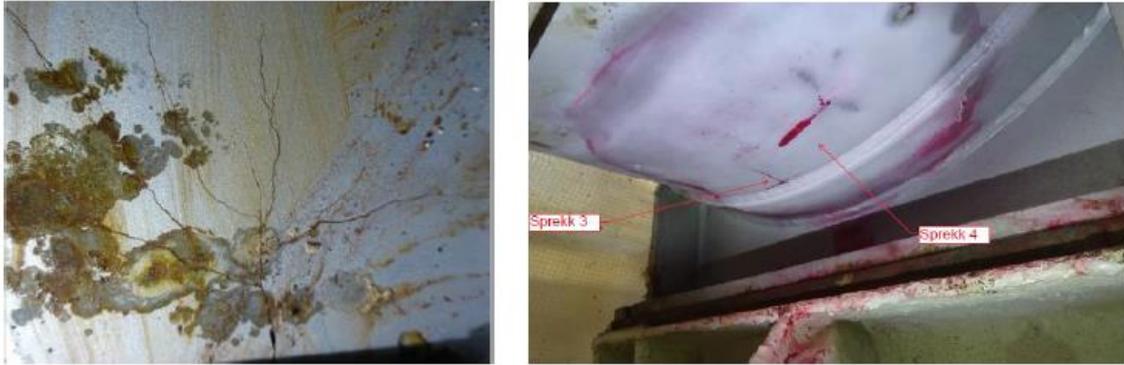
Figure 9: Visual images of crack 1 (left) and penetrant indications of cracks 3 and 4 (right). (Photos: Equinor)

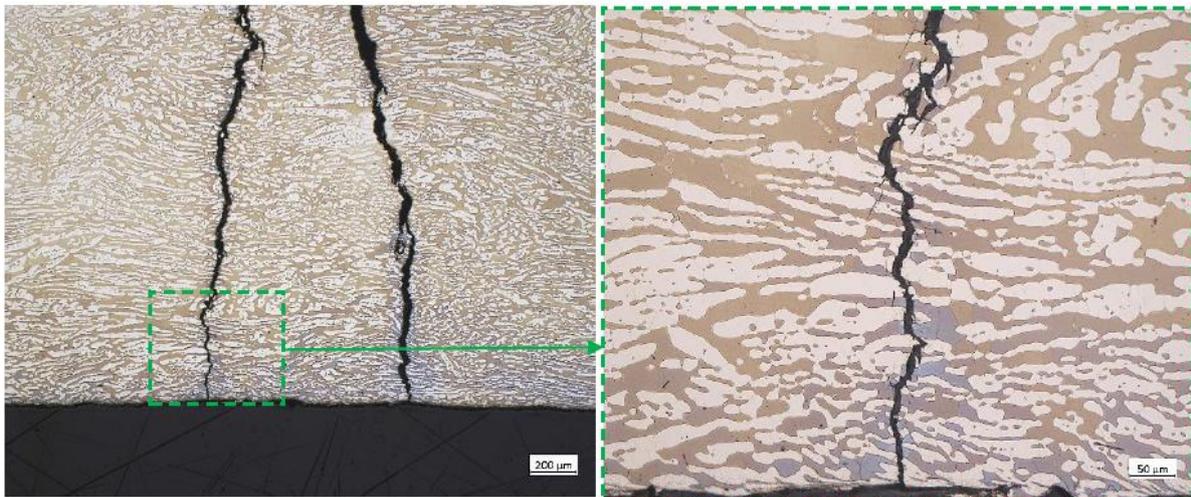
A disc 18 centimetres in diameter in full wall thickness was cut from the HTB cooler at the point where cracks were identified and subjected to technical investigations in Equinor's materials lab at Rotvoll. The microstructure (with ferrite dark and austenite light) and crack morphology are shown in the figure below.

Figure 10: The sample is taken in parallel with a weld, and the crack in the relevant cross-section therefore runs first through weld metal and then base material towards the inner surface. (Photos: Equinor)

It was concluded that the cracks were through-wall and caused by CSCC, which had begun externally. The material had a normal duplex microstructure in both weld and base material. No damaging intermetallic phases or welding faults were identified. The chemical composition, hardness and impact resistance accorded with Norsok M-630, data sheet D45.

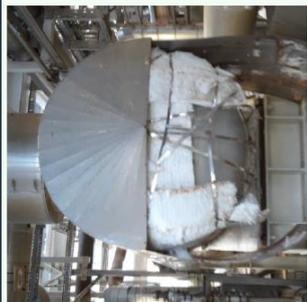
Pic. 1: Gas cooler after partly removal of insulation.

**How the damage was unveiled:**  
 During a routine area check asphaltene was observed on the underside of the insulation on the 2<sup>nd</sup> stage gas cooler. Upon stripping and inspection cracks and pitting were identified.

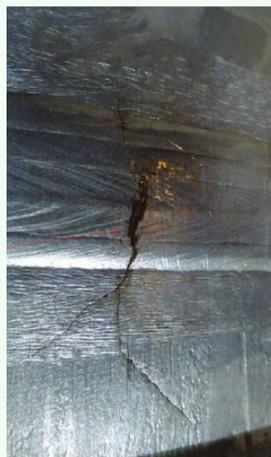
A test piece of the cracked material was cut out and subject to further examination. Results from the material examination showed chloride stress corrosion cracking. An internal investigation has been commissioned and a report will be published when ready.

Pic. 2: Field observation on gas cooler.
